FIRE SAFETY INSPECTION REPORT

UNIVERSAL MENSWEAR LTD
PLOT # 234-238, 252-254, ADAMJEE EPZ,
NARAYANGONJ - 1800

ACC   **RD**
on Fire and Building Safety in Bangladesh

July 6, 2014

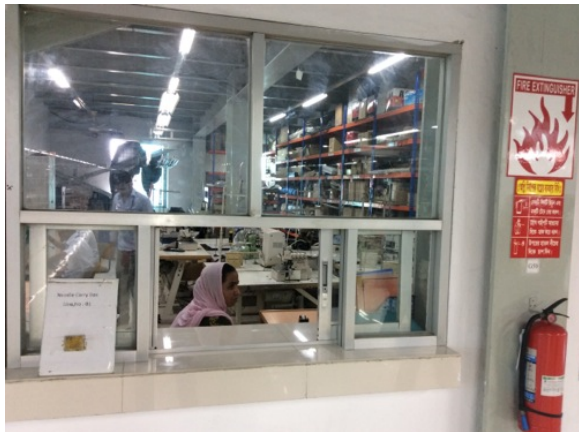
No.	Category	Finding	Recommendation	Remediation Timeframe
F-1	Fire Rated Construction	Rooms used for combustible storage are not separated by fire-rated construction on the ground floor.	Provide dedicated storage rooms separated by minimum 1-hr fire-rated construction.	Within 3 months

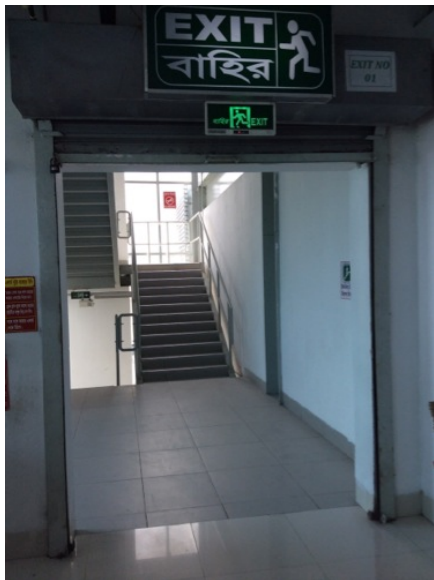
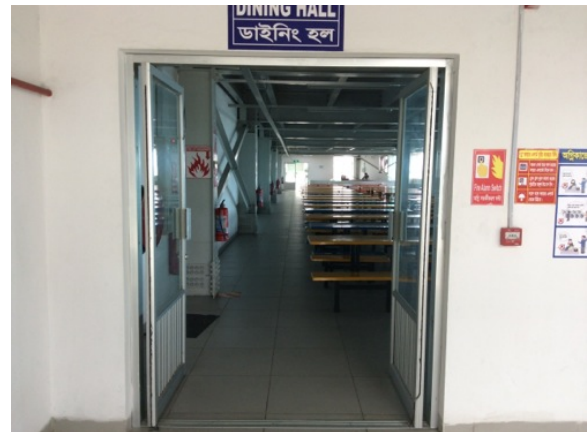
F-2	Fire Rated Construction	The exit stairs are not separated from work areas on each floor by fire-rated construction.	Provide minimum 1.5-hr fire rated doors and seal all unprotected openings to separate the exit stairs from work areas and other building spaces on all floor levels. Ensure that the fire doors are self-closing and positive latching and that they are provided with fire exit (panic) hardware where serving production floors.	Within 3 months
			If fire doors are required to be held open for functional reasons, provide automatic-closing devices tied to the fire alarm system.

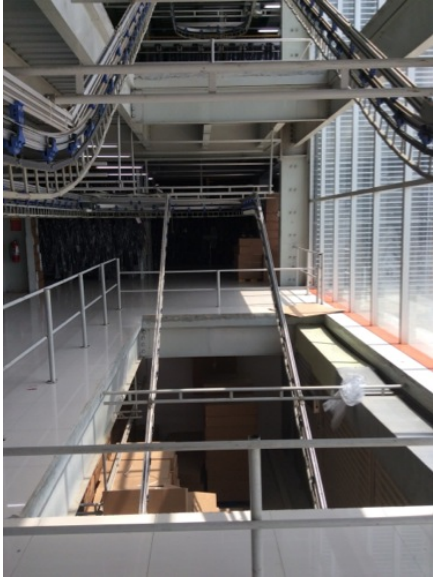
F-3	Fire Rated Construction	Unsealed penetrations and openings are located in the fire-rated floor and ceiling assemblies.	Provide a minimum 2-hr fire-rated shaft to separate the utility risers from each floor level. Seal all penetrations and openings in floor/ceiling assemblies to maintain the fire separation.	Within 3 months
-----	-------------------------	--	--	-----------------

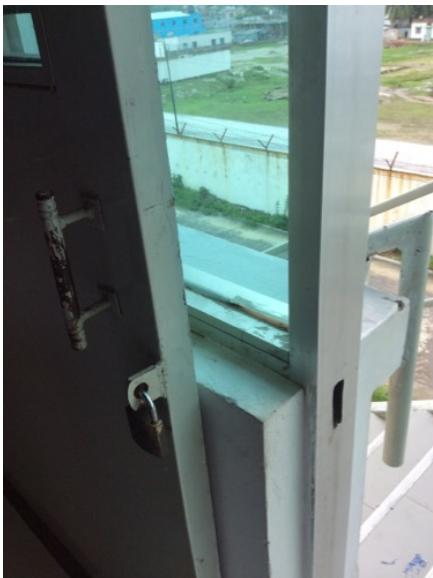
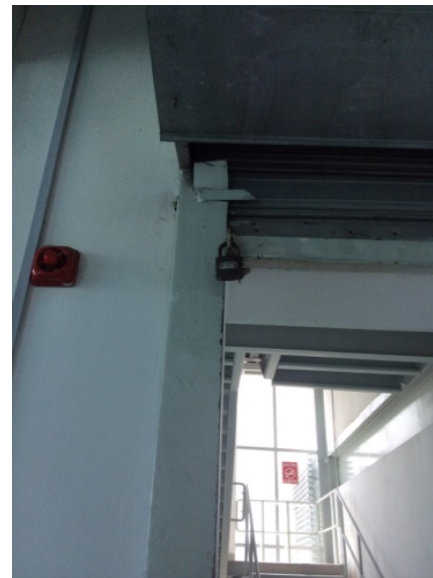
F-4	Egress	Egress doors with locking features are provided at exit stairs on every floor.	Remove locking features from all egress doors. If locks are required for security reasons, utilize special door locking features complying with NFPA 101.	Immediate
-----	--------	--	--	-----------

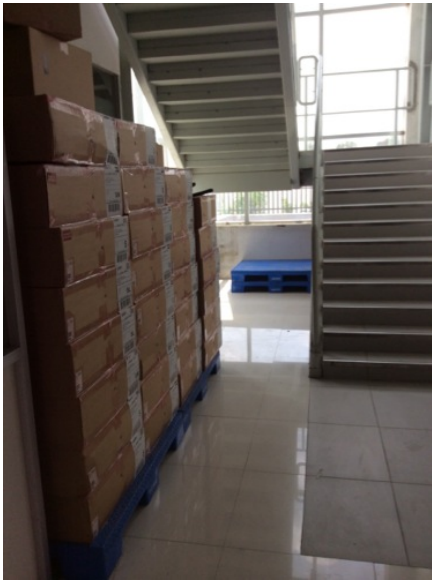
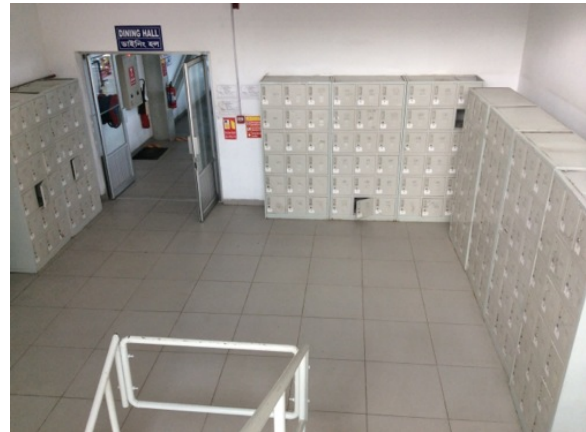
F-5	Egress	Storage was located in the exit stair on the ground floor.	Remove all storage from exit stairs and egress paths.	Immediate
-----	--------	--	---	-----------

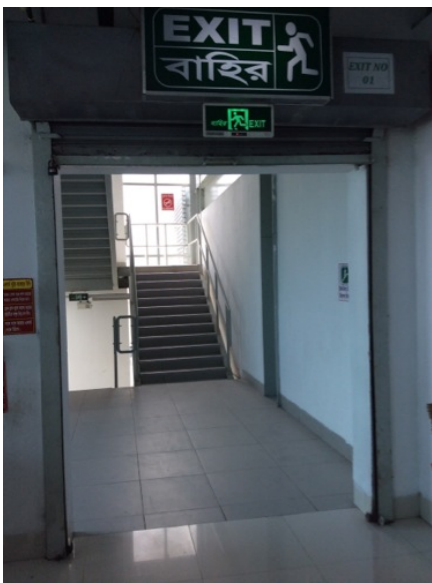
F-6 Egress

Collapsible gates are provided at exit stairs on every floor.

Replace all gates along the means of egress with side-hinged, swinging egress doors.

Within 1 month

If locks are required for security reasons, utilize special door locking features complying with NFPA 101.

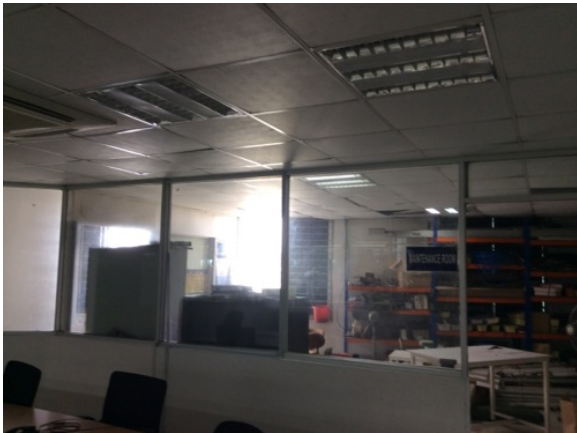
F-7	Fire Protection	Inspection, testing, and maintenance of the fire alarm system is not in accordance with NFPA 72.	Inspect, test and maintain the fire alarm system, and keep written records on-site, in accordance with NFPA 72.	Within 3 months
F-8	Fire Protection	Based off observations, the existing smoke detectors tied to the fire alarm and heat detectors were not adequately provided.	Based on ceiling configuration, provide additional detectors where needed, and space them in accordance with NFPA 72.	Within 3 months
