# **FIRE SAFETY INSPECTION REPORT**

## **VISUAL KNITWEAR LTD.**

**SHAFI COMPLEX  
HATHAJARI ROAD  
JALALABAD**

May 4, 2014

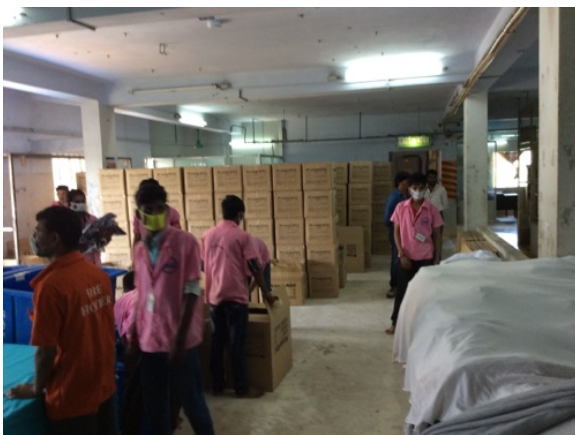
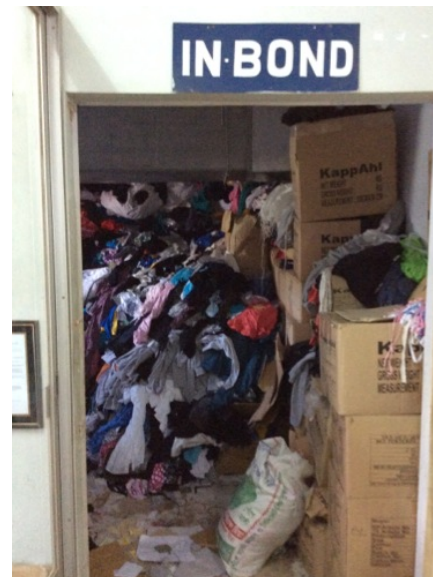
| No. | Category | Finding | Recommendation | Remediation Timeframe |
|---|---|---|---|---|
| F-1 | Fire Rated Construction | Storage rooms and process storage areas on floors 3 and 4 used for combustible storage are not separated by fire-rated construction. | <p>Provide dedicated storage rooms separated by minimum 1-hr fire-rated construction.</p> <p>Where separate storage rooms are not feasible, provide defined storage areas and limit the storage arrangement as follows:</p> <ul style="list-style-type: none"> <li>- Maximum height of 2.4m and maximum area of 23m<sup>2</sup></li> <li>- If sprinkler protected: maximum height of 3.66m and maximum area of 93m<sup>2</sup></li> </ul> <p>Separate areas of unenclosed combustible storage by a minimum clear distance of 3m.</p> | Within 3 months |

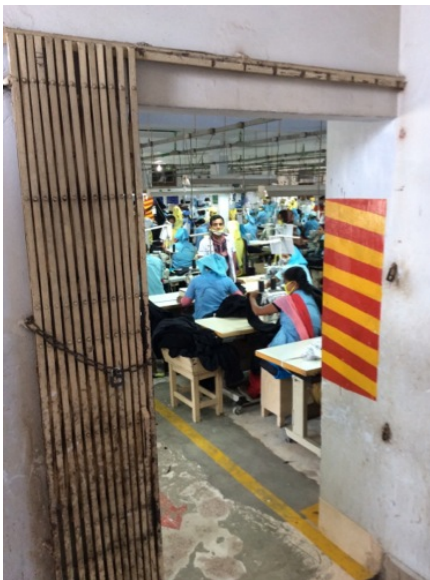
| F-2 | Fire Rated Construction | The exit stairs are not separated from work areas on each floor by fire-rated construction. | Provide minimum 1.5-hr fire rated doors and seal all unprotected openings to separate the exit stairs from work areas and other building spaces on all floor levels. Ensure that the fire doors are self-closing and positive latching and that they are provided with fire exit (panic) hardware where serving production floors.<br><br>If fire doors are required to be held open for functional reasons, provide automatic-closing devices tied to the fire alarm system. | Within 3 months |

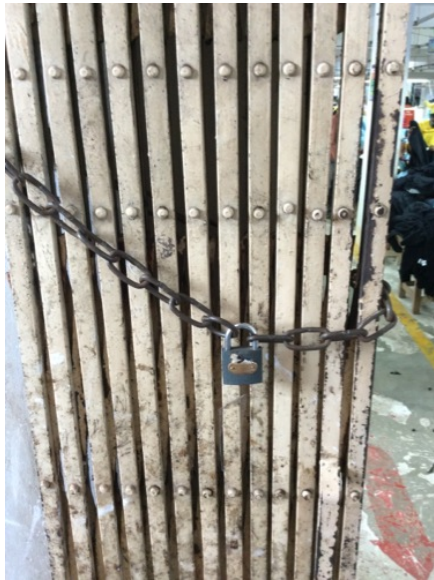
| F-3 | Egress | Egress gates with locking features are provided at exit stairs throughout the building. | Remove locking features from all egress gates.<br><br>If locks are required for security reasons, utilize special door locking features complying with NFPA 101. | Immediate |

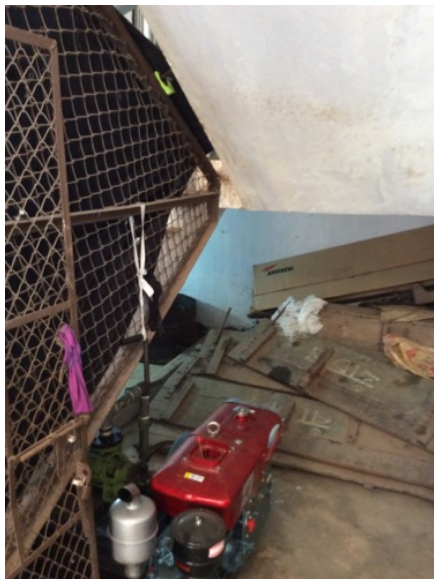
| F-4 | Egress | Storage was located in both exit stairs at the ground floor. | Remove all storage from exit stairs and egress paths. | Immediate |

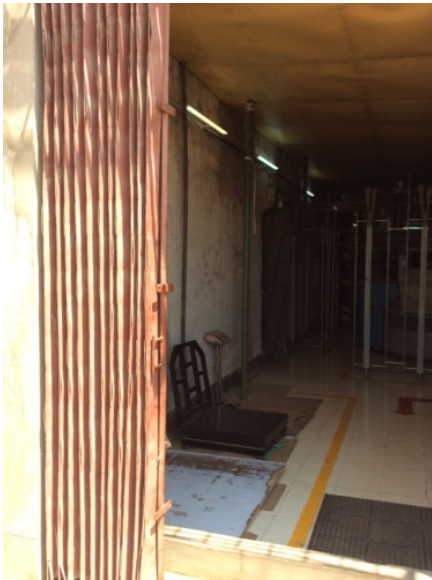
| F-5 | Egress | Collapsible gates are provided at all exit stairs, along interior egress routes, and exit discharge. | Replace all gates along the means of egress with side-hinged, swinging egress doors.<br><br>If locks are required for security reasons, utilize special door locking features complying with NFPA 101. | Within 1 month |

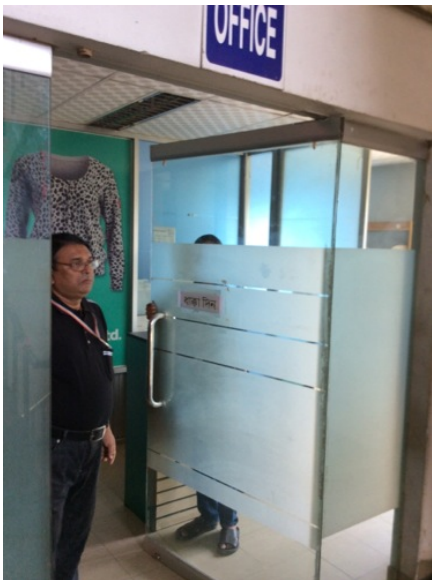
| F-6 | Egress | Exit door from office on floor 3 does not swing in the direction of egress travel. | Modify the egress door to swing in the direction of egress travel. | Within 3 months |

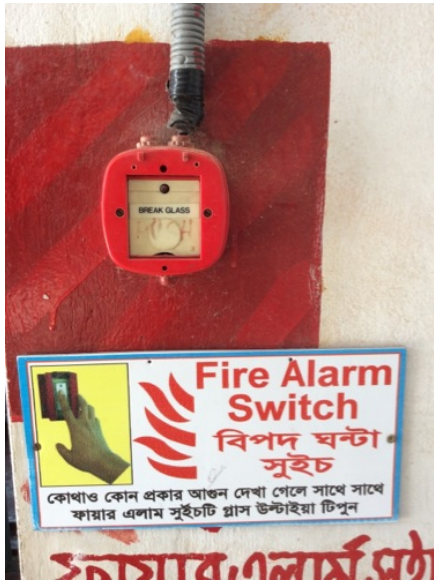
| F-7 | Fire Protection | The fire alarm system is antiquated, not a listed system, and does not provide alarm and notification features consistent with acceptable standards. | Replace the fire alarm system with a new, listed addressable fire alarm system in accordance with NFPA 72. | Design within 4 months, install within 9 months |

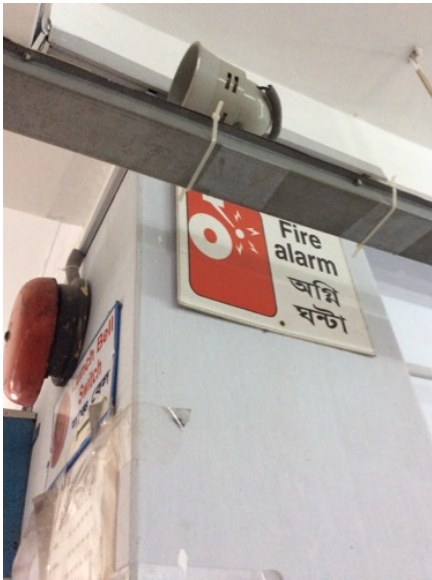
| F-9 | Fire Protection | The fire alarm system does not appear to provide adequate audible coverage on the floor 5 dining area. | Provide additional notification appliances such that the fire alarm system is audible throughout the building in accordance with NFPA 72. | Within 6 months |

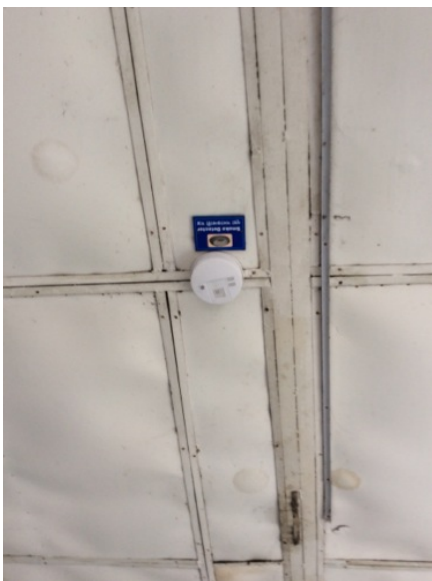
| F-10 | Fire Protection | The building is equipped with single-station smoke alarms. Smoke alarm activation sounds only a local alarm and does not provide automatic fire alarm notification of occupants. | Remove single-station smoke alarms. Provide automatic smoke detection throughout the building in accordance with NFPA 72. | Within 6 months |

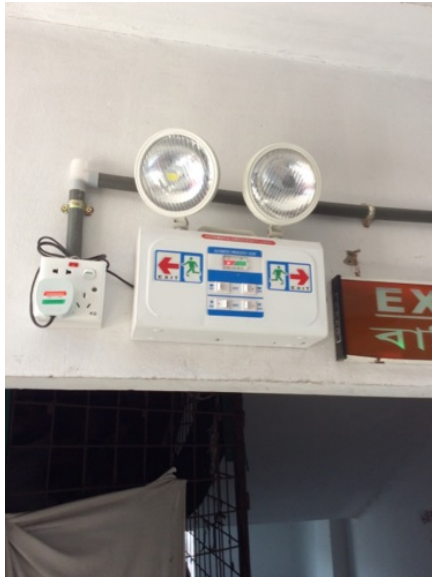
| F-11 | Egress Lighting | Emergency lighting did not function in test mode (burned out, broken, etc.). | Regularly test the emergency lighting system on each floor and replace/repair lights as needed. | Within 1 month |

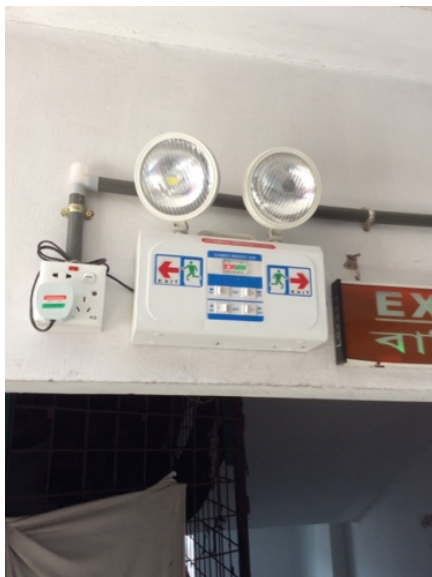
| F-12 | Egress Lighting | Inspection, testing, and maintenance records for the emergency lighting system were not available. | Inspect, test and maintain the emergency lighting system in accordance with The ACCORD standard. Keep written records on-site. | Within 3 months |

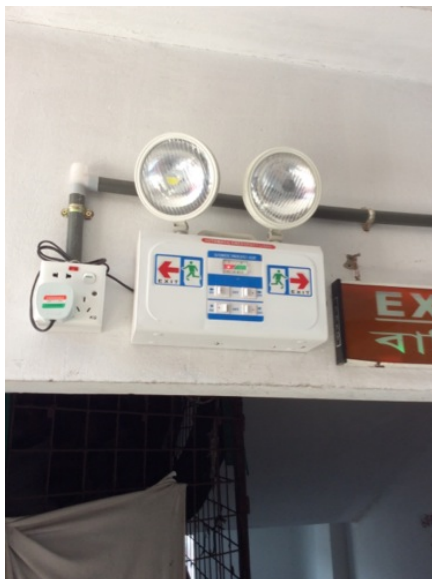
| F-13 | Egress Lighting | Based on the number and location of emergency lights observed, adequate illumination levels are not anticipated along egress routes on floor 5 in the dining area. | Test the emergency lighting system on each floor and provide additional emergency fixtures to provide adequate illumination along the means of egress. Provide a minimum illumination of 10 lux at the floor level within exit stairs and exit discharge paths and minimum 2.5 lux along exit access aisles. | Within 3 months |
