FIRE SAFETY INSPECTION REPORT

FIAT FASHIONS LTD

ACCORD
on Fire and Building Safety in Bangladesh

August 16, 2014

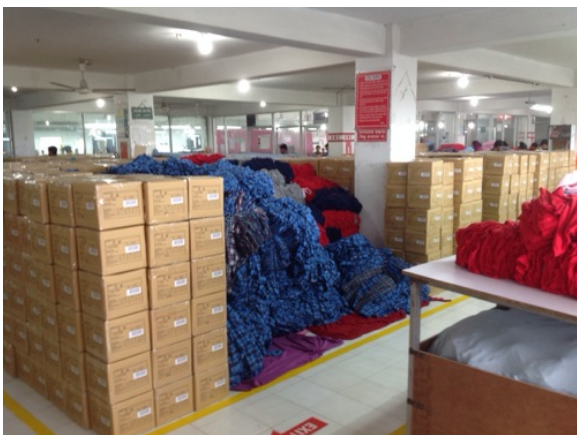
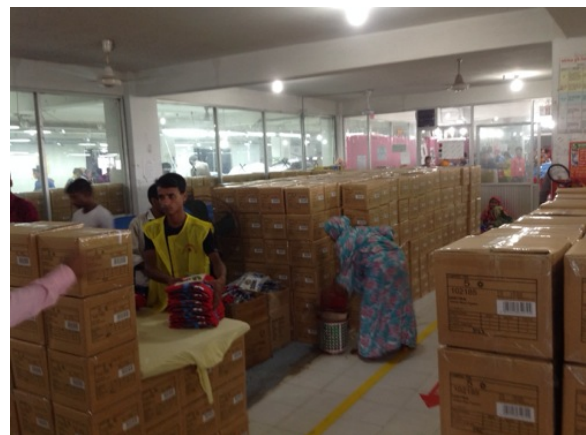
No.	Category	Finding	Recommendation	Remediation Timeframe
F-1	Fire Rated Construction	Areas used for storage on the fifth floor are not separated by fire rated construction.	<p>Provide dedicated storage rooms separated by minimum 1-hr fire-rated construction.</p> <p>Where separate storage rooms are not feasible, provide defined storage areas and limit the storage arrangement as follows:</p> <ul style="list-style-type: none"> - Maximum height of 2.4m and maximum area of 23m² - If sprinkler protected: maximum height of 3.66m and maximum area of 93m² <p>Separate areas of unenclosed combustible storage by a minimum clear distance of 3m.</p>	Within 3 months

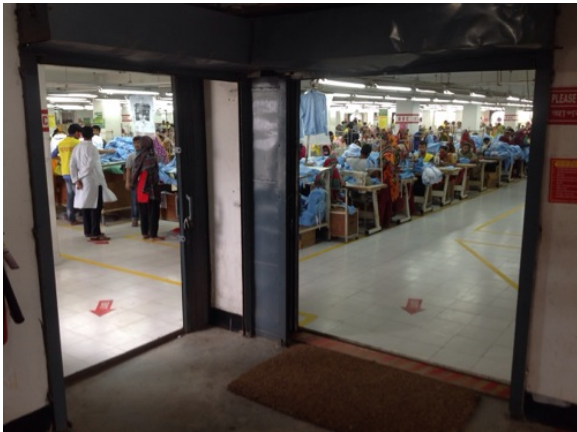
F-2	Fire Rated Construction	Exit stairs is not separated from work areas, other spaces on each floor by fire-rated construction.	Provide minimum 1.5-hr fire rated doors and seal all unprotected openings to separate the exit stairs from work areas and other building spaces on all floor levels. Ensure that the fire doors are self-closing and positive latching and that they are provided with fire exit (panic) hardware where serving production floors. If fire doors are required to be held open for functional reasons, provide automatic-closing devices tied to the fire alarm system.	Within 3 months
-----	-------------------------	--	---	-----------------

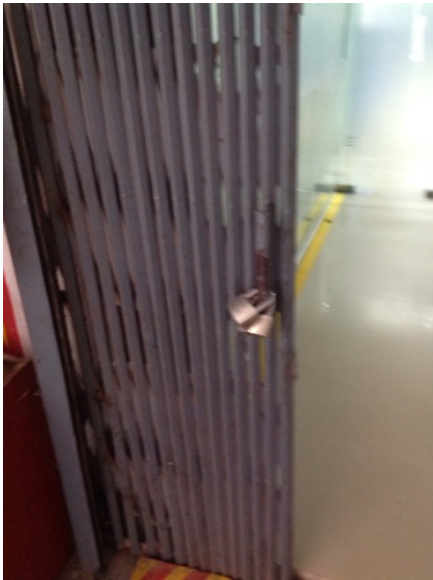
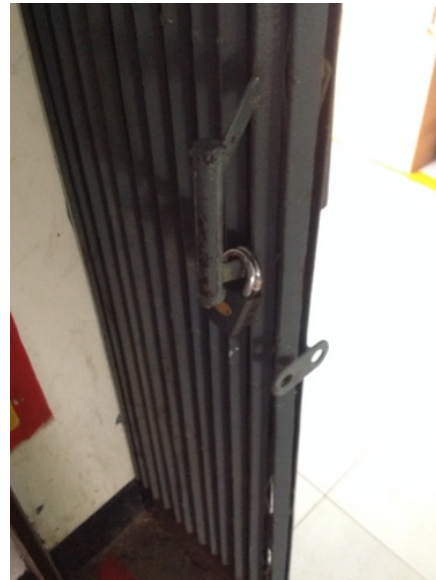
F-3	Egress	Egress doors and gates with locking features are provided at building exits, exit stairs, along egress routes, exit discharge. These locking features can be found on all exits.	Remove locking features from all egress doors / gates. If locks are required for security reasons, utilize special door locking features complying with NFPA 101.	Immediate
-----	--------	--	--	-----------

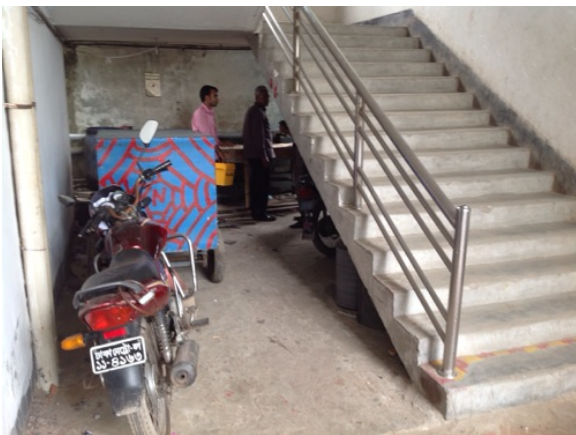
F-4	Egress	Storage was located in the exit stair of the east exit discharge.	Remove all storage from exit stairs and egress paths.	Immediate
-----	--------	---	---	-----------

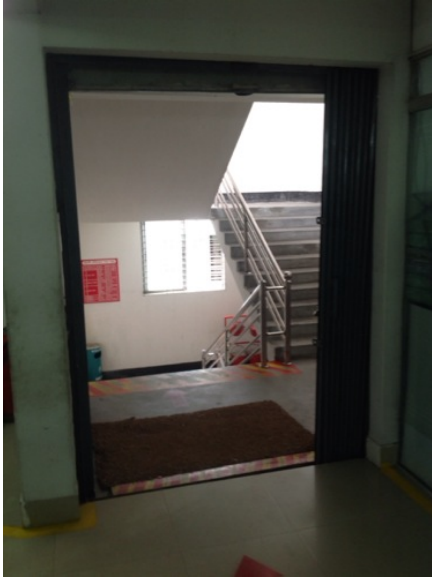
F-5	Egress	Collapsible gates and sliding doors are provided at building exits, exit stairs, along egress routes, exit discharge on both exits.	Replace all gates / sliding doors along the means of egress with side-hinged, swinging egress doors. If locks are required for security reasons, utilize special door locking features complying with NFPA 101.	Within 1 month
-----	--------	---	--	----------------

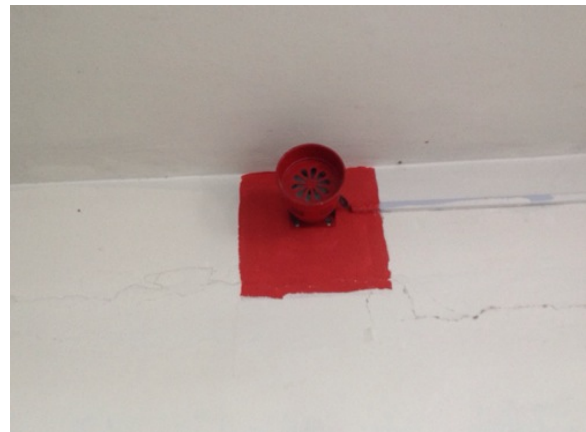
F-6	Fire Protection	The fire alarm system is antiquated, not a listed system, and does not provide alarm and notification features consistent with acceptable standards.	Replace the fire alarm system with a new, listed addressable fire alarm system in accordance with NFPA 72.	Design within 4 months, install within 9 months
-----	-----------------	--	--	---

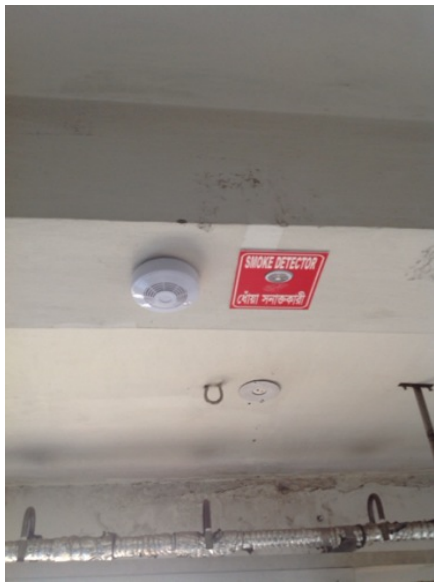
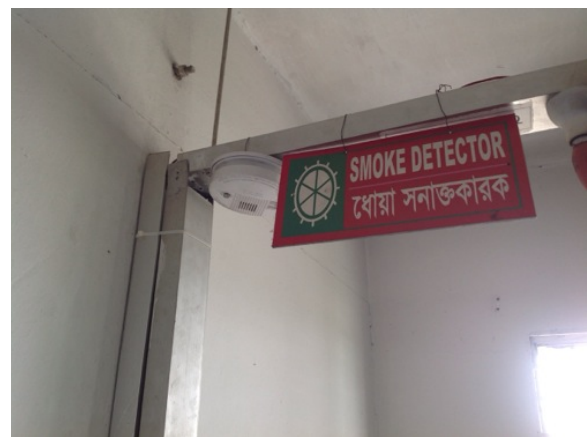
F-8	Fire Protection	The building is equipped with single-station smoke alarms. Smoke alarm activation sounds only a local alarm and does not provide automatic fire alarm notification of occupants.	Remove single-station smoke alarms. Provide automatic smoke detection throughout the building, tied into the fire alarm system, in accordance with NFPA 72.	Within 6 months
-----	-----------------	--	---	-----------------
