# **FIRE SAFETY INSPECTION REPORT**

**SPOTFAME APPARELS LTD.  
CHAMUDDA, MIRAR BAZAR, PUBAIL**

**ACCORD**  
on Fire and Building Safety in Bangladesh

July 14, 2014

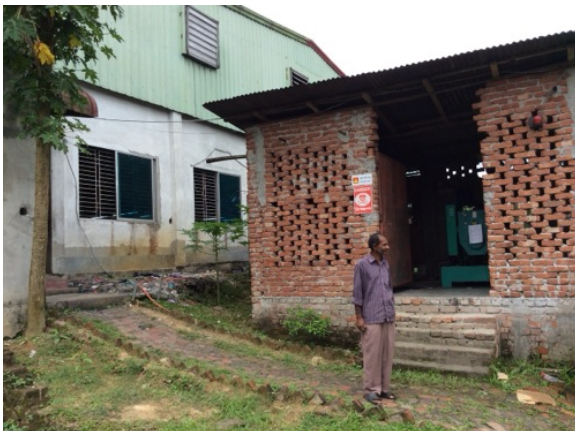
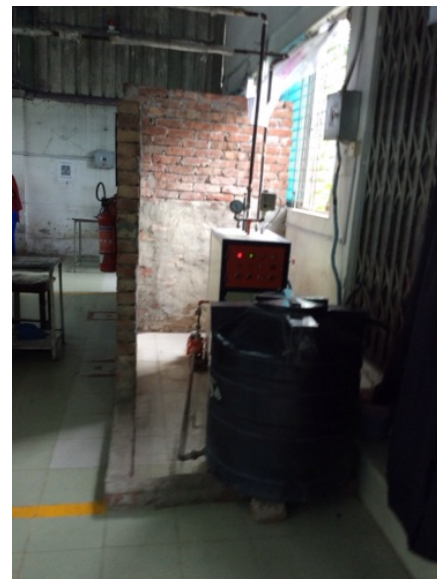
| No. | Category | Finding | Recommendation | Remediation Timeframe |
|---|---|---|---|---|
| F-1 | Fire Rated Construction | <p>The generator room is not separated from the discharge pathway of the northern building exit by means of fire rated separation</p> <p>The boiler room on the ground floor is not separated from the adjacent work areas by means of fire-rated construction.</p> | Separate the generator and boiler room by a minimum 2-hr fire-rated construction. Seal and/or protected all openings to maintain the required fire separations | Within 3 months |

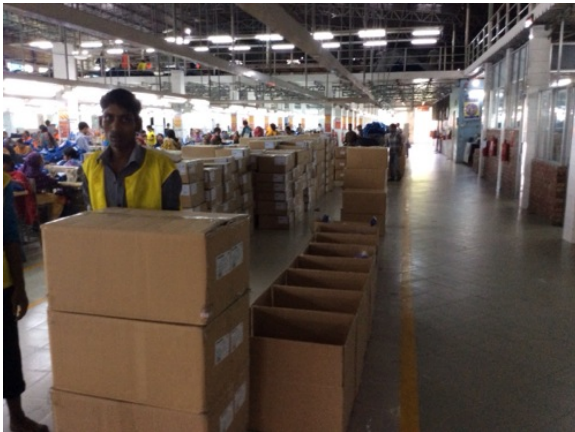
| F-2 | Fire Rated Construction | Transient storage areas on the ground floor is not separated form the adjacent working area by means of fire rated construction (non-rated door and unprotected openings). | <p>Provide dedicated storage rooms separated by minimum 1-hr fire-rated construction.</p> <p>Where separate storage rooms are not feasible, provide defined storage areas and limit the storage arrangement as follows:</p> <ul style="list-style-type: none"> <li>- Maximum height of 2.4m and maximum area of 23m<sup>2</sup></li> <li>- If sprinkler protected: maximum height of 3.66m and maximum area of 93m<sup>2</sup></li> </ul> <p>Separate areas of unenclosed combustible storage by a minimum clear distance of 3m.</p> | Within 3 months |

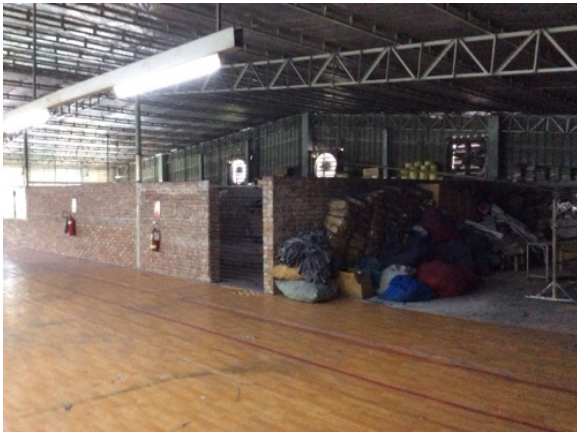
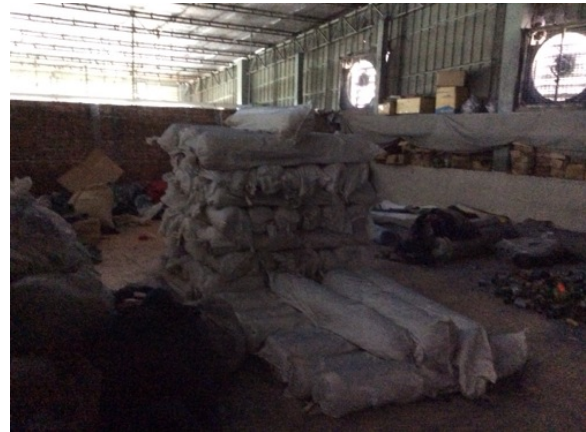
| F-3 | Fire Rated Construction | Dedicated storage areas on the 1st floor are not separated from the adjacent working areas by means of fire-rated construction (non-rated door and unprotected openings). | Separate the storage room by a minimum 2-hr fire-rated construction. Seal and/or protected all openings to maintain the required fire separations | Within 3 months |

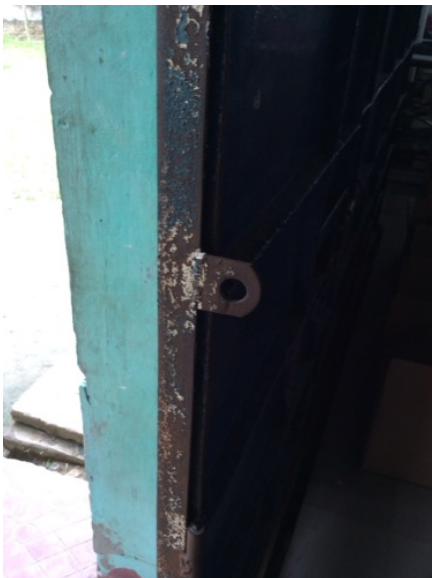
| F-4 | Egress | Egress doors / gates with locking features are provided at building exits and exit stairs. | Remove locking features from all egress doors / gates.<br><br>If locks are required for security reasons, utilize special door locking features complying with NFPA 101. | Immediate |

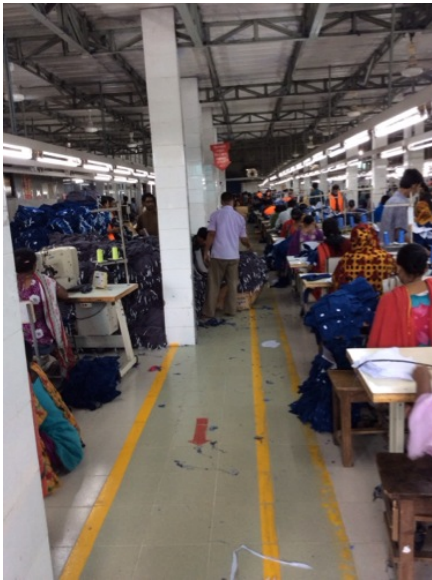
| F-5 | Egress | Storage was located in the egress paths on the ground floor. | Keep egress paths and stairs clear of storage. | Immediate |

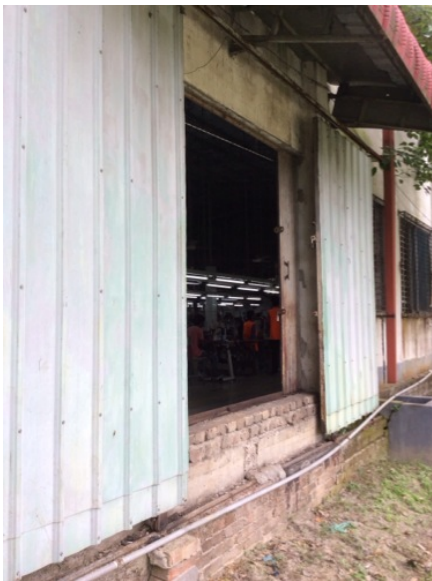
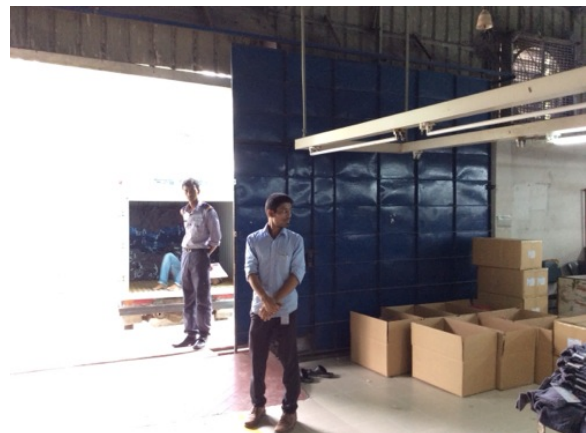
| F-6 | Egress | Collapsible gates / sliding doors are provided at all exit stairs and building exits. | Replace all gates / sliding doors along the means of egress with side-hinged, swinging egress doors. | Within 1 month |

| | | | If locks are required for security reasons, utilize special door locking features complying with NFPA 101. | |

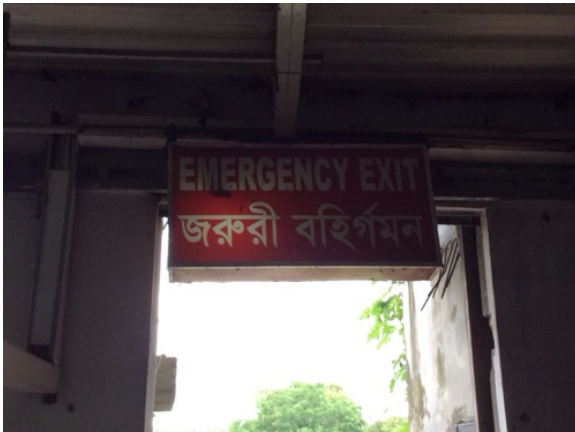
| F-10 | Egress Lighting | Exit signage of the northern building exit was not illuminated (burned out, broken, etc.) | Regularly inspect all exit signage and replace/install lights as needed to illuminate signs. | Within 1 month |

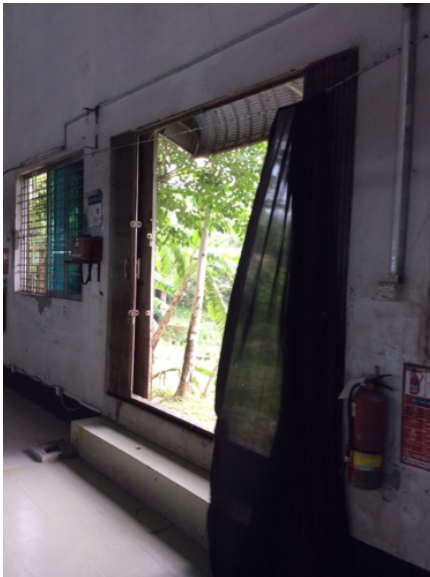
| F-11 | Egress Lighting | Exit sign not provided at western exit on the ground floor. | Provide exit signs above all exits to the exterior and all doors to the exit stairs. | Within 1 month |

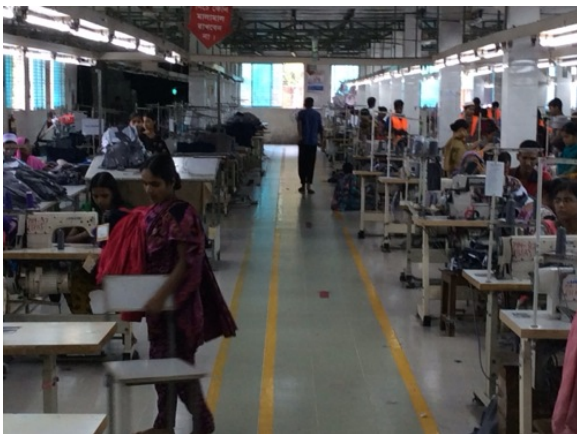
| F-13 | Egress Lighting | Based on the number and location of emergency lights observed, adequate illumination levels are not anticipated along egress routes on all floors | Test the emergency lighting system on each floor and provide additional emergency fixtures to provide adequate illumination along the means of egress. Provide a minimum illumination of 10 lux at the floor level within exit stairs and exit discharge paths and minimum 2.5 lux along exit access aisles. | Within 3 months |
