FIRE SAFETY INSPECTION REPORT

**STARLET APPARELS LTD.
ROAD NO.# 01, PLOT NO.# 223-224, BSCIC,
FATULLAH**

July 16, 2014

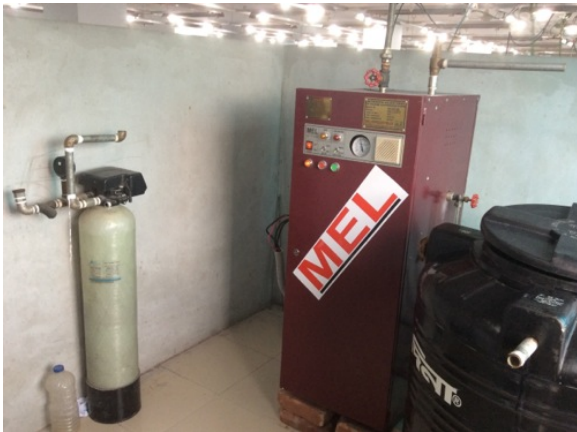
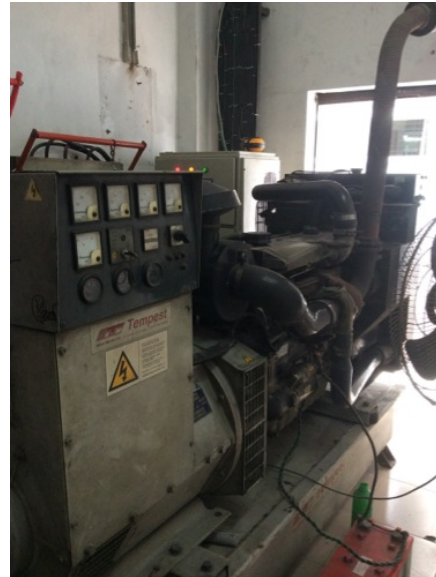
No.	Category	Finding	Recommendation	Remediation Timeframe
F-1	Fire Rated Construction	<p>The boiler and generator rooms are not separated by fire-rated construction (openings, non-rated doors, penetrations).</p> <p>The boiler room was located on 5th floor, and the generator room was located on ground floor. The generator room was open to public road.</p>	Separate the boiler and generator rooms by a minimum 2-hr fire-rated construction. Seal and/or protected all openings to maintain the required fire separations	Within 3 months

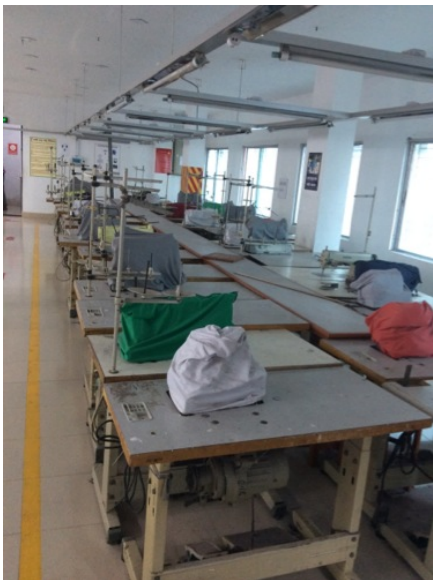
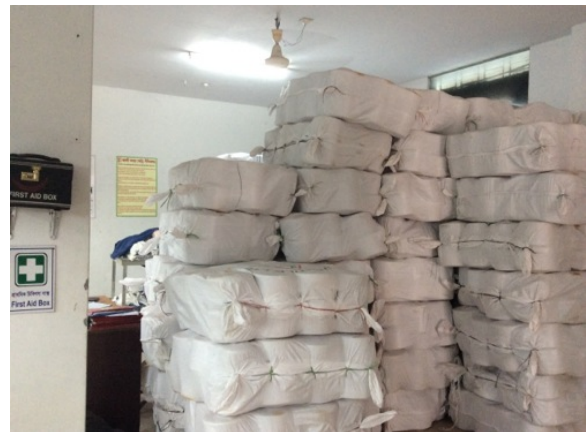
F-2	Fire Rated Construction	Areas used for combustible storage on the ground and 3rd floors are not separated by fire-rated construction.	Provide dedicated storage rooms separated by minimum 1-hr fire-rated construction. Where separate storage rooms are not feasible, provide defined storage areas and limit the storage arrangement as follows: - Maximum height of 2.4m and maximum area of 23m ² - If sprinkler protected: maximum height of 3.66m and maximum area of 93m ² Separate areas of unenclosed combustible storage by a minimum clear distance of 3m.	Within 3 months
-----	-------------------------	---	--	-----------------

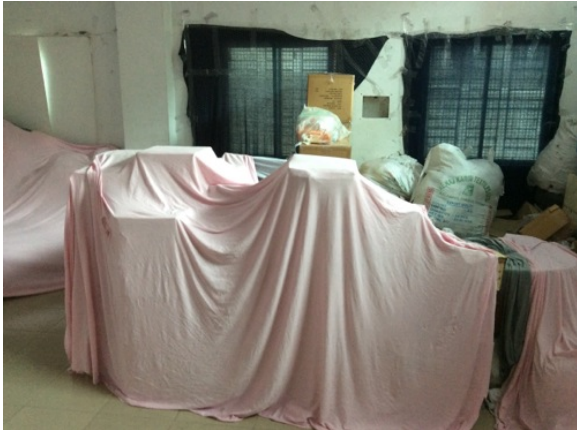
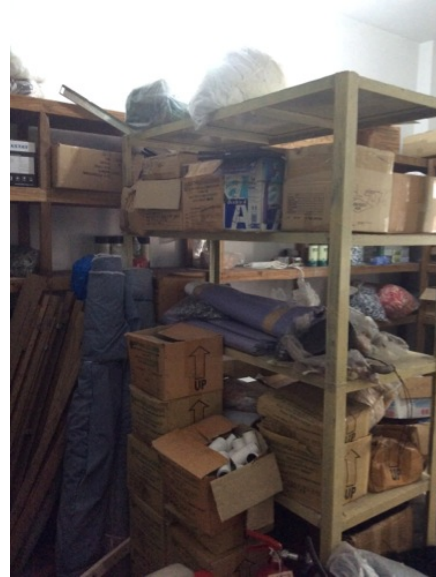
F-3	Fire Rated Construction	Rooms used for combustible storage on the ground floor are not separated by fire-rated construction.	Provide dedicated storage rooms separated by minimum 1-hr fire-rated construction.	Within 3 months
-----	-------------------------	--	--	-----------------

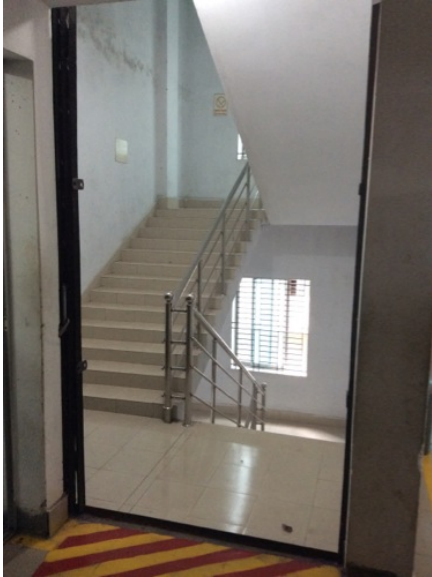
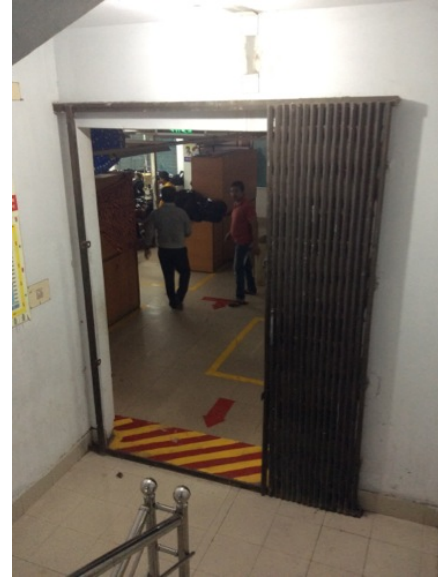
F-4	Fire Rated Construction	All exit stairs are not separated from work areas or other spaces on each floor by fire-rated construction.	Provide minimum 1.5-hr fire rated doors and seal all unprotected openings to separate the exit stairs from work areas and other building spaces on all floor levels. Ensure that the fire doors are self-closing and positive latching and that they are provided with fire exit (panic) hardware where serving production floors. If fire doors are required to be held open for functional reasons, provide automatic-closing devices tied to the fire alarm system.	Within 3 months
-----	-------------------------	---	---	-----------------

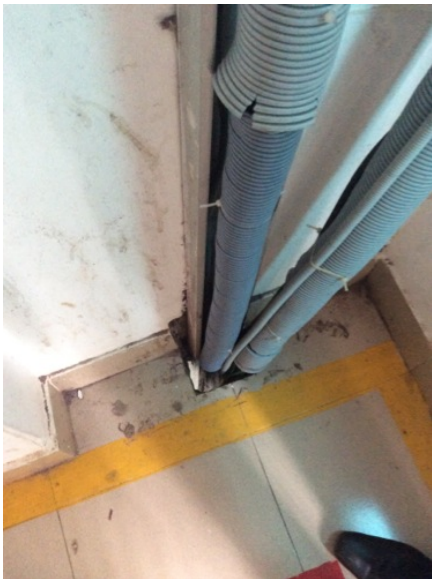
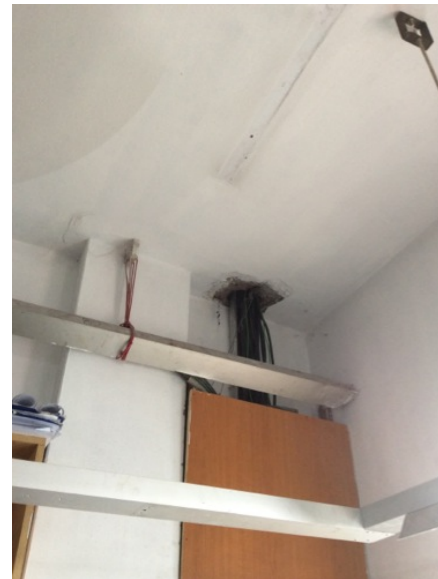
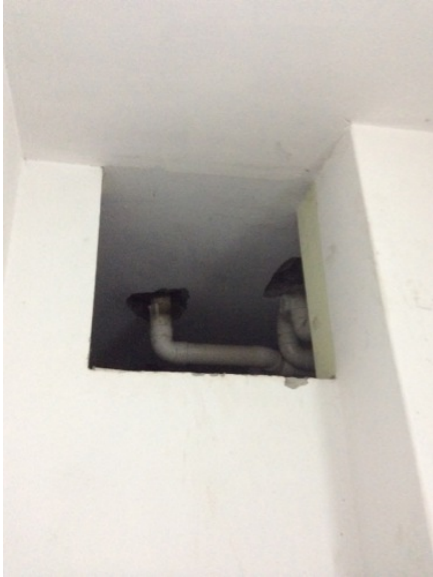
F-5	Fire Rated Construction	Unsealed penetrations and openings on all floors are located in the fire-rated floor/ceiling assemblies.	Provide a minimum 2-hr fire-rated shaft to separate the utility risers from each floor level.	Within 3 months
-----	-------------------------	--	---	-----------------

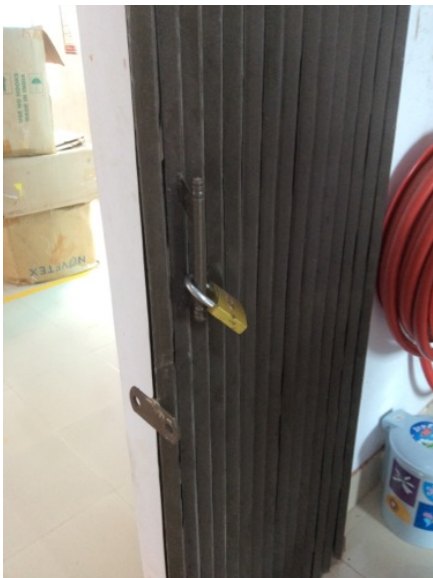
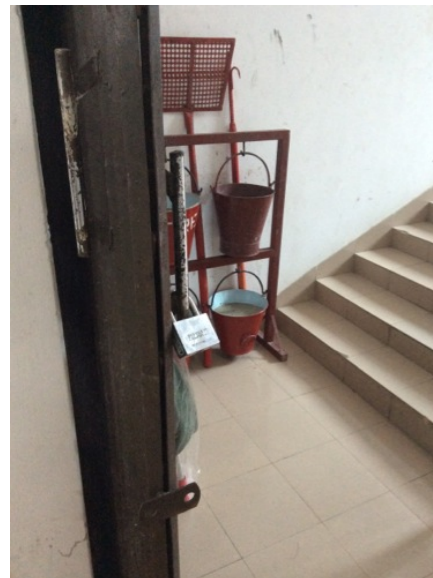
F-6	Egress	Egress doors / gates with locking features are provided at building exits, exit stairs, along egress routes and exit discharge.	Remove locking features from all egress doors / gates. If locks are required for security reasons, utilize special door locking features complying with NFPA 101.	Immediate
-----	--------	---	--	-----------

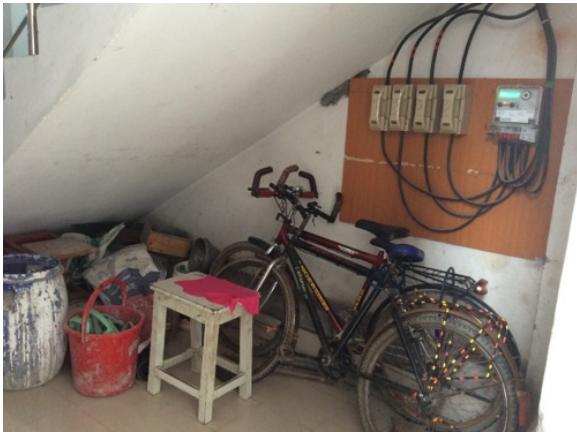
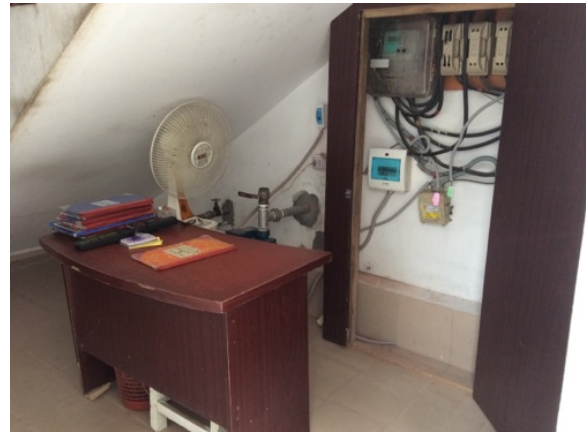
F-7	Egress	Storage was located in all exit stairs.	Remove all storage from exit stairs and egress paths.	Immediate
-----	--------	---	---	-----------

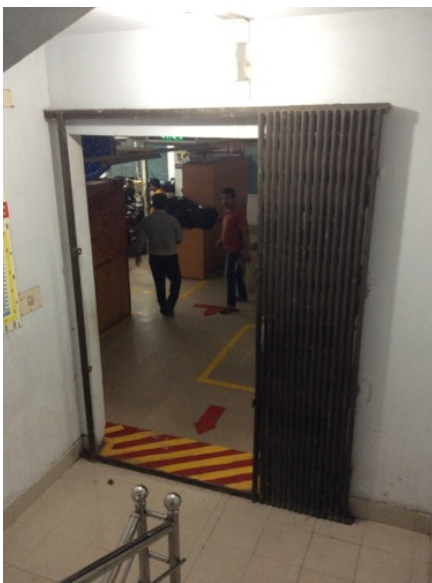
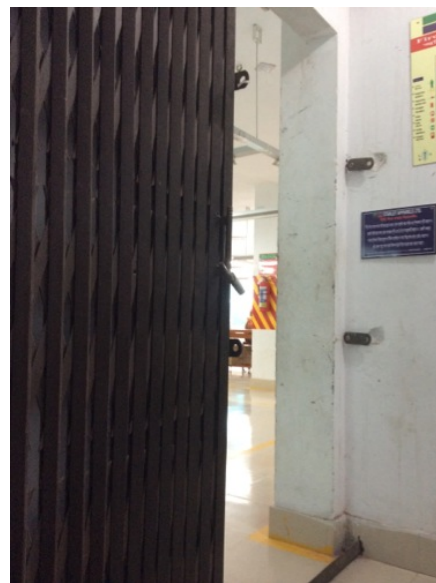
F-8 Egress

Collapsible gates / sliding doors are provided at building exits, exit stairs, along egress routes and exit discharge.

Replace all gates / sliding doors along the means of egress with side-hinged, swinging egress doors.

Within 1 month

If locks are required for security reasons, utilize special door locking features complying with NFPA 101.

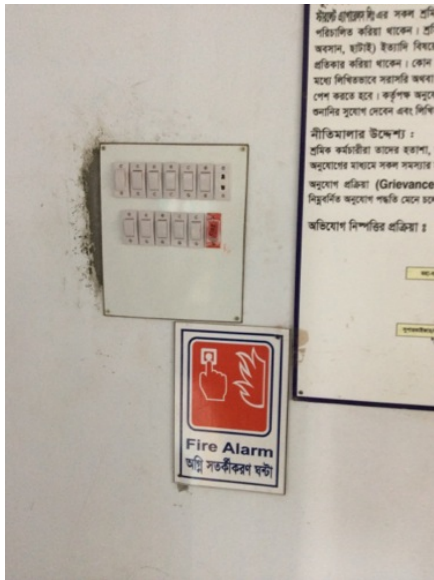
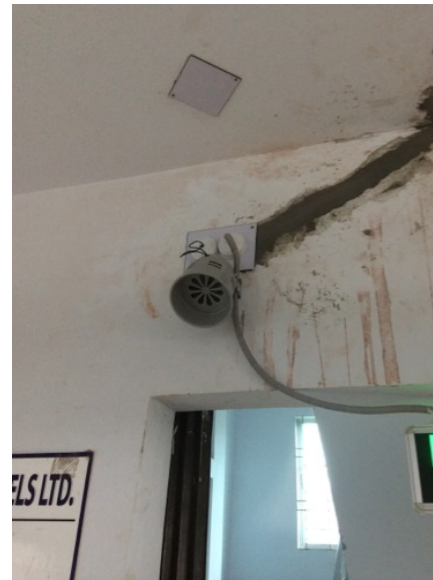
F-9	Fire Protection	The fire alarm system is antiquated, not a listed system, and does not provide alarm and notification features consistent with acceptable standards.	Replace the fire alarm system with a new, listed addressable fire alarm system in accordance with NFPA 72.	Design within 4 months, install within 9 months
-----	-----------------	--	--	---

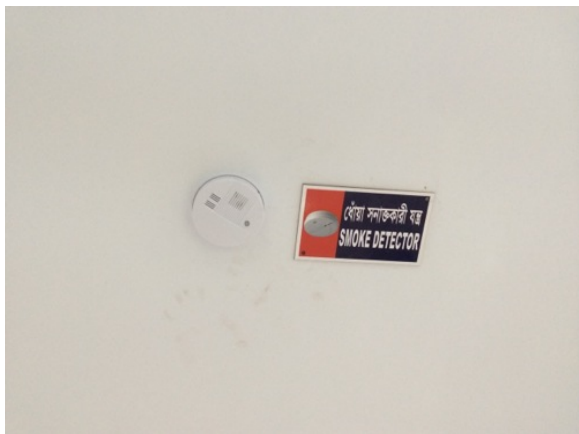
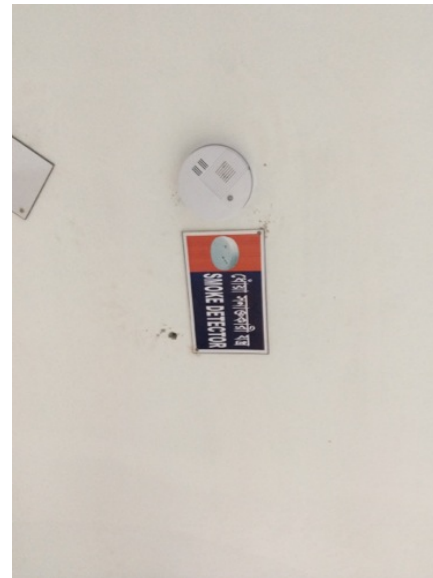
F-12	Fire Protection	The building is equipped with single-station smoke alarms. Smoke alarm activation sounds only a local alarm and does not provide automatic fire alarm notification of occupants.	Remove single-station smoke alarms. Provide automatic smoke detection throughout the building, tied into the fire alarm system, in accordance with NFPA 72.	Within 6 months
------	-----------------	--	---	-----------------

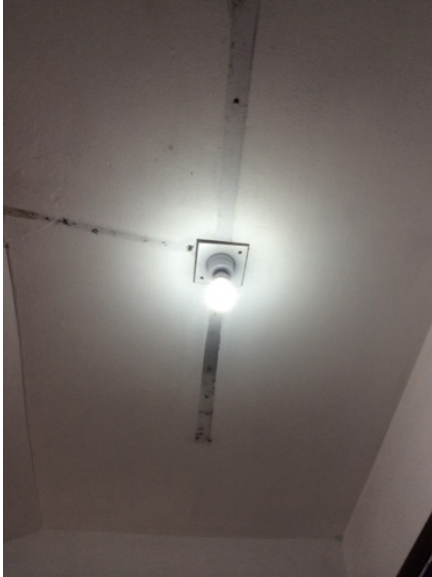
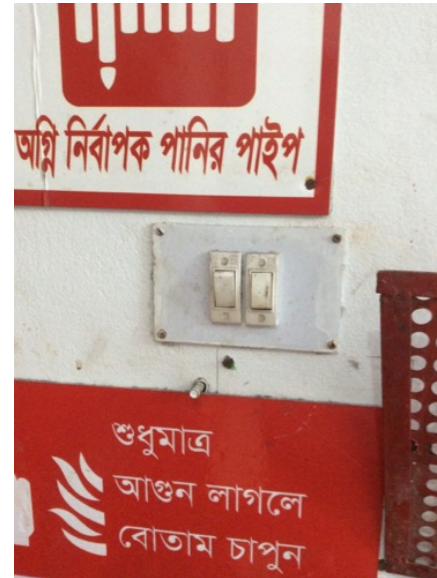
F-13	Egress Lighting	Manual on-off switch is provided for emergency lighting / exit signage units.	Remove manual on/off switches from emergency lighting / exit signage units to prevent them from being switched off.	Within 1 month
------	-----------------	---	---	----------------
