# **FIRE SAFETY INSPECTION REPORT**

## **COMFIT COMPOSITE KNIT LIMITED UNIT**

**AMTOLA, KATHGORA BAZAR, ASHULIA, SAVAR**

April 3, 2014

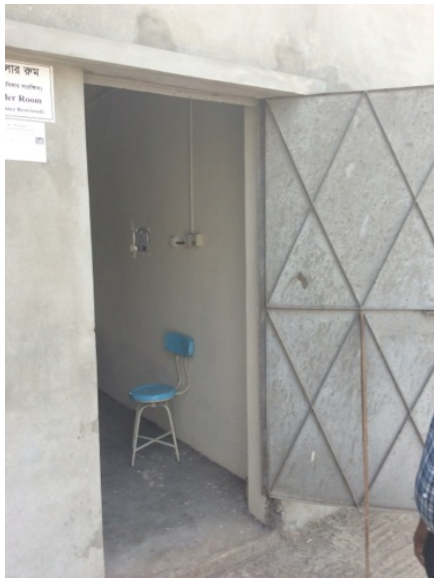
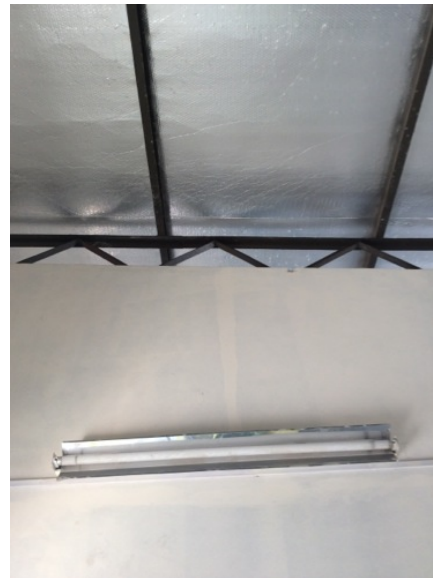
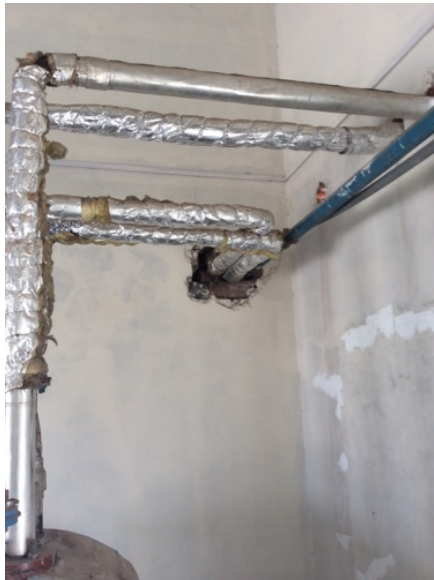
No.	Category	Finding	Recommendation	Remediation Timeframe
F-1	Fire Rated Construction	The boiler room is not separated by fire-rated construction. Located on the fourth floor roof area openings, non-rated doors and penetrations were all noted present.	Separate the boiler room by a minimum 2-hr fire-rated construction. Seal and/or protected all openings to maintain the required fire separations	Within 3 months

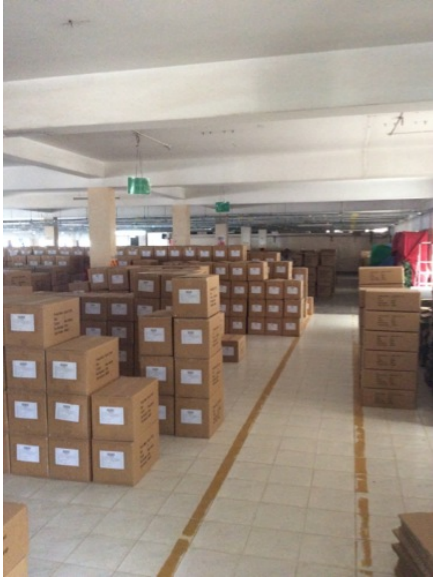
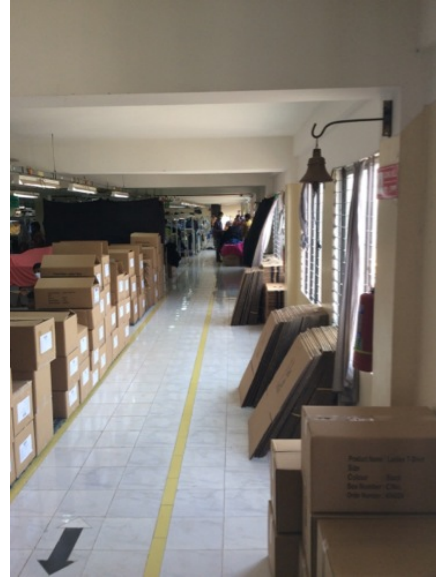
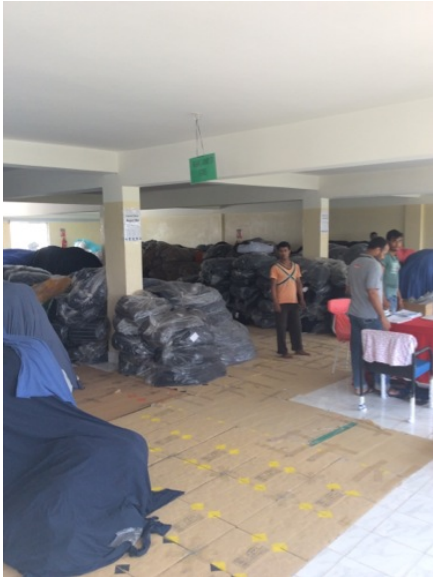
F-2	Fire Rated Construction	<p>Areas used for combustible storage are not separated by fire-rated construction.</p> <p>Ground floor area has insufficient fire rated separation at door and window assemblies, in close proximity to egress route path externally. Floors 1, 2 and 3 with combustible storage not adequately fire separated.</p>	<p>Provide dedicated storage rooms separated by minimum 1-hr fire-rated construction.</p> <p>Where separate storage rooms are not feasible, provide defined storage areas and limit the storage arrangement as follows:</p> <ul style="list-style-type: none"> <li>- Maximum height of 2.4m and maximum area of 23m<sup>2</sup></li> <li>- If sprinkler protected: maximum height of 3.66m and maximum area of 93m<sup>2</sup></li> </ul> <p>Separate areas of unenclosed combustible storage by a minimum clear distance of 3m.</p>	Within 3 months
-----	-------------------------	--	--	-----------------

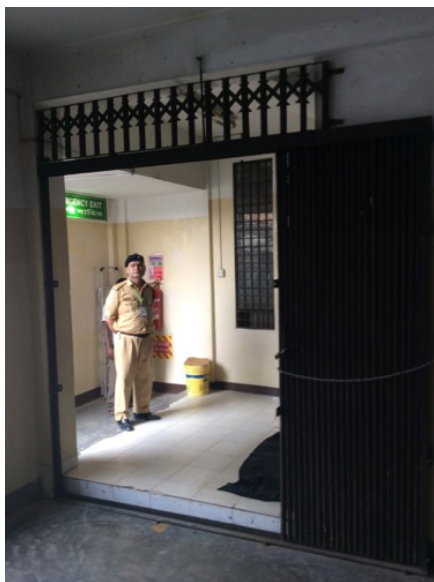
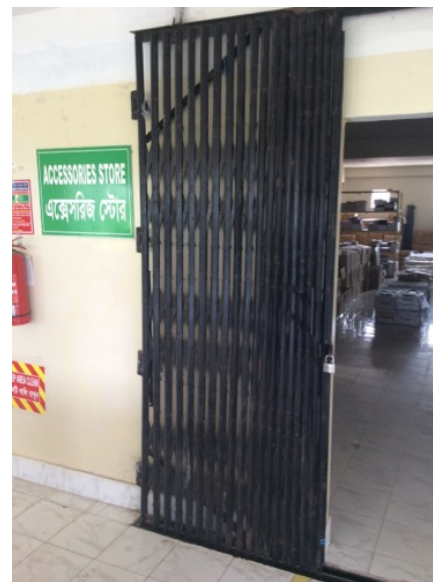
F-3	Fire Rated Construction	All exit stairs are not separated from work areas, other spaces on each floor by fire-rated construction.	<p>Provide minimum 1.5-hr fire rated doors and seal all unprotected openings to separate the exit stairs from work areas and other building spaces on all floor levels. Ensure that the fire doors are self-closing and positive latching and that they are provided with fire exit (panic) hardware where serving production floors.</p> <p>If fire doors are required to be held open for functional reasons, provide automatic-closing devices tied to the fire alarm system.</p>	Within 3 months
-----	-------------------------	---	--	-----------------

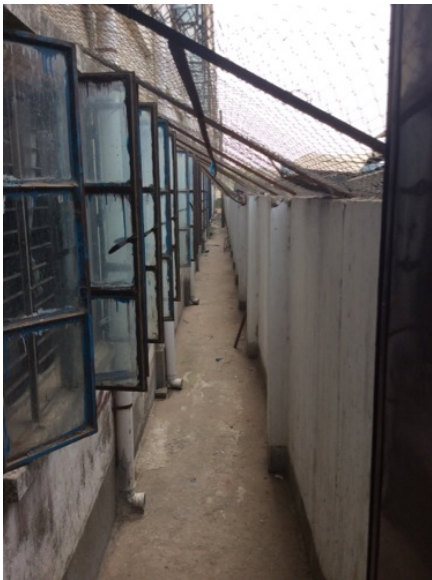
F-4	Fire Rated Construction	Uncovered discharge path to assembly point, with less than 10 ft. building separation, has unprotected openings at a height of less than 10 ft. This discharge is from the rear of the building along the West elevation to the main assembly point at the front of the building.	Seal all penetrations and openings to the interior of the building, up to a height of 10 ft, to maintain the fire separation. Alternately, provide 1-hr fire-rated separation up to a height of 10 ft	Within 3 months
-----	-------------------------	---	---	-----------------

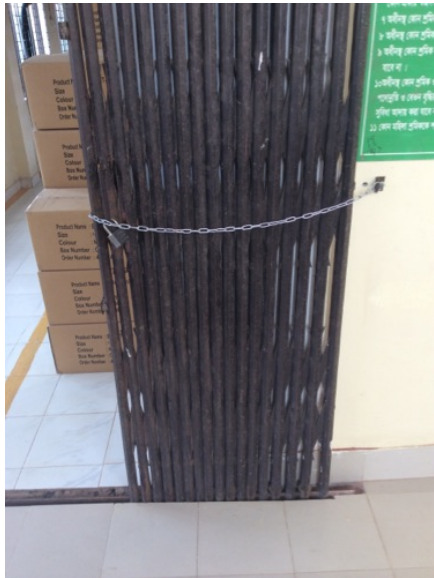
F-5	Egress	Egress sliding steel gates with locking features are provided at all building exits, exit stairs, along egress routes and exit discharge to floors. All sliding gates were open and unlocked during the inspection.	Remove locking features from all egress gates.  If locks are required for security reasons, utilize special door locking features complying with NFPA 101.	Immediate
-----	--------	---	--	-----------

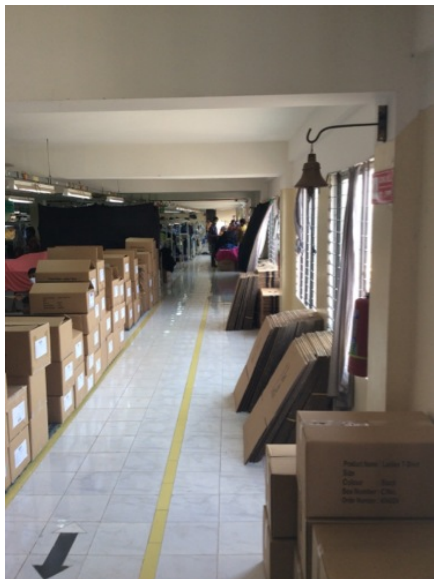
F-6	Egress	Storage was located in the egress path on floor 3.	Keep egress paths and stairs clear of storage.	Immediate
-----	--------	--	--	-----------

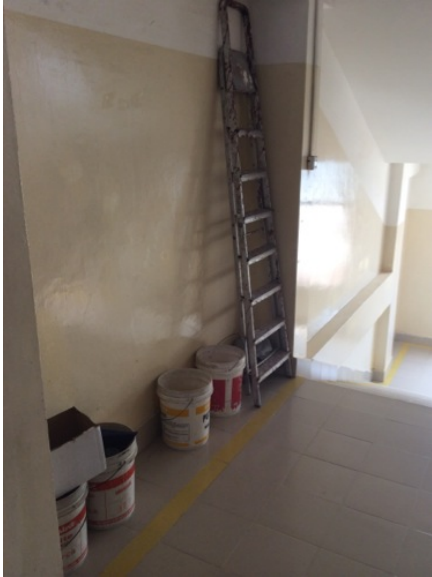
F-7	Egress	Storage was located in the North East exit stair. Exit discharge must be completely clear of storage.	Remove all storage from exit stairs and egress paths.	Immediate
-----	--------	---	---	-----------

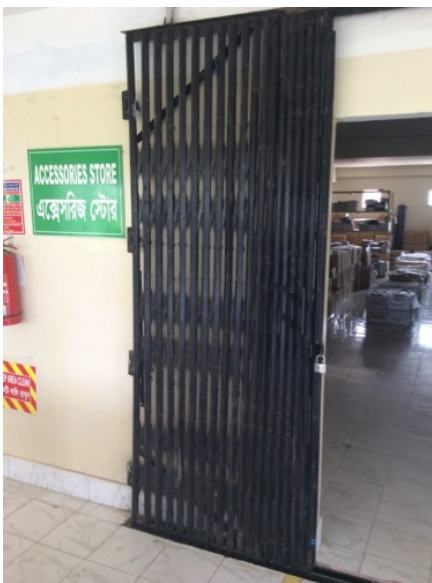
F-8 Egress

Collapsible gates are provided at all building exits, exit stairs, along egress routes and exit discharge to all floors.

Replace all steel sliding gates along the means of egress with side-hinged, swinging egress doors.

If locks are required for security reasons, utilize special door locking features complying with NFPA 101.

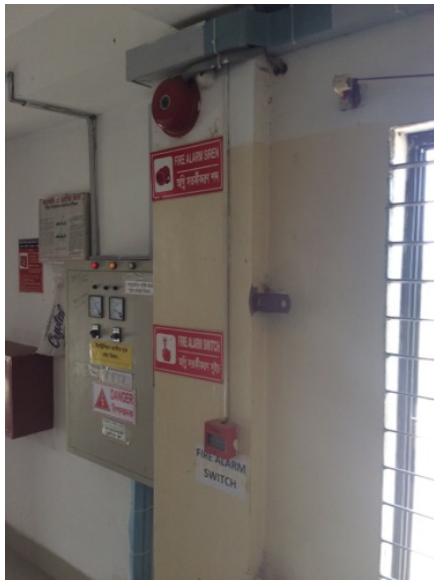
F-9	Fire Protection	The fire alarm system is antiquated, not a listed system, and does not provide alarm and notification features consistent with acceptable standards.	Replace the fire alarm system with a new, listed addressable fire alarm system in accordance with NFPA 72.	Design within 4 months, install within 9 months
-----	-----------------	--	--	---

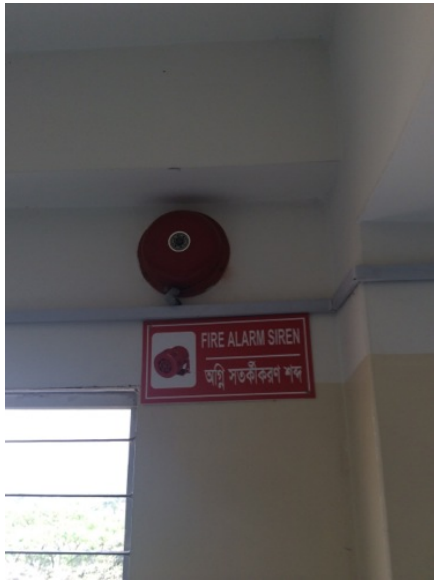
F-11	Fire Protection	The fire alarm system does not appear to provide adequate audible notification coverage throughout the factory floor, no alarm was present on the fourth floor.	Provide additional notification appliances such that the fire alarm system is audible throughout the building in accordance with NFPA 72.	Within 6 months
------	-----------------	---	---	-----------------

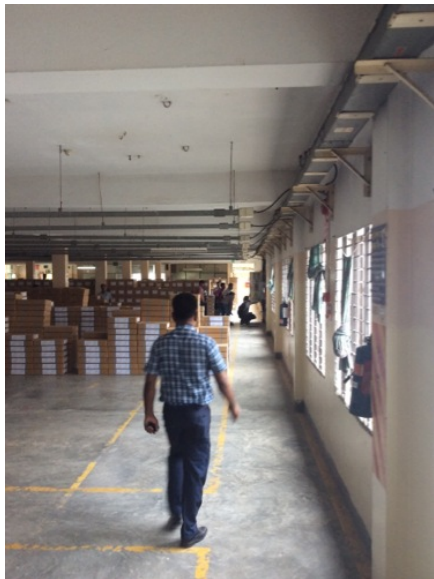
F-12	Fire Protection	No fire detection system in place. No smoke alarms or heat detectors present throughout any of the factory floors.	Provide automatic smoke detection throughout the building in accordance with NFPA 72.	Within 6 months
------	-----------------	--	---	-----------------

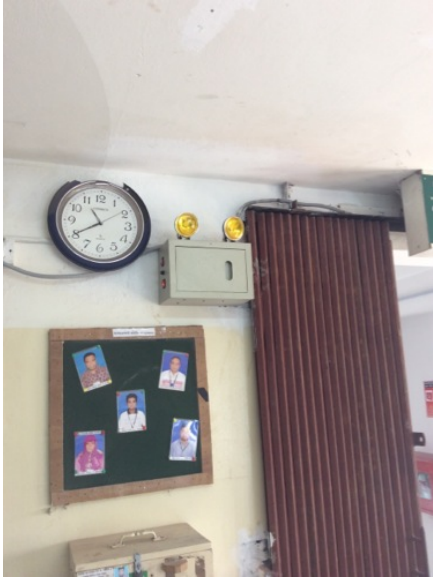
F-13	Egress Lighting	Manual on-off switch is provided for exit signage on all battery backup units	Remove manual on/off switches from exit signage units to prevent them from being switched off.	Within 1 month
------	-----------------	---	--	----------------

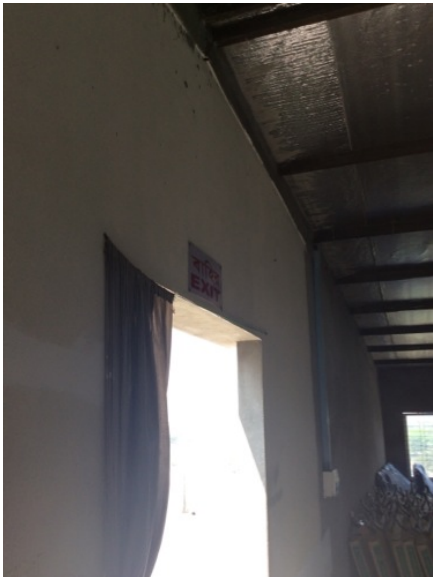
F-14	Egress Lighting	Exit Light sign not provided at Fourth floor Dining escape stair.	Provide exit signs above all exits to the exterior and all doors to the exit stairs.	Within 3 months
------	-----------------	---	--	-----------------
