FIRE SAFETY INSPECTION REPORT

**ARA APPAREL EXPORT LTD.
2/C DARUSSALUM ROAD, MIRPUR**

ACC   **RD**
on Fire and Building Safety in Bangladesh

July 17, 2014

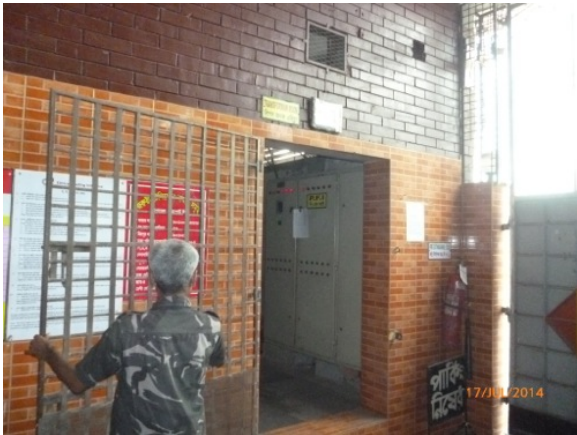
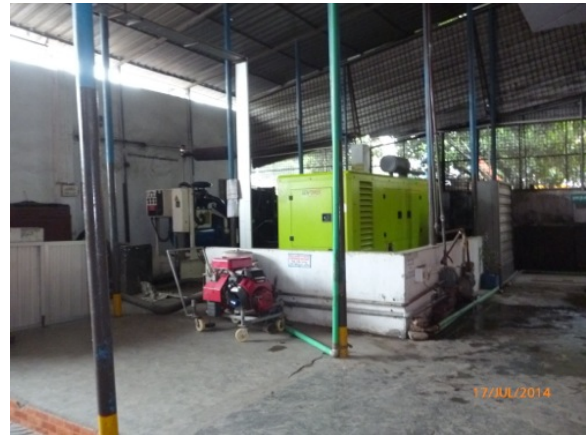
No.	Category	Finding	Recommendation	Remediation Timeframe
F-1	Fire Rated Construction	The generator and transformer rooms are not separated by fire-rated construction resulting to unprotected exit discharge. (openings, non-rated doors, penetrations).	Separate the generator and transformer rooms by a minimum 2-hr fire-rated construction. Seal and/or protected all openings to maintain the required fire separations	Within 3 months

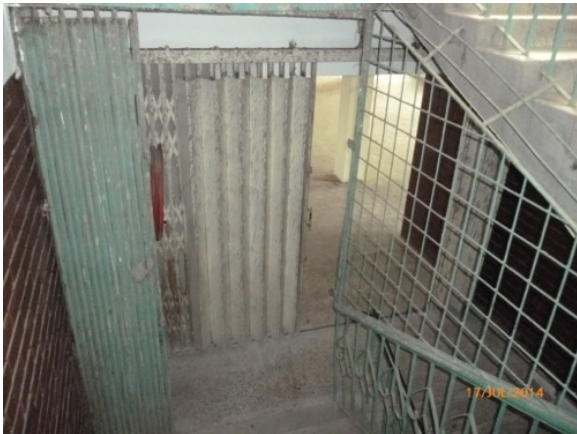
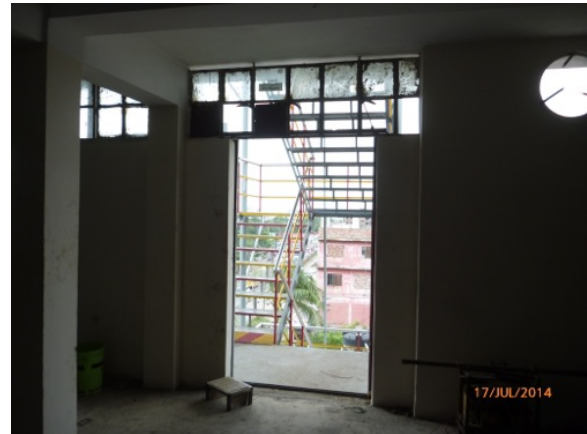
F-2	Fire Rated Construction	The exit stairs are not separated from work areas, other spaces on each floor by fire-rated construction.	Provide minimum 1.5-hr fire rated doors and seal all unprotected openings to separate the exit stairs from work areas and other building spaces on all floor levels. Ensure that the fire doors are self-closing and positive latching and that they are provided with fire exit (panic) hardware where serving production floors. If fire doors are required to be held open for functional reasons, provide automatic-closing devices tied to the fire alarm system.	Within 3 months
-----	-------------------------	---	---	-----------------

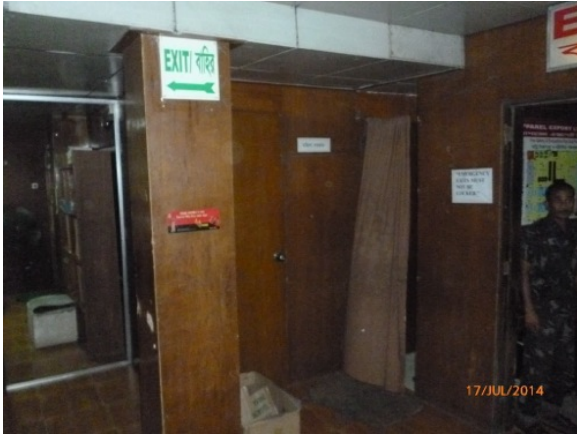
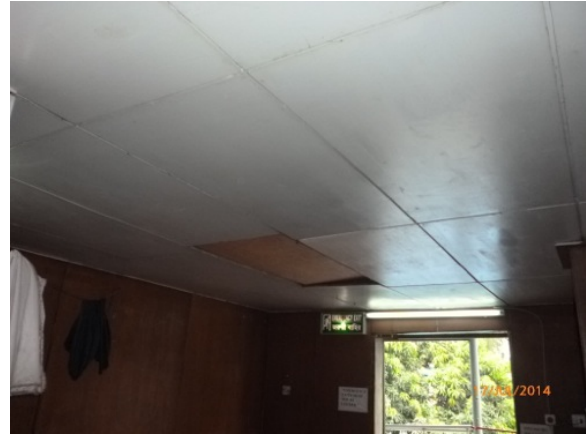
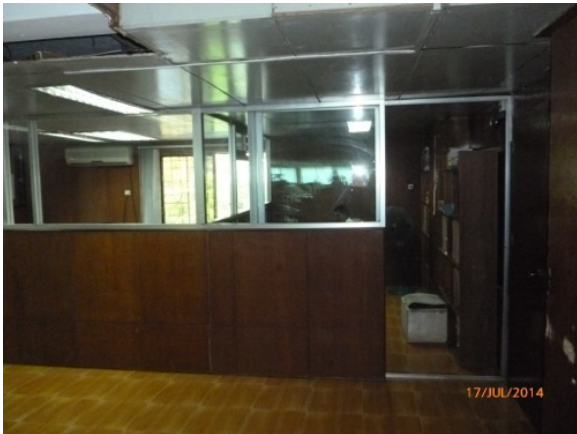
F-3	Fire Rated Construction	Combustible construction materials was used inside the building. (Wooden ceiling and wall). Location: 2nd floor office.	Remove and replace all combustible construction materials by non-combustible.	Within 3 months
-----	-------------------------	---	---	-----------------

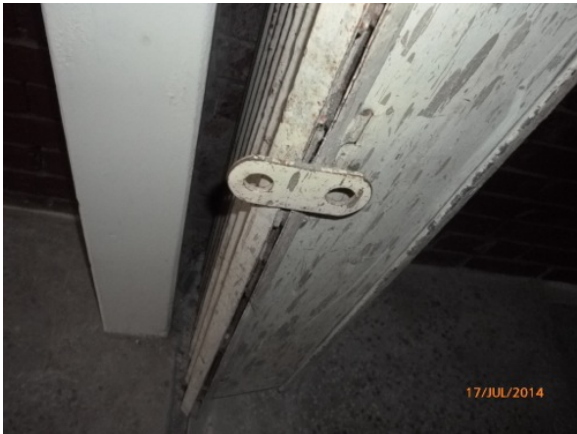
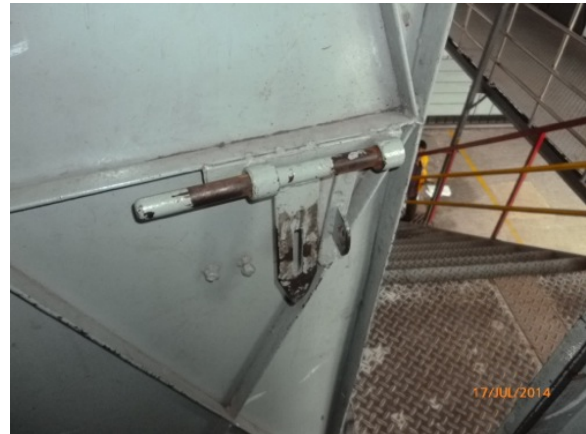
F-4	Egress	<p>Egress doors with locking features are provided at building exits, exit stairs and along egress routes.</p> <p>All doors were open and unlocked during the inspection.</p>	<p>Remove locking features from all egress doors.</p> <p>If locks are required for security reasons, utilize special door locking features complying with NFPA 101.</p>	Immediate
-----	--------	---	---	-----------

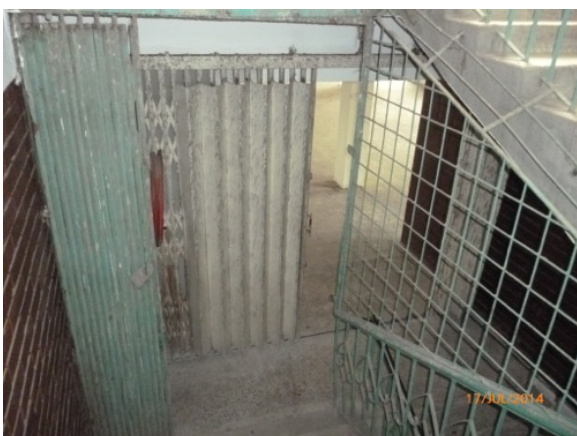
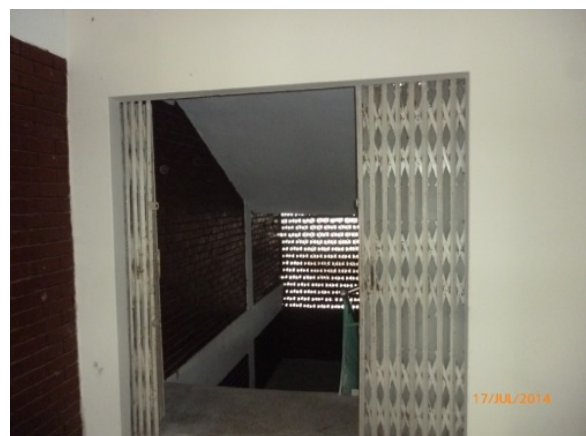
F-5 Egress

Collapsible gates and sliding doors are provided at building exits, exit stairs and along egress routes.

Replace all gates / sliding doors along the means of egress with side-hinged, swinging egress doors.

Within 1 month

If locks are required for security reasons, utilize special door locking features complying with NFPA 101.

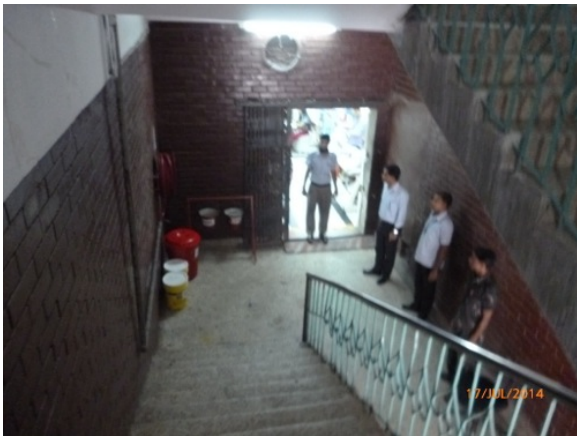
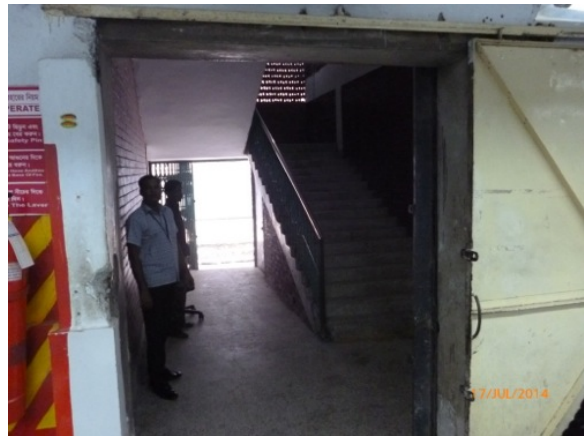
F-6	Egress	Northwest exit stairs discharge inside the building.	Provide 2-hr fire-rated exit passageway leading directly outside (vestibules to separate any storage areas).	Within 6 months
Or				
Provide sprinkler protection for discharge floor in accordance with NFPA 13.

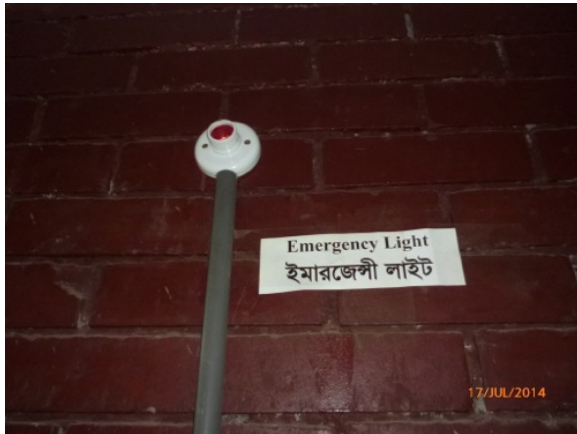
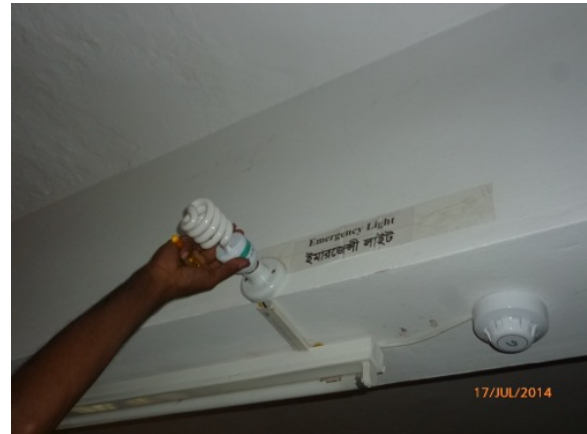
F-8	Egress Lighting	Several emergency lighting did not function in test mode (burned out, broken, etc.).	Regularly test the emergency lighting system on each floor and replace/repair lights as needed.	Within 1 month
-----	-----------------	--	---	----------------

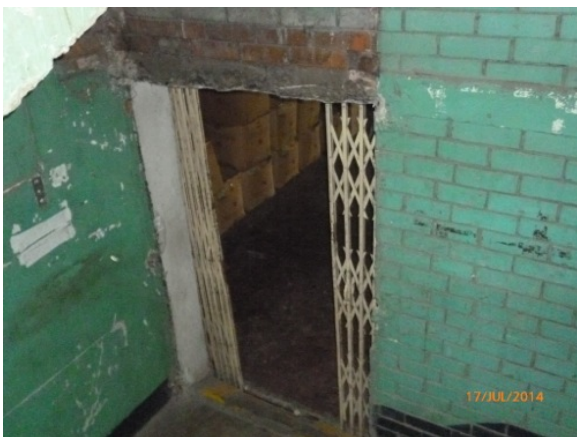
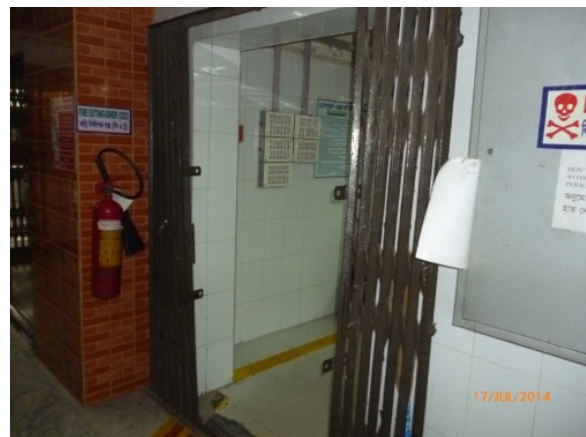
No.	Category	Finding	Recommendation	Remediation Timeframe
F-1	Fire Rated Construction	The exit stairs are not separated from work areas, other spaces on each floor by fire-rated construction.	<p>Provide minimum 1.5-hr fire rated doors and seal all unprotected openings to separate the exit stairs from work areas and other building spaces on all floor levels. Ensure that the fire doors are self-closing and positive latching and that they are provided with fire exit (panic) hardware where serving production floors.</p> <p>If fire doors are required to be held open for functional reasons, provide automatic-closing devices tied to the fire alarm system.</p>	Within 3 months

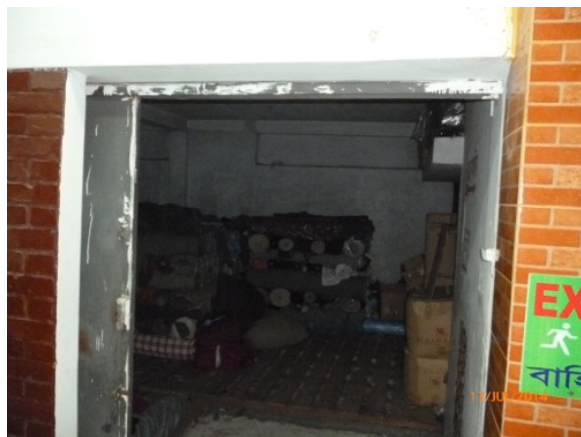
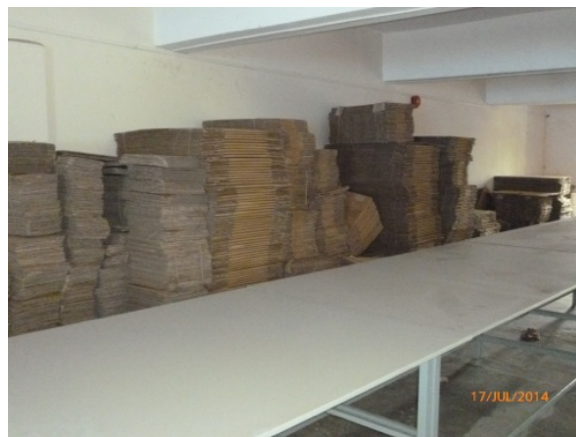
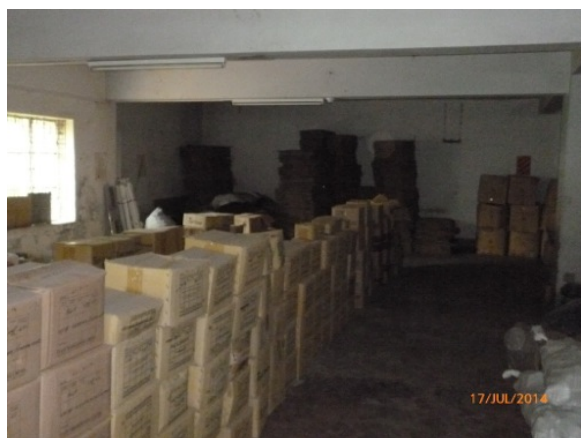
F-2	Fire Rated Construction	Rooms used for combustible storage in 1st and 2nd floors are not separated by fire-rated construction.	Provide dedicated storage rooms separated by minimum 1-hr fire-rated construction.	Within 3 months
-----	-------------------------	--	--	-----------------

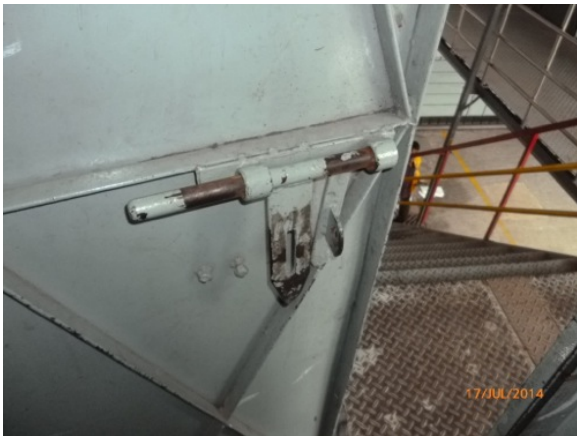
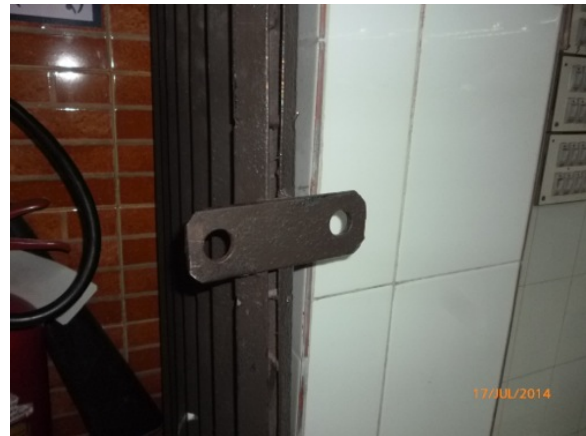
F-3	Egress	Egress doors with locking features are provided at building exits, exit stairs and along egress routes.	Remove locking features from all egress doors.	Immediate
		All doors were open and unlocked during the inspection.	If locks are required for security reasons, utilize special door locking features complying with NFPA 101.

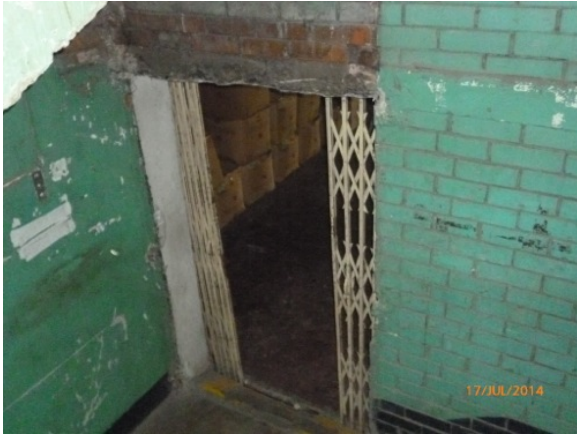
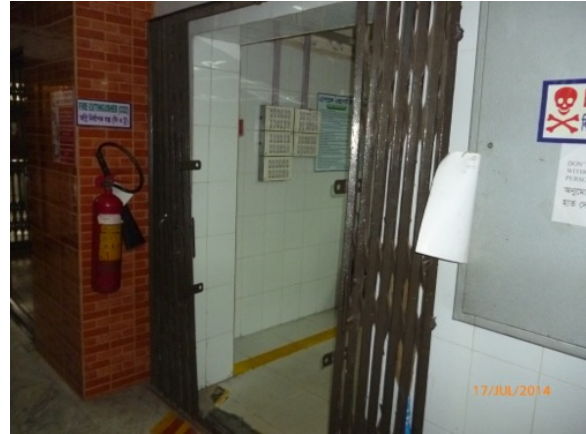
F-4	Egress	Collapsible gates and sliding doors are provided at building exits, exit stairs and along egress routes.	Replace all gates / sliding doors along the means of egress with side-hinged, swinging egress doors.	Within 1 month
			If locks are required for security reasons, utilize special door locking features complying with NFPA 101.

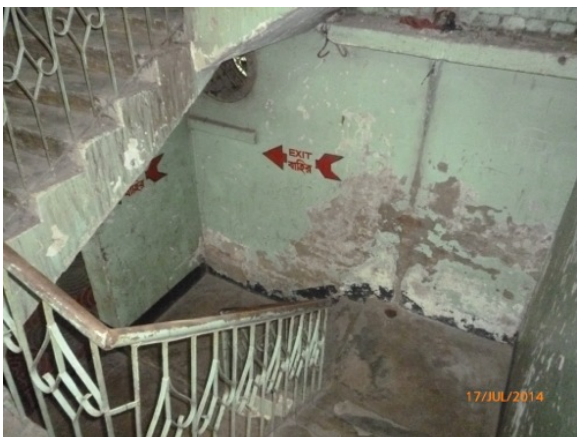
F-5 Egress

Northwest exit stairs discharge inside the building.

Provide 2-hr fire-rated exit passageway leading directly outside (vestibules to separate any storage areas).

Within 6 months

Or

Provide sprinkler protection for discharge floor in accordance with NFPA 13.

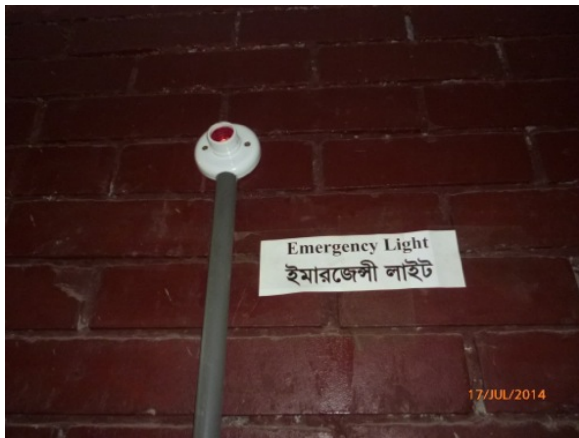
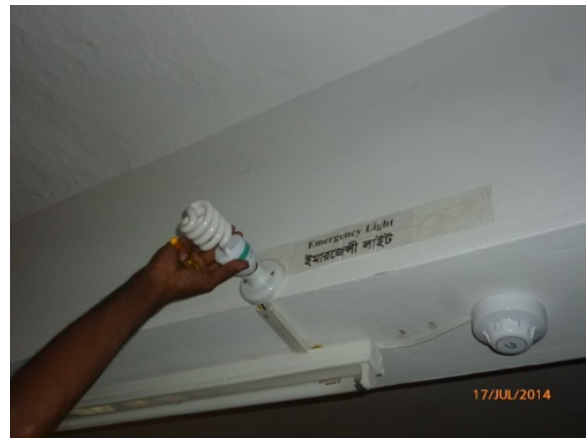
F-6	Fire Protection	Inspection, testing, and maintenance of the fire alarm system is not in accordance with NFPA 72.	Inspect, test and maintain the fire alarm system, and keep written records on-site, in accordance with NFPA 72.	Within 3 months
F-7	Egress Lighting	Several emergency lighting did not function in test mode (burned out, broken, etc.).	Regularly test the emergency lighting system on each floor and replace/repair lights as needed.	Within 1 month

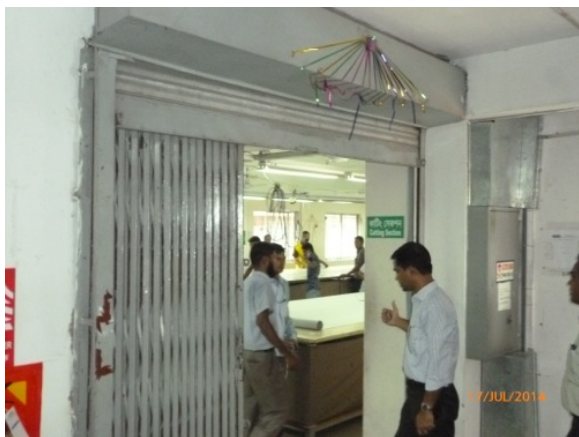
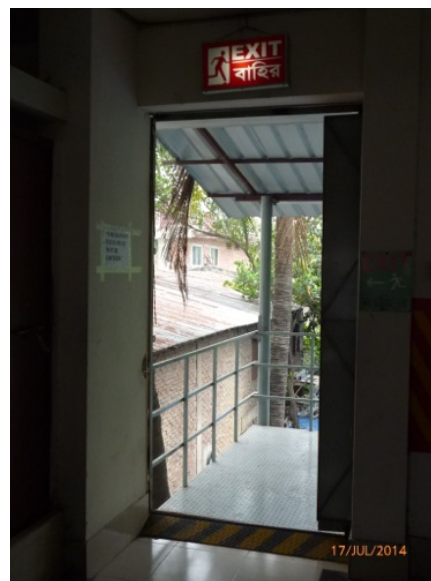
No.	Category	Finding	Recommendation	Remediation Timeframe
F-1	Fire Rated Construction	The exit stairs are not separated from work areas, other spaces on each floor by fire-rated construction.	<p>Provide minimum 1.5-hr fire rated doors and seal all unprotected openings to separate the exit stairs from work areas and other building spaces on all floor levels. Ensure that the fire doors are self-closing and positive latching and that they are provided with fire exit (panic) hardware where serving production floors.</p> <p>If fire doors are required to be held open for functional reasons, provide automatic-closing devices tied to the fire alarm system.</p>	Within 3 months

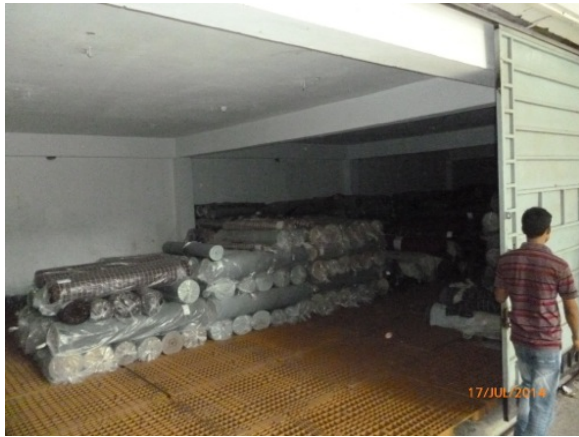
F-2	Fire Rated Construction	Rooms used for combustible storage in ground floor is not separated by fire-rated construction.	Provide dedicated storage rooms separated by minimum 1-hr fire-rated construction.	Within 3 months
-----	-------------------------	---	--	-----------------

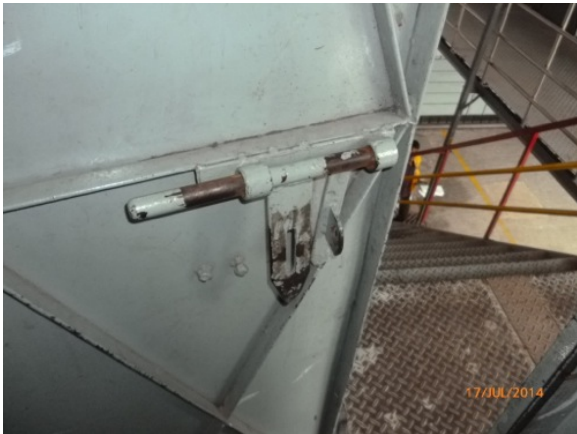
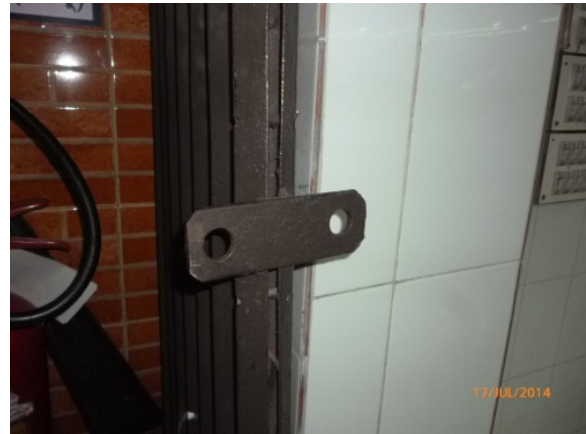
F-3	Egress	<p>Egress doors with locking features are provided at building exits, exit stairs and along egress routes.</p> <p>All doors were open and unlocked during the inspection.</p>	<p>Remove locking features from all egress doors.</p> <p>If locks are required for security reasons, utilize special door locking features complying with NFPA 101.</p>	Immediate
-----	--------	---	---	-----------

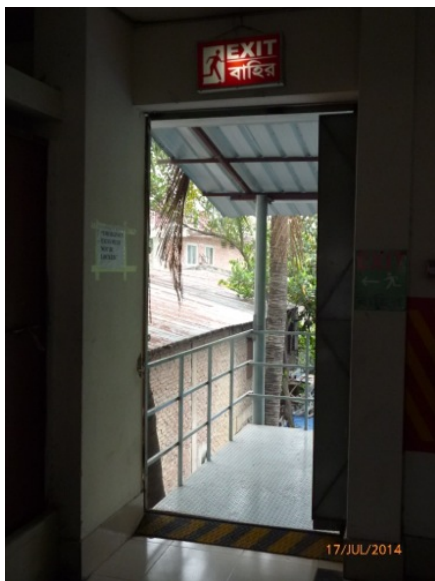
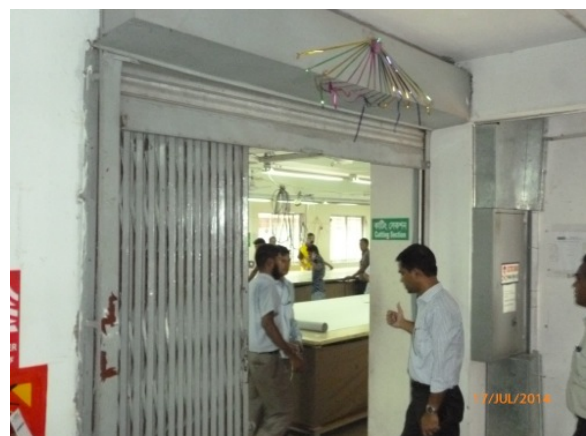
F-4 Egress

Collapsible gates and sliding doors are provided at building exits, exit stairs and along egress routes.

Replace all gates / sliding doors along the means of egress with side-hinged, swinging egress doors.

Within 1 month

If locks are required for security reasons, utilize special door locking features complying with NFPA 101.
