# **FIRE SAFETY INSPECTION REPORT**

**TARASIMA APPARELS LTD.**

**VILL: GOLORA, P/O:KAITTA, SATURIA, MANIKGONJ**

July 15, 2014

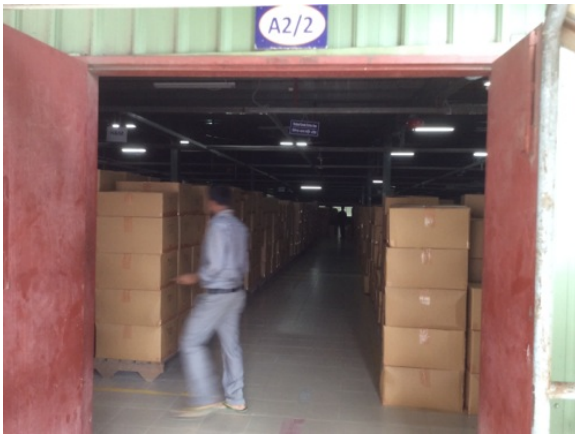
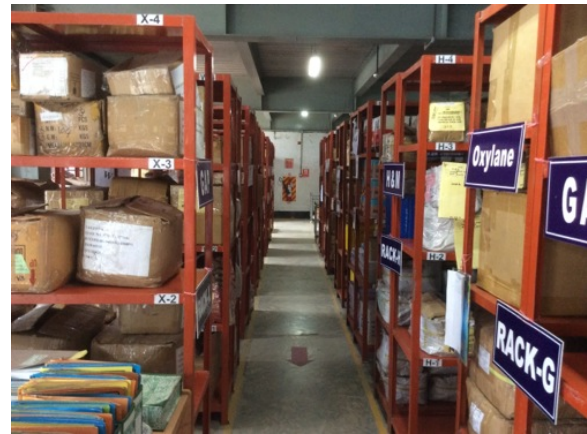
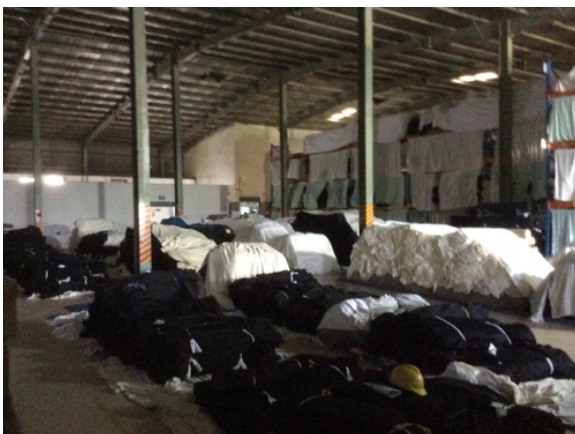
| F-1 | Fire Rated Construction | The all storage rooms are not separated by fire-rated construction. | Provide dedicated storage rooms separated by minimum 1-hr fire-rated construction. | Within 3 months |

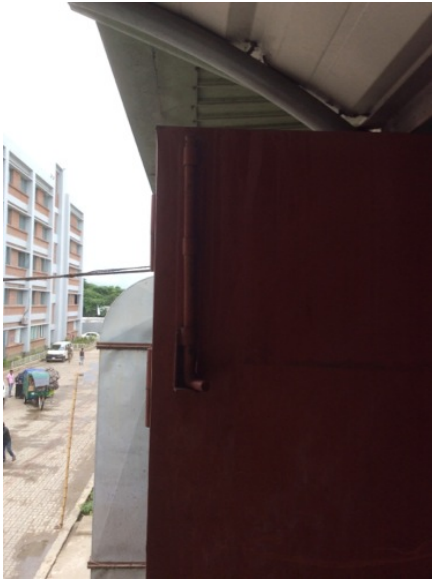
| F-2 | Egress | Egress doors with locking features are provided at building exits and exit discharge. | Remove locking features from all egress doors and gates.<br><br>If locks are required for security reasons, utilize special door locking features complying with NFPA 101. | Immediate |

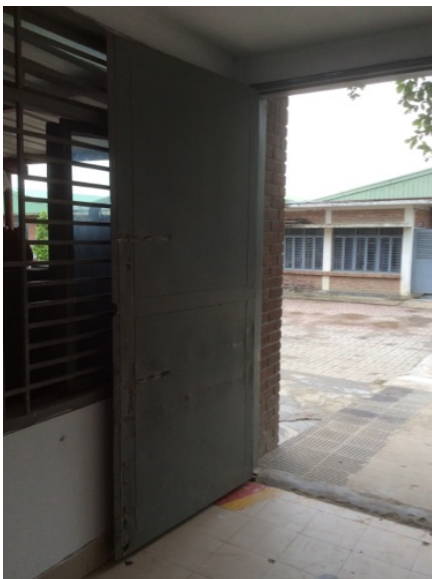
| F-3 | Egress | Exit door does not swing in the direction of egress travel. | Modify the egress door to swing in the direction of egress travel. | Within 3 months |

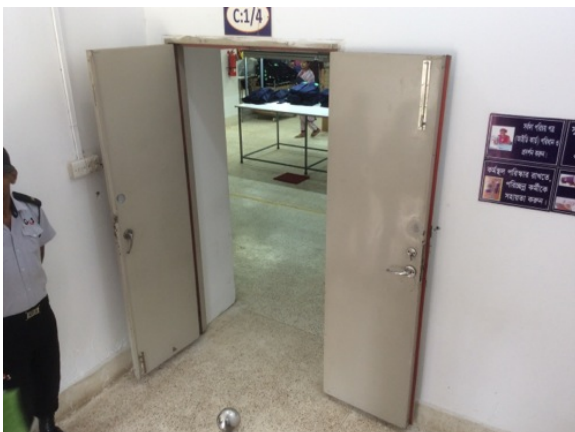
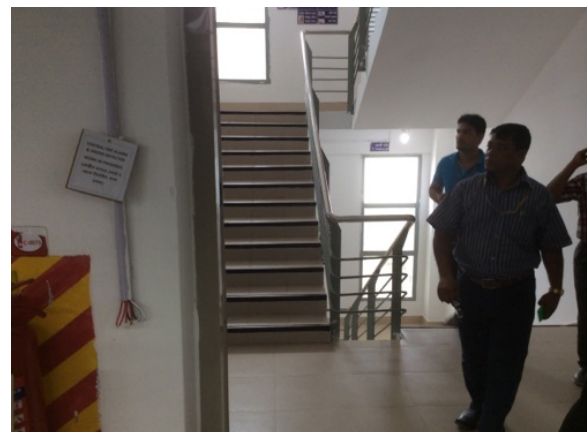
| No. | Category | Finding | Recommendation | Remediation Timeframe |
|---|---|---|---|---|
| F-1 | Fire Rated Construction | The exit stairs are not separated from work areas and other spaces on each floor by fire-rated construction. | <p>Provide minimum 1.5-hr fire rated doors and seal all unprotected openings to separate the exit stairs from work areas and other building spaces on all floor levels. Ensure that the fire doors are self-closing and positive latching and that they are provided with fire exit (panic) hardware where serving production floors.</p> <p>If fire doors are required to be held open for functional reasons, provide automatic-closing devices tied to the fire alarm system.</p> | Within 3 months |

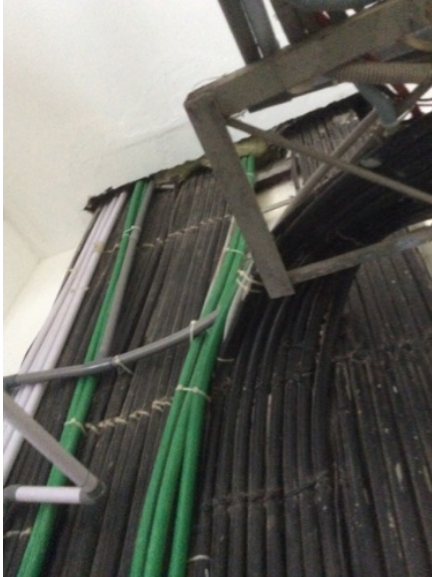
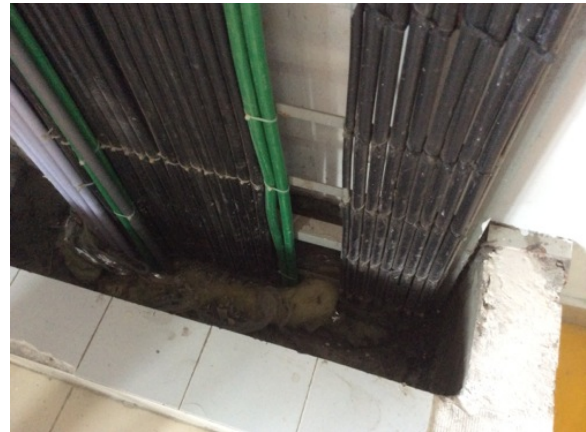
| F-2 | Fire Rated Construction | Unsealed penetrations and openings are located in the fire-rated floor/ceiling assemblies. | Provide a minimum 2-hr fire-rated shaft to separate the utility risers from each floor level. | Within 3 months |

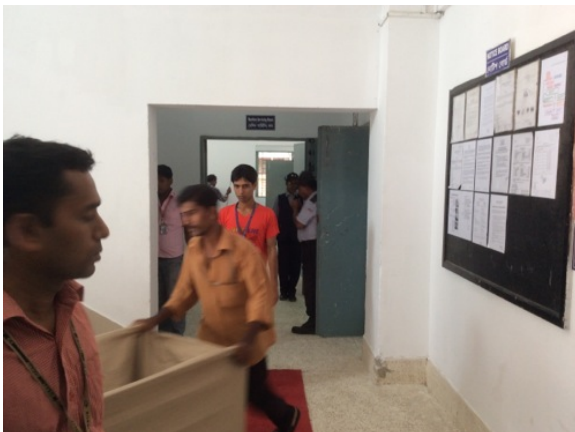
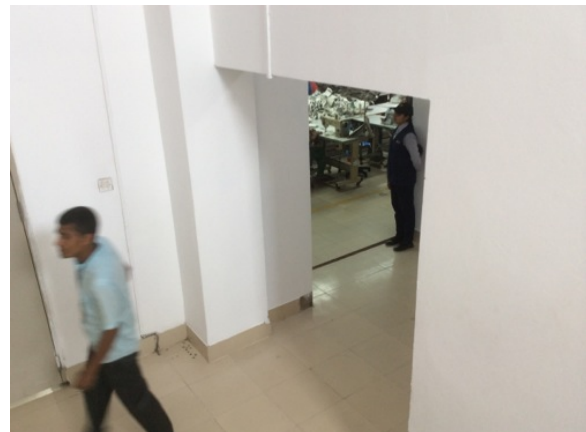
| F-3 | Fire Rated Construction | Unsealed penetrations and openings are located in exit stair enclosures on each floor. | Seal all penetrations and openings in exit stair enclosure walls to maintain the fire separation. | Within 3 months |

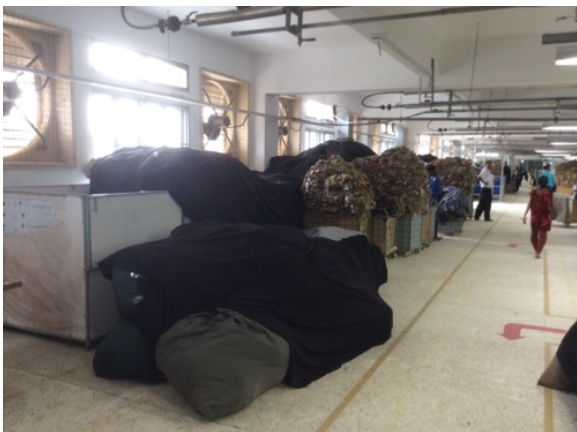
| F-4 | Fire Rated Construction | Areas used for combustible storage on ground floor are not separated by fire-rated construction. | <p>Provide defined storage areas and limit the storage arrangement as follows:</p> <ul style="list-style-type: none"> <li>- Maximum height of 2.4m and maximum area of 23m<sup>2</sup></li> <li>- If sprinkler protected: maximum height of 3.66m and maximum area of 93m<sup>2</sup></li> </ul> <p>Separate areas of unenclosed combustible storage by a minimum clear distance of 3m.</p> | Within 3 months |

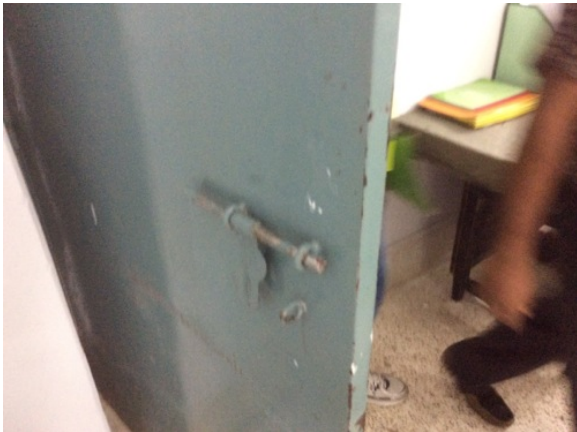
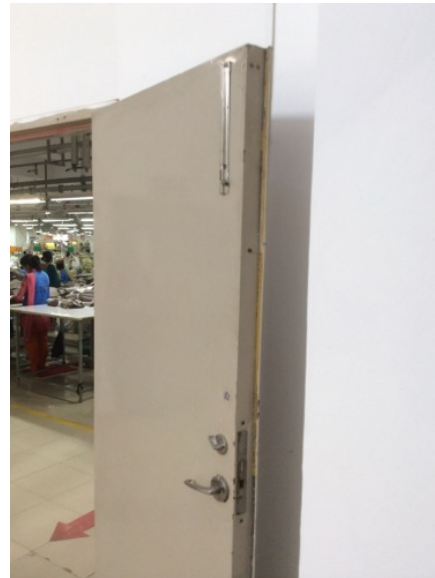
| F-6 | Egress | Egress doors and gates with locking features are provided at building exits, exit stairs, along egress routes and exit discharge. | <p>Remove locking features from all egress doors and gates.</p> <p>If locks are required for security reasons, utilize special door locking features complying with NFPA 101.</p> | Immediate |

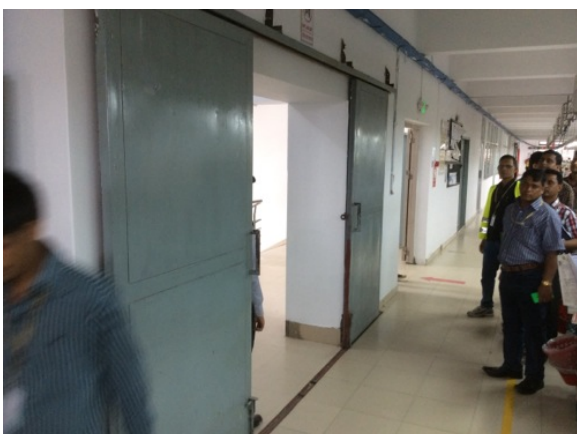
| F-7 | Egress | Collapsible sliding doors are provided at along egress routes and exit discharge. | Replace all gates and sliding doors along the means of egress with side-hinged, swinging egress doors. | Within 1 month |

| | | | If locks are required for security reasons, utilize special door locking features complying with NFPA 101. | |

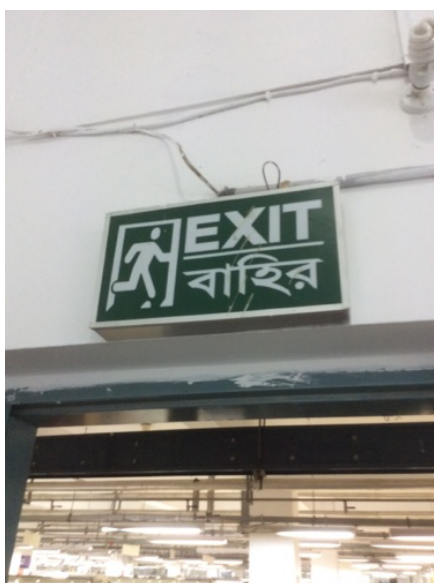
| F-11 | Egress Lighting | Exit signage not illuminated (broken). | Regularly inspect all exit signage and replace lights as needed to illuminate signs. | Within 1 month |

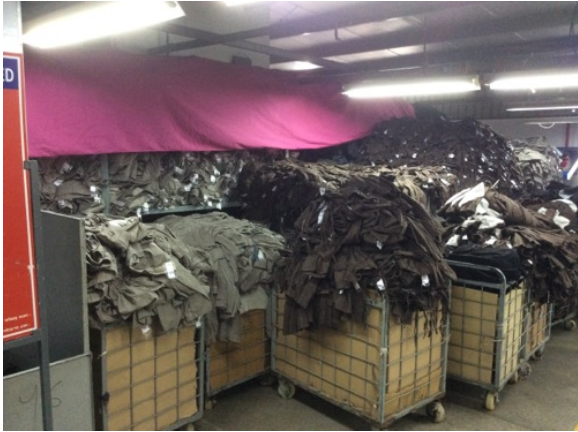
| No. | Category | Finding | Recommendation | Remediation Timeframe |
|---|---|---|---|---|
| F-1 | Fire Rated Construction | Areas used for combustible storage on the mezzanine are not separated by fire-rated construction. | <p>Provide defined storage areas and limit the storage arrangement as follows:</p> <ul style="list-style-type: none"> <li>- Maximum height of 2.4m and maximum area of 23m<sup>2</sup></li> <li>- If sprinkler protected: maximum height of 3.66m and maximum area of 93m<sup>2</sup></li> </ul> <p>Separate areas of unenclosed combustible storage by a minimum clear distance of 3m.</p> | Within 3 months |

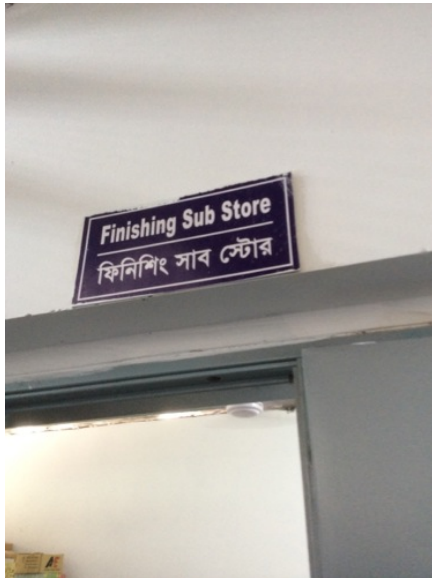
| No. | Category | Finding | Recommendation | Remediation Timeframe |
|---|---|---|---|---|
| F-2 | Fire Rated Construction | The storage on ground floor are not separated by fire-rated construction. | Provide dedicated storage rooms separated by minimum 1-hr fire-rated construction. | Within 3 months |

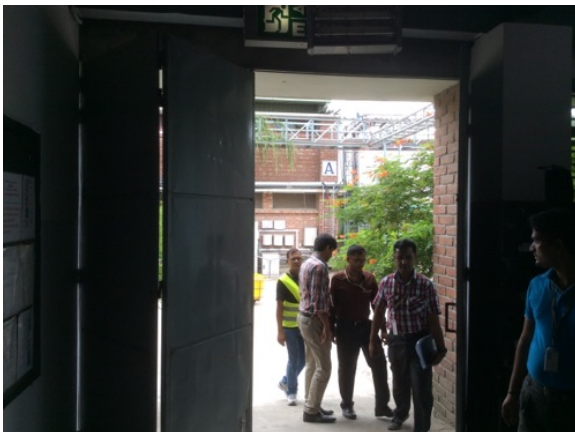
| F-3 | Egress | Egress doors with locking features are provided at building exits. | Remove locking features from all egress doors and gates.<br><br>If locks are required for security reasons, utilize special door locking features complying with NFPA 101. | Immediate |

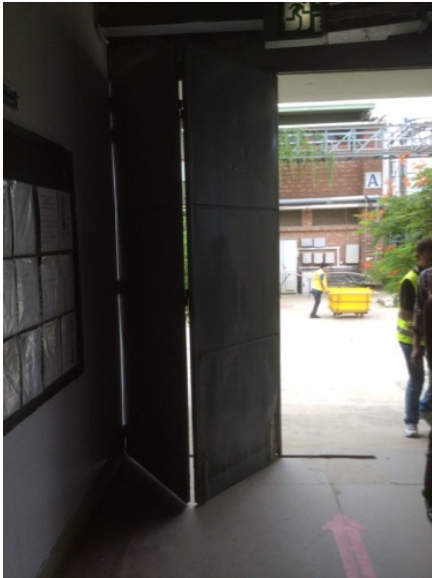
| F-4 | Egress | Collapsible sliding doors are provided at building exits. | Replace all gates and sliding doors along the means of egress with side-hinged, swinging egress doors.<br><br>If locks are required for security reasons, utilize special door locking features complying with NFPA 101. | Within 1 month |

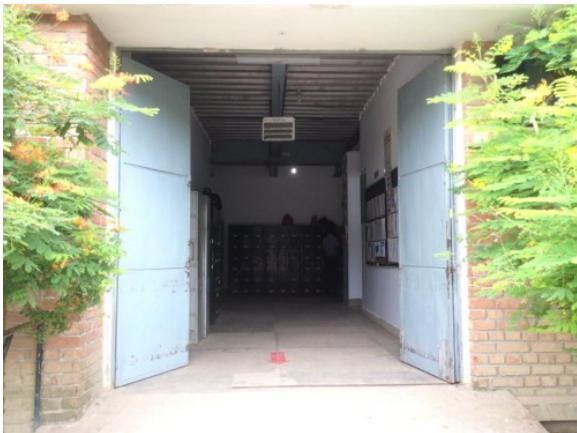
| F-5 | Egress | Exit door does not swing in the direction of egress travel. | Modify the egress door to swing in the direction of egress travel. | Within 3 months |

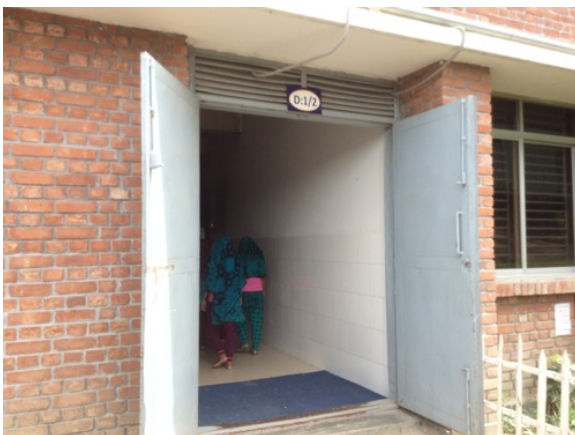
| No. | Category | Finding | Recommendation | Remediation Timeframe |
|---|---|---|---|---|
| F-2 | Egress | Egress doors with locking features are provided at building exits and exit stairs. | Remove locking features from all egress doors and gates.<br><br>If locks are required for security reasons, utilize special door locking features complying with NFPA 101. | Immediate |

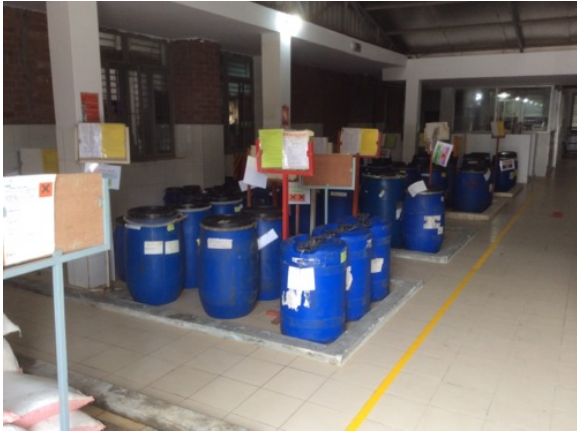
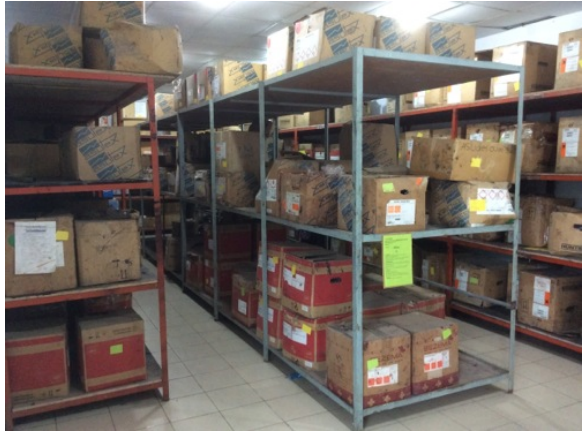
| No. | Category | Finding | Recommendation | Remediation Timeframe |
|---|---|---|---|---|
| F-1 | Fire Rated Construction | Hazardous materials storage area is not separated by fire-rated construction (openings, non-rated doors, penetrations). | Separate the hazardous materials and flammable liquid storage room by a minimum 2-hr fire-rated construction. Seal and protected all openings to maintain the required fire separations. | Within 3 months |

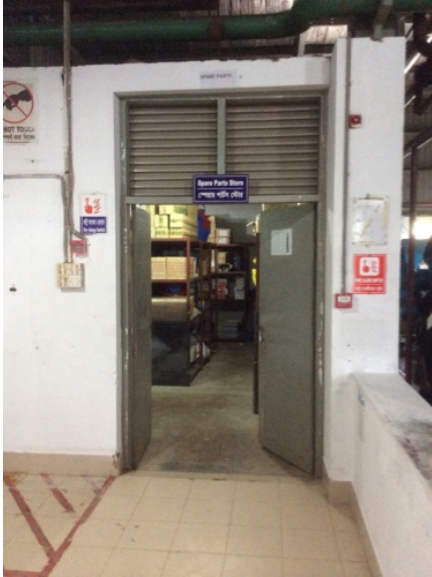
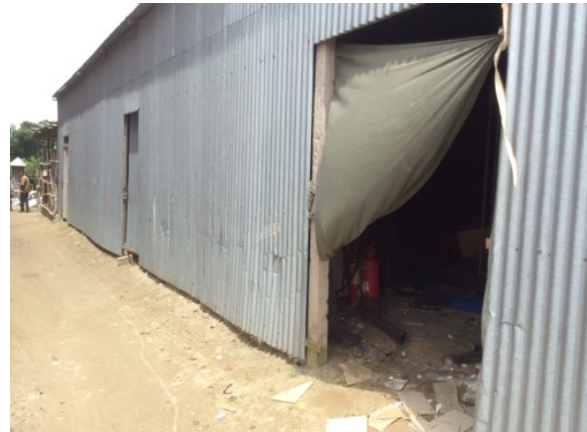
| No. | Category | Finding | Recommendation | Remediation Timeframe |
|---|---|---|---|---|
| F-2 | Fire Rated Construction | The storage room are not separated by fire-rated construction. | Provide dedicated storage rooms separated by minimum 1-hr fire-rated construction. | Within 3 months |

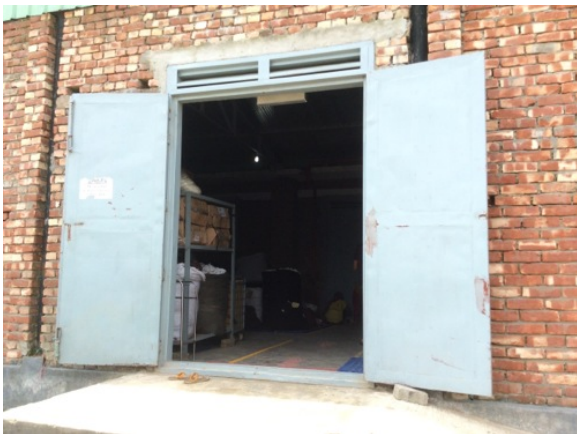
| F-3 | Egress | Egress doors with locking features are provided at building exits and along egress routes. | Remove locking features from all egress doors and gates.<br><br>If locks are required for security reasons, utilize special door locking features complying with NFPA 101. | Immediate |

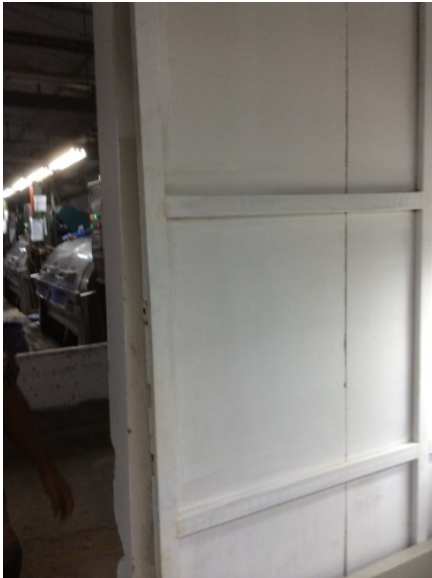
| F-4 | Egress | Collapsible sliding doors are provided at along egress routes. | <p>Replace all gates and sliding doors along the means of egress with side-hinged, swinging egress doors.</p> <p>If locks are required for security reasons, utilize special door locking features complying with NFPA 101.</p> | Within 1 month |
