# FIRE SAFETY INSPECTION REPORT

## Jamuna Knit Concern

ACCORD ID: 10591

Date: 8 January, 2017

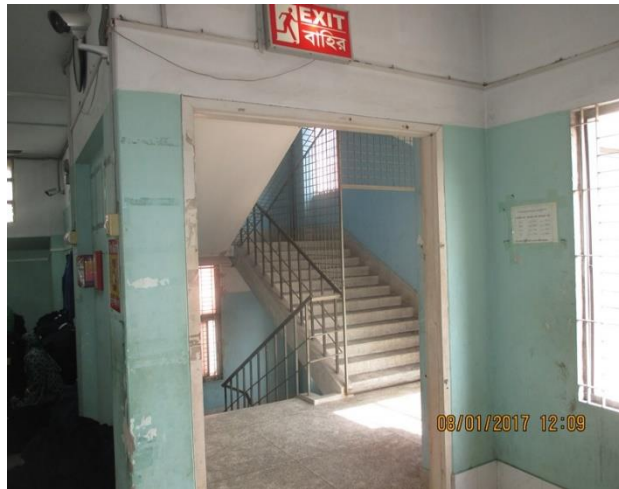
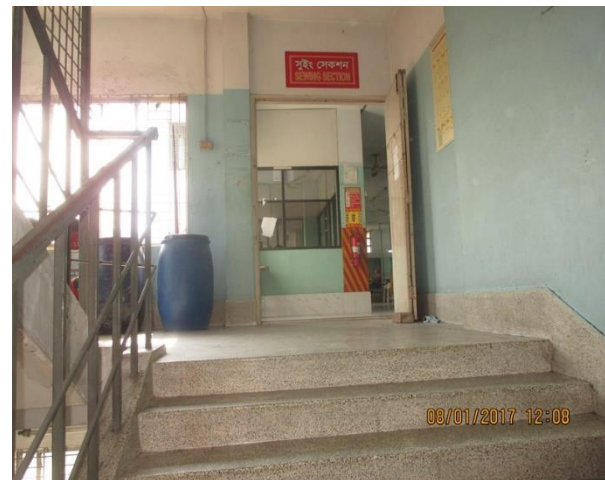
| No. | Category | Finding | Recommendation | Remediation<br>Timeframe |
|---|---|---|---|---|
| F-1 | Fire Rated Construction | Exit stairs are not separated from work areas & other spaces on each floor by fire-rated construction due to unprotected openings and penetrations. | <p>Separate the exit stairs from work areas and other building spaces on all floor levels by minimum 2- hr fire-rated construction. Provide minimum 1.5- hr fire rated doors and seal all unprotected openings and penetrations to maintain the fire separation.</p> <p>Ensure that all fire doors are self-closing and positive latching, and are provided with fire exit (panic) hardware where serving production floors or assembly occupancies.</p> <p>If fire doors are required to be held open for functional reasons, provide automatic-closing devices tied to the fire alarm system.</p> | Within 3 months |

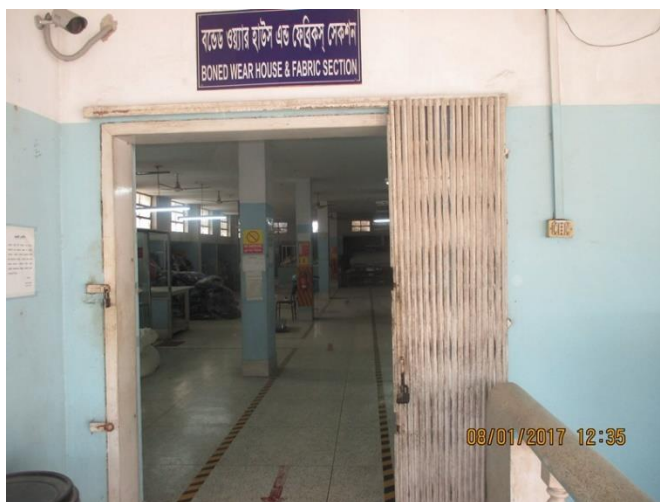
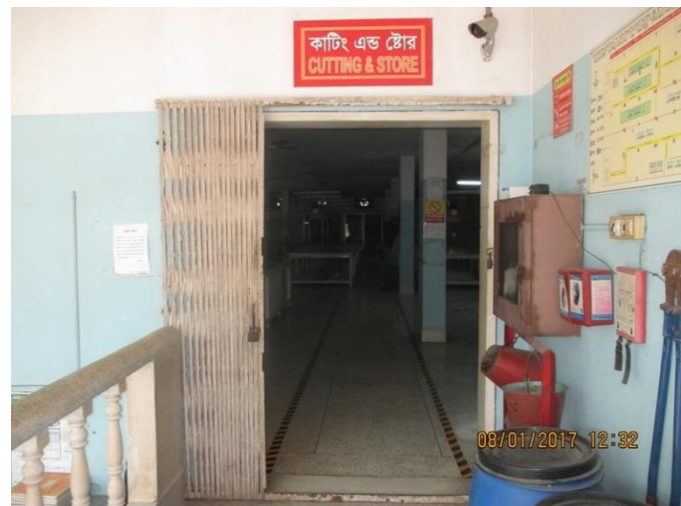
F-2 Fire Rated Construction Room on the ground floor used for combustible storage is not separated by a minimum 1-hr fire-rated construction.

Provide dedicated storage rooms separated by minimum 1-hr fire-rated construction.

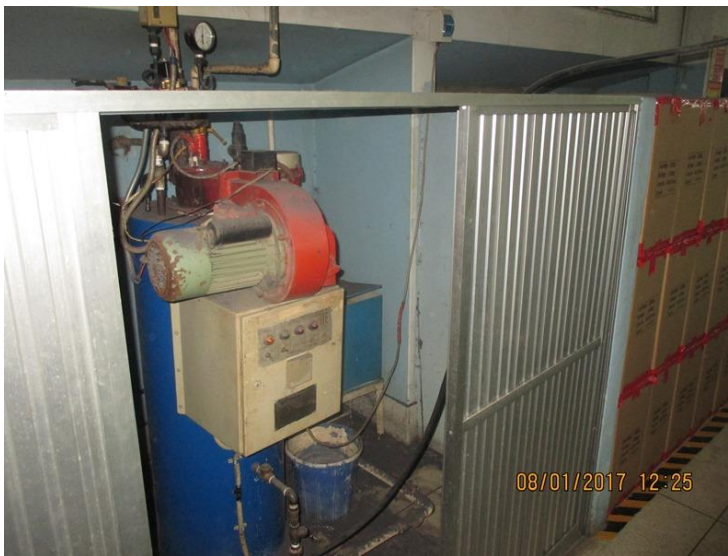
| F-3 | Fire Rated Construction | The boiler open on the 1st floor and is not separated by fire-rated construction. | <p>Separate the boiler room by a minimum 1-hr fire-rated construction.</p> <p>Seal and/or protect all openings to maintain the required fire separations.</p> <p>Provide proper ventilation and consult a qualified engineer.</p> <p>If applicable: When located to the exterior of a building, separate the boiler by by a minimum distance of 3m (10 ft).</p> | Within 3 months |

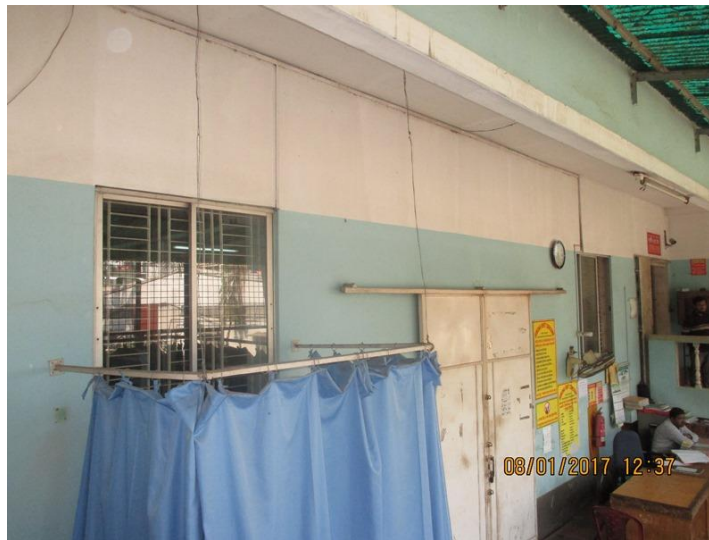
| F-4 | Fire Rated Construction | Unsealed penetrations and openings are located in exit stair discharge path. | Seal all penetrations and openings in the exit stair discharge to maintain the required 2 hr. fire separation. | Within 3 months |

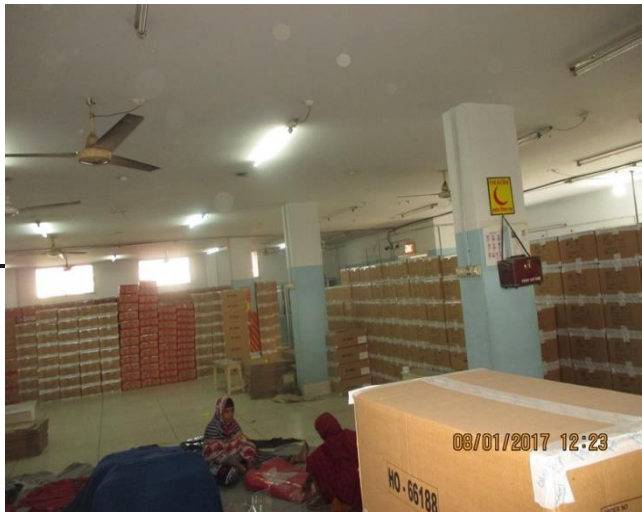
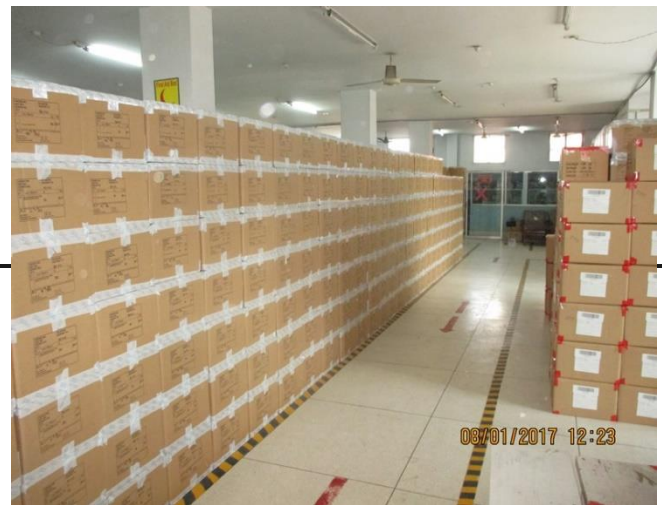
| F-5 | Fire Rated Construction | Areas on the 1st floor used for combustible storage open to the factory are not properly defined and/or not within limits. | <p>Provide defined storage areas and limit the storage arrangement as follows:</p> <p>Maximum height of 2.45m (8 ft) and maximum area of 23 m<sup>2</sup> (250 ft<sup>2</sup>).</p> <p>If sprinkler protected: maximum height of 3.66m (12 ft) and maximum area of 93m<sup>2</sup> (1000 ft<sup>2</sup>).</p> <p>Separate the areas of unenclosed combustible storage by a minimum clear distance of 3 m (10 ft).</p> | Within 3 months |

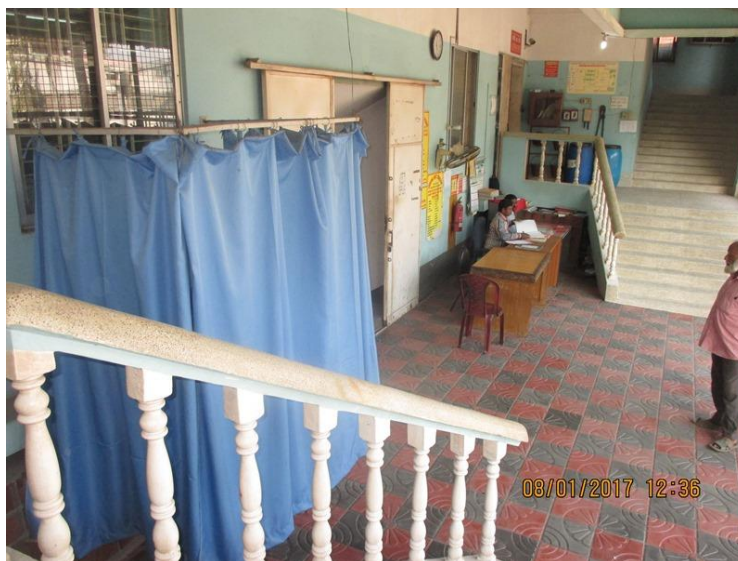
| F-6 | Fire Rated Construction | Storage rooms at ground floor discharges directly into the exit stair discharge. Basement store also discharges directly into the exit stair discharge. | Openings from exit enclosure to storage rooms shall be provided with a vestibule with fire rated construction and openings.<br><br>Provide a 1.5 hr. fire rated door on the exit stair side and a 1 hr. fire rated door on the store room side. Ensure that the fire rating of the vestibule construction matches that of the exit stair enclosure. | Within 3 months |

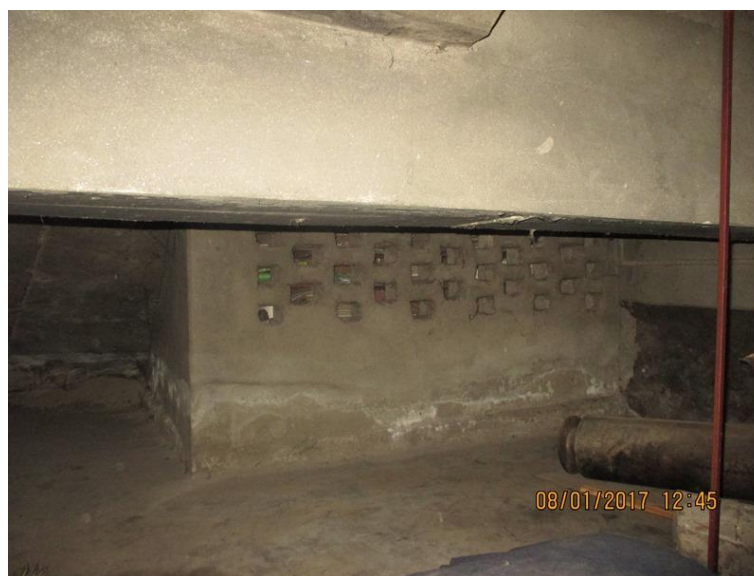
| F-7 | Fire Rated Construction | Unsealed penetrations and openings are located in generator room. | Seal all penetrations and openings in generator room to maintain the required 2 hr. fire separation. | Within 3 months |

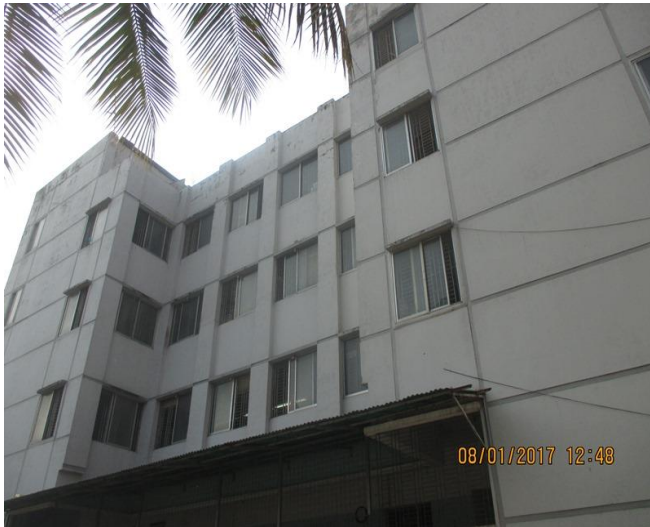
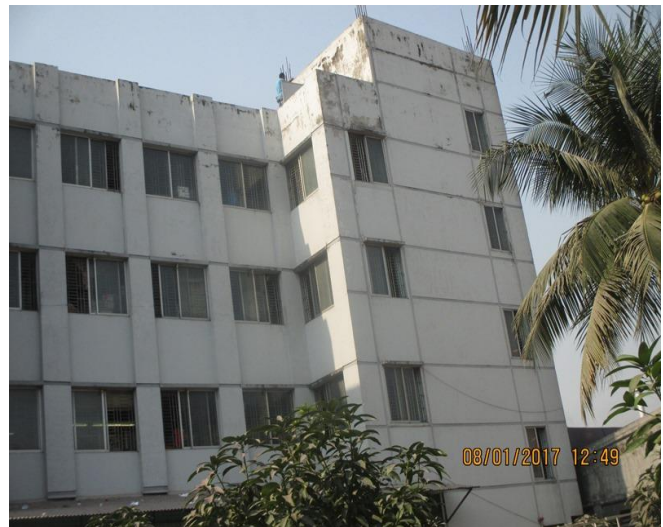
| F-8 | Fire Rated Construction | The exit stairs are not properly separated from the building interior by 2-hr fire rated construction. | The rating of the exterior wall shall be extended 3.05 m (10ft) beyond the ends of the exit stair structures in accordance with Accord standard 6.3.1.3 and 6.14.7. | Within 3 months |

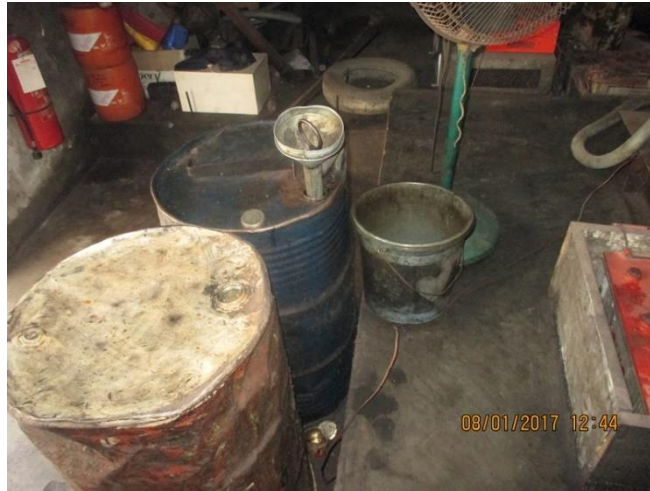
| F-9 | Fire Rated Construction | Diesel fuel storage was located inside the generator room. | Remove all diesel fuel storage from the generator room and relocate to the exterior such that the diesel fuel storage is at least 10 ft from required egress paths.<br>Or<br>Separate the diesel fuel storage with 2- hr fire rated construction. | Within 3 months |

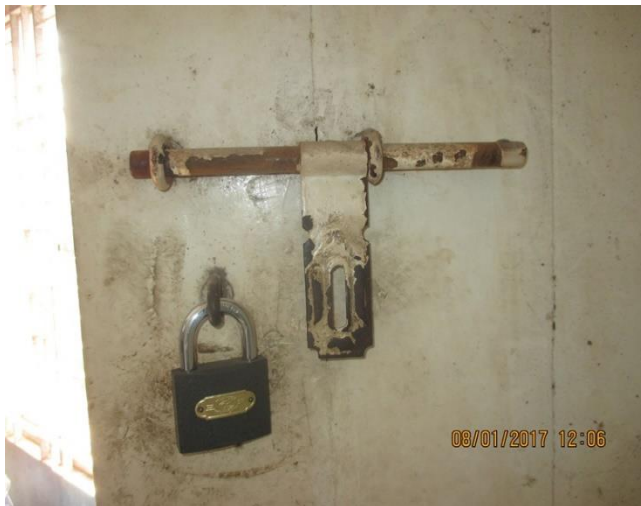
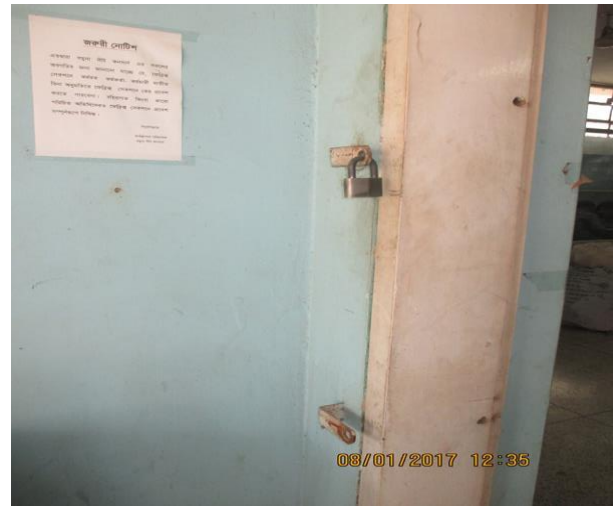
| F-10 | Egress | Egress gates on the all floor with locking features are provided at all exits & exit discharge. | <p>Remove locking features from all egress gates.</p> <p>If locks are required for security reasons, utilize special door locking features complying with ACCORD standard 6.8.2.</p> | Immediate |

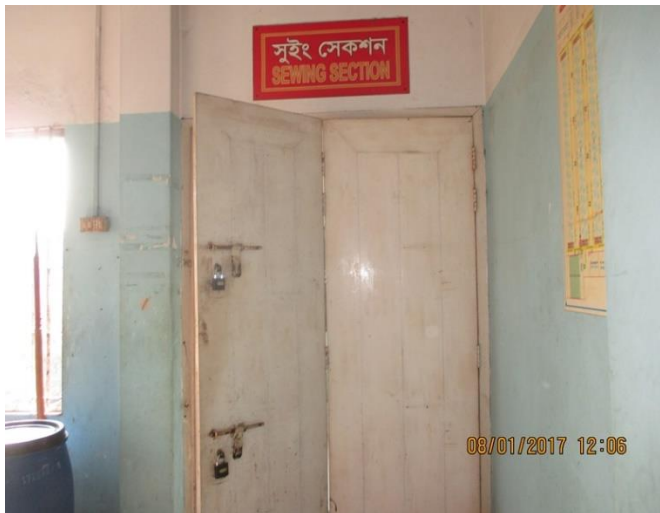
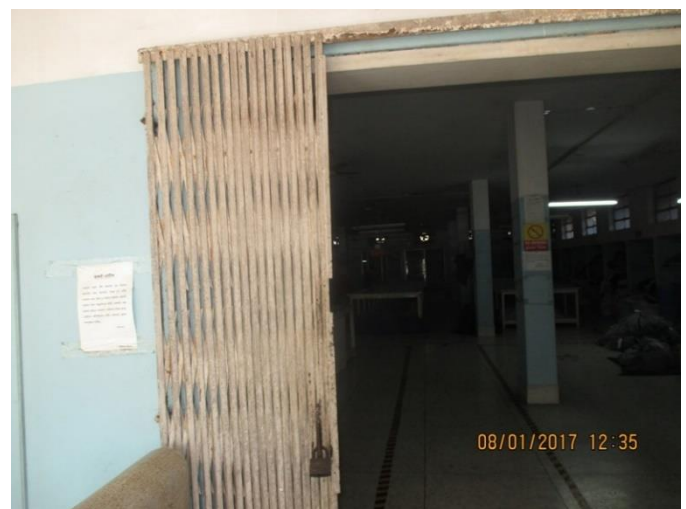
| F-11 | Egress | Collapsible gates and semi swing type doors provided at the building exits, exit stairs, along egress routes and exit discharge. | Replace all gates, sliding doors and rolling shutters along the means of egress with side-hinged, swinging egress doors.<br><br>If locks are required for security reasons, utilize special door locking features complying with NFPA 101. | Within 1 month |

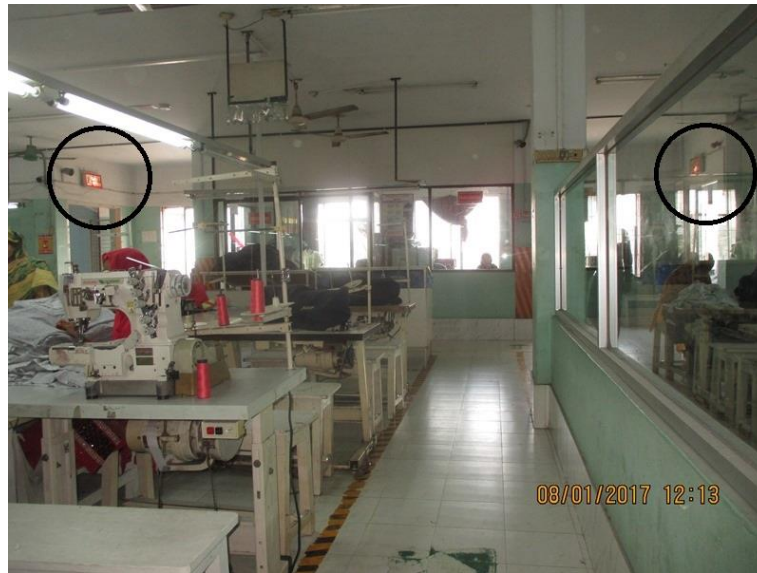
| F-12 | Egress | Exits are not remotely located from each other such that a single fire event could compromise both exits. | Provide additional exit(s) to meet ACCORD standard 6.6.6.<br><br>Or<br>Provide sprinkler protection in accordance with NFPA 13 to meet ACCORD standard 6.6.6.<br><br>Or<br>Modify exit arrangement to meet ACCORD standard 6.6.6. | Within 6 months |

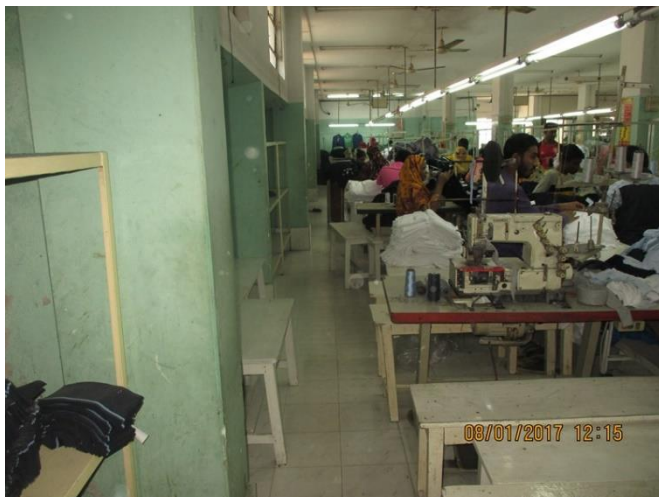
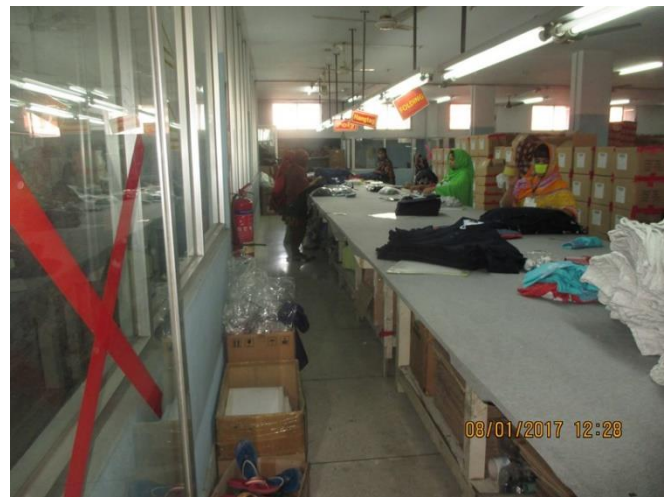
F-13 Egress

The width of egress  
aisles is less than 36-in.

At 1st & 2nd floors.

Aisles shall be provided with  
a minimum unobstructed  
clear-width of 0.9 m (36 in.).

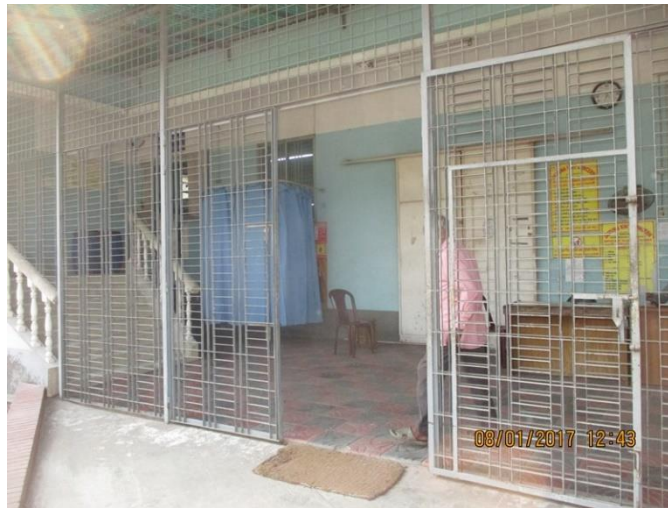
| F-14 | Egress | At the ground floor level only one exit serves the building occupants to discharge outside of the building. | Modify exit stair discharge paths so that each stair can discharge the occupants directly outside the building.<br>Or<br>Provide an additional exit discharge for the building. | Within 6 months |

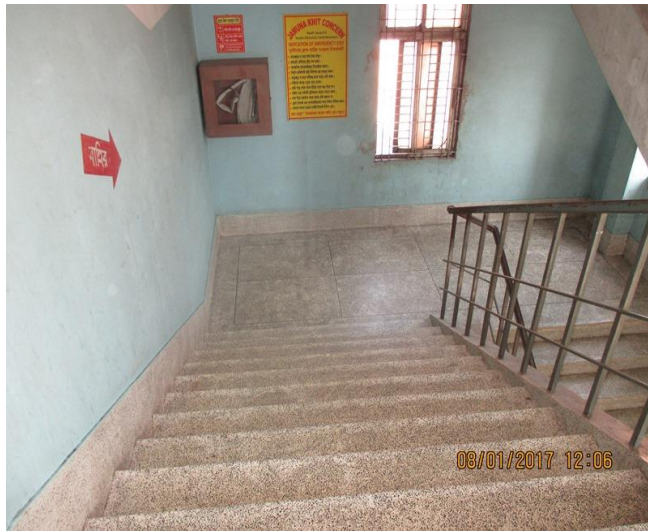
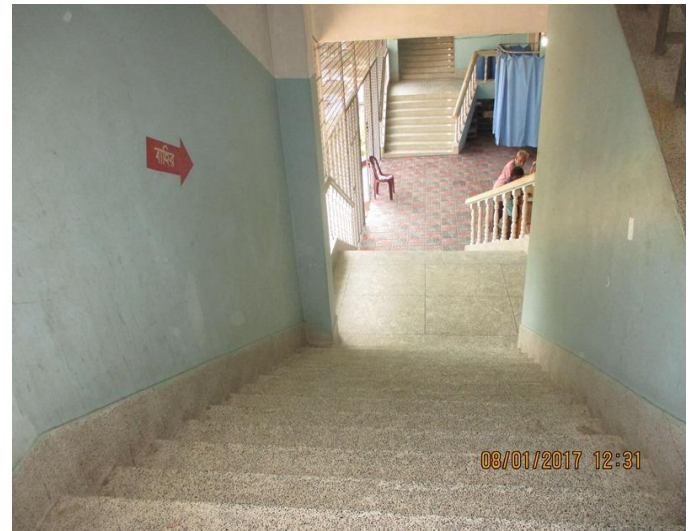
| F-15 | Egress | Handrails are not provided on both sides of both exit stairs. | Provide handrails on both sides of the exit stair. New handrails shall have a minimum height of 865 mm (34 in.) and a maximum height of 965 mm (38 in.) as measured from the leading edge of the tread.<br>Intermediate handrails shall be provided when the stair width exceeds 2.2 m (87 in.) | Within 3 months |

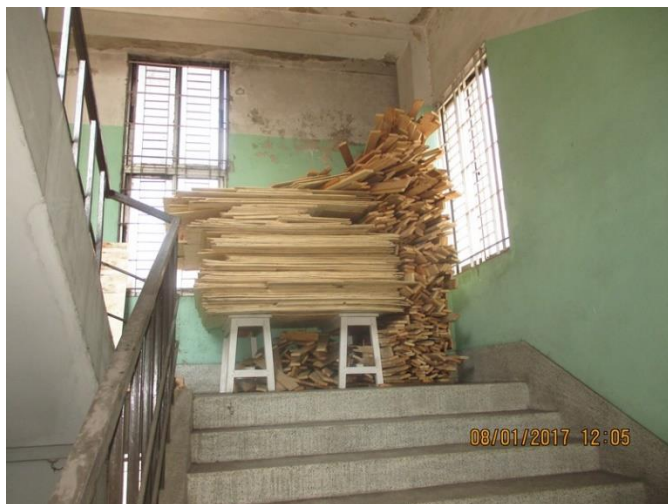
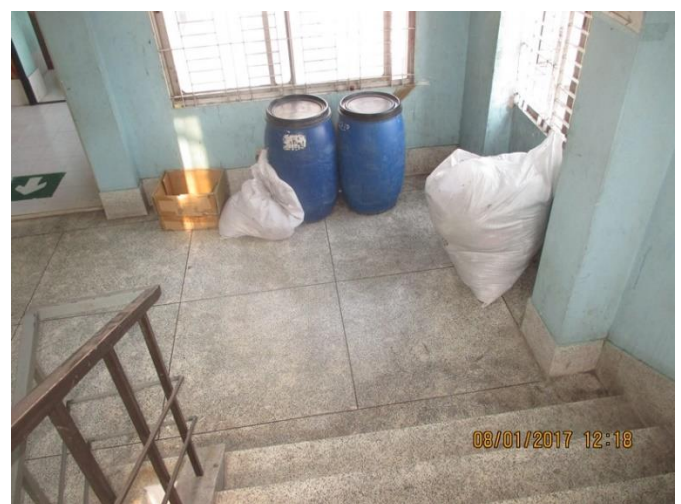
| F-16 | Egress | Storage was located in the exit stairs.<br><br>All floors. | Remove all storage from the exit stairs and egress paths | Immediate |

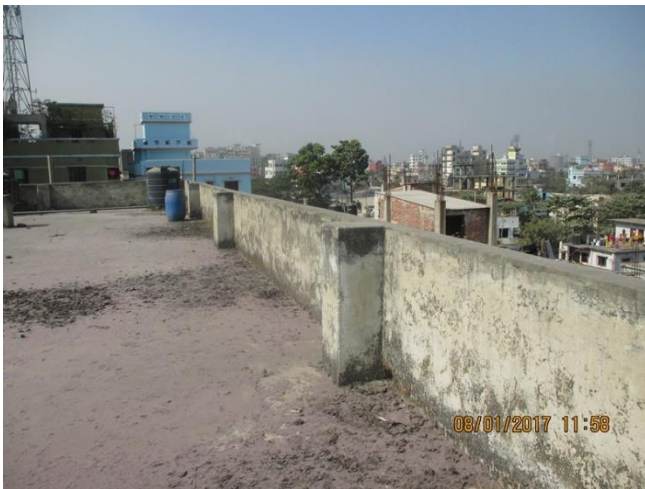
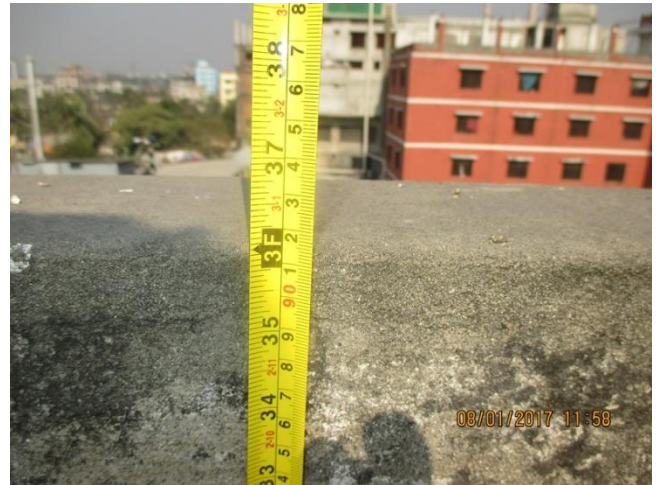
| F-17 | Egress | Occupiable roof is not provided with an adequate parapet / guard rail. | All occupiable roofs shall be provided with parapets or guards with a minimum height of 1067 mm (42 in.) | Within 3 months |

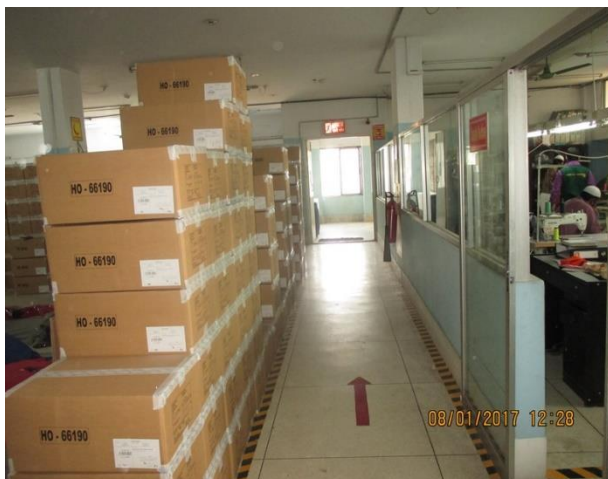
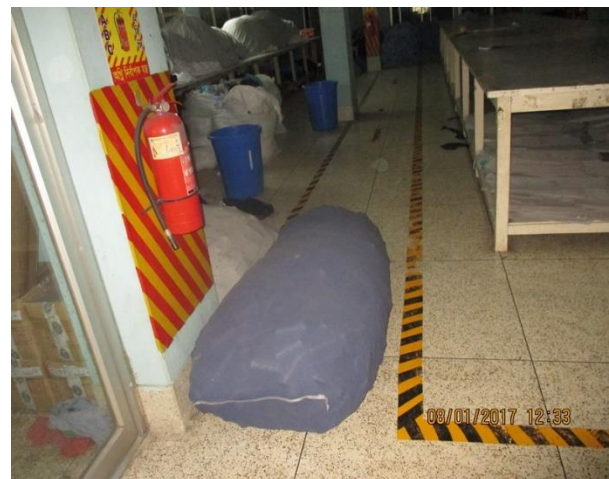
| F-18 | Egress | Storage was located in the egress paths and aisles. | Remove all storage from the egress paths and aisles. | Immediate |

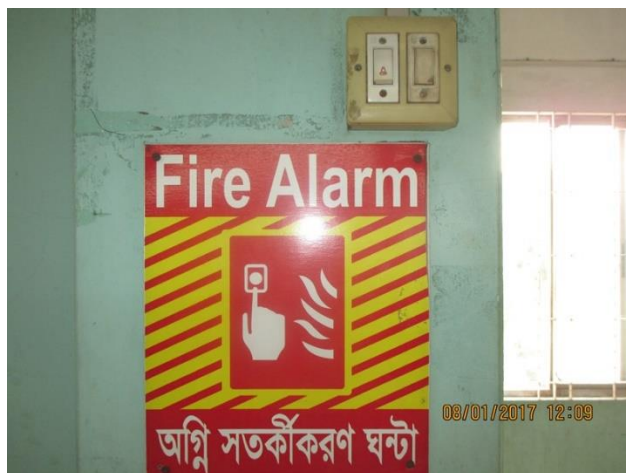
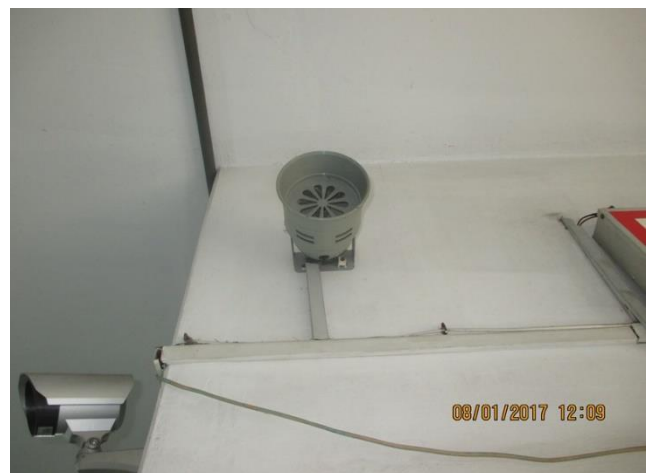
| F-20 | Fire Protection | The fire alarm system is antiquated, not a listed system and does not provide alarm and notification features consistent with acceptable standards. | Replace the fire alarm system with a new, listed automatic fire alarm system in accordance with NFPA 72 and ACCORD standards. | Design within 4 months<br>Install within 9 months |

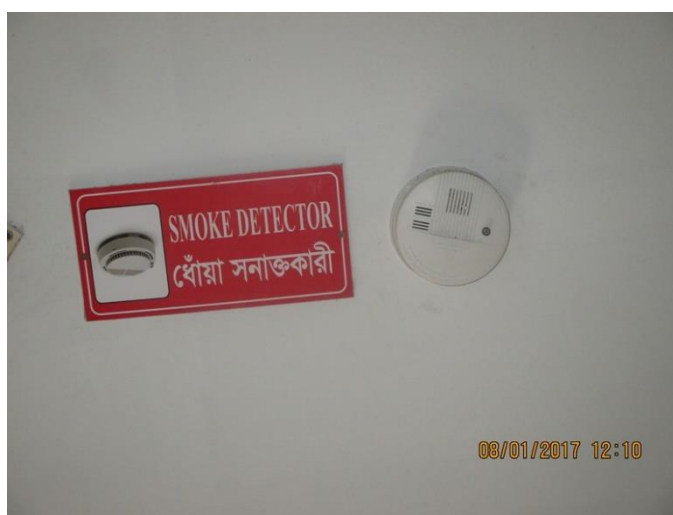
| F-22 | Fire Protection | The building is equipped with single-station smoke alarms. Smoke alarm activation sounds only a local alarm and does not provide automatic fire alarm notification of occupants. | Remove single-station smoke alarms. Provide automatic smoke detection throughout the building, tied into the fire alarm system, in accordance with NFPA 72 and ACCORD standards. | Design within 4 months<br>Install within 9 months |

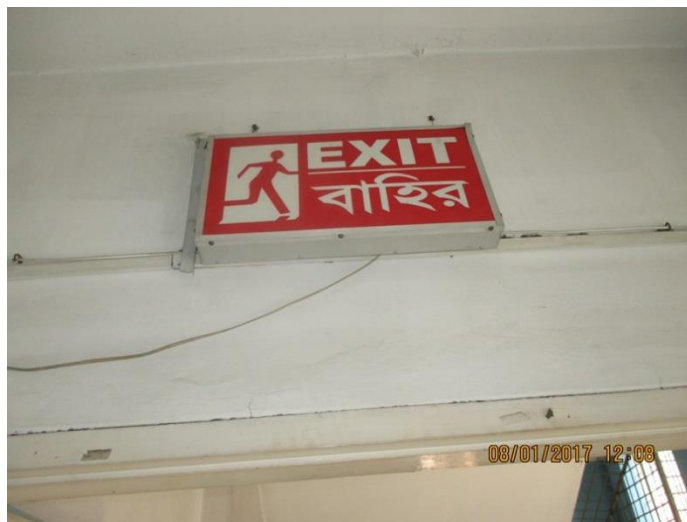
| F-26 | Egress Lighting | Exit signage not illuminated (burned out, broken, etc.). | Regularly inspect all exit signage and replace/install lights as needed to illuminate signs. The source of illumination shall provide not less than 50 lux at the illuminated surface with a contrast of not less than 0.5. Approved self-luminous signs which provide evenly illuminated letters having a minimum luminance of 0.2 cd/m <sup>2</sup> may also be used. | Within 1 month |

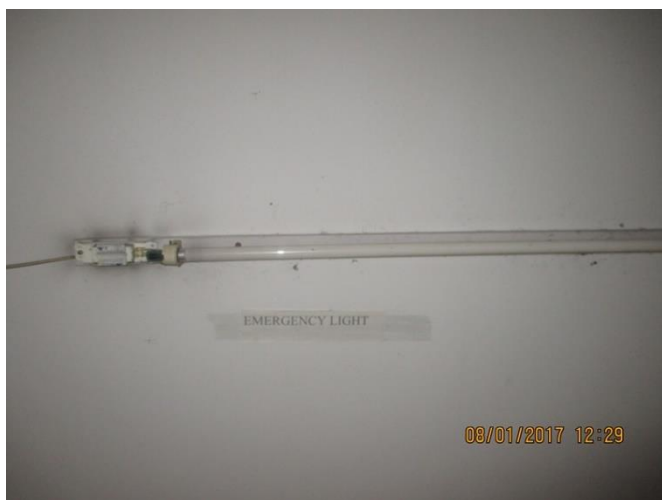
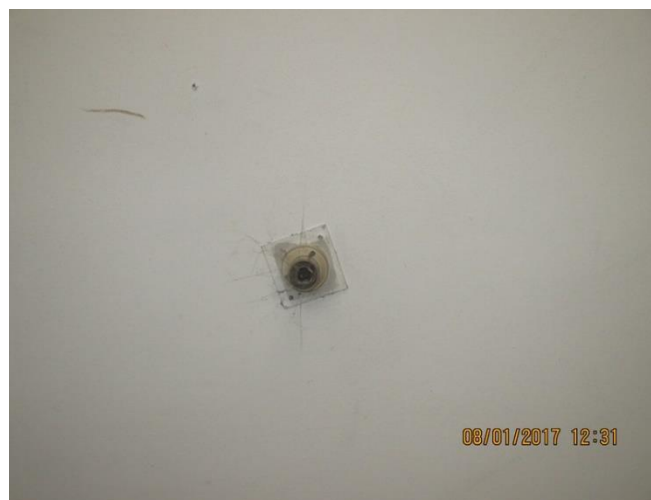
| F-27 | Egress Lighting | Emergency lighting did not function in test mode (burned out, broken, etc.). | Regularly test the emergency lighting system on each floor and replace/repair lights as needed. | Within 1 month |

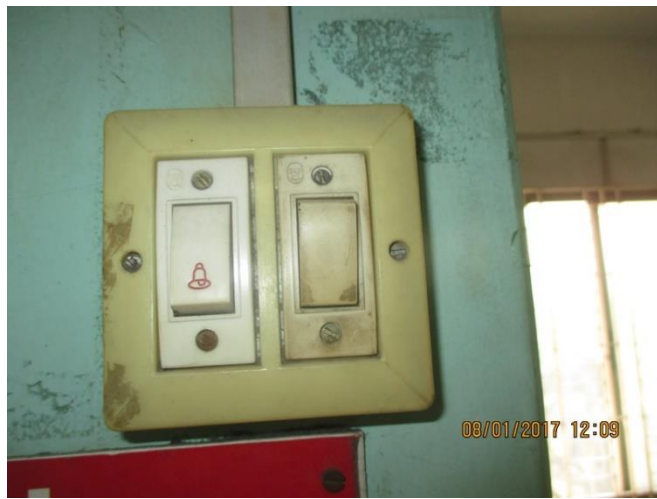
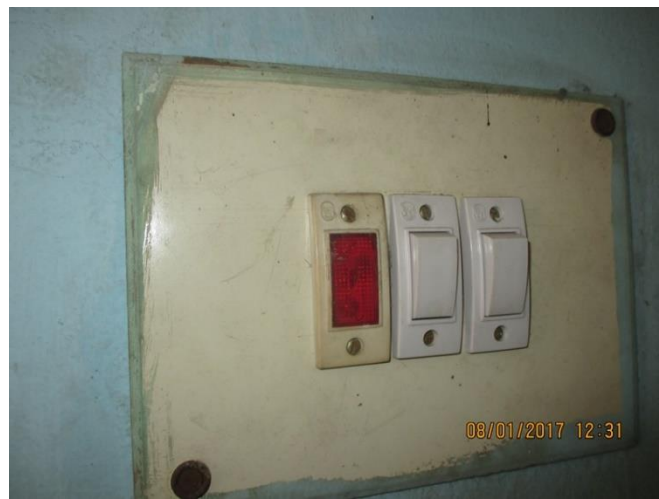
| F-30 | Egress Lighting | Manual on-off switch is provided for emergency lighting and exit signage units. | Remove manual on/off switches from emergency Lighting & exit signage units to prevent them from being switched off. | Within 1 month |
