# **FIRE SAFETY INSPECTION REPORT**

**NRG KNIT COMPOSITE  
ENAYETNAGAR BHOLAIL, FATULLAH**

**ACCORD**  
on Fire and Building Safety in Bangladesh

July 17, 2014

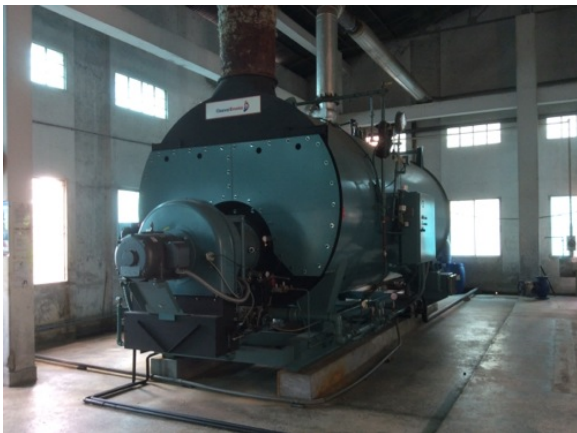
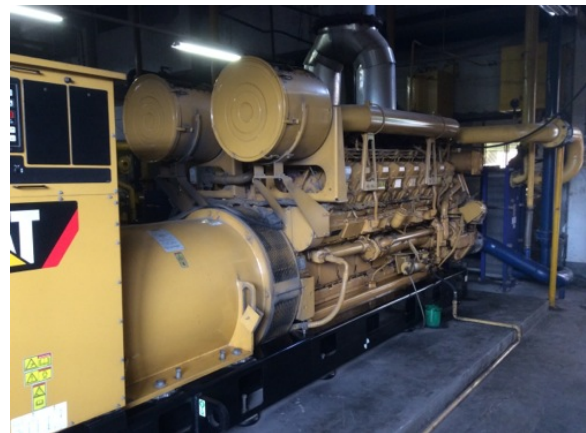
| No. | Category | Finding | Recommendation | Remediation Timeframe |
|---|---|---|---|---|
| F-1 | Fire Rated Construction | The boiler and generator room located on the ground floor, is not separated by fire-rated construction, openings, non-rated doors, and penetrations. | Separate the boiler and generator room by a minimum 2-hr fire-rated construction. Seal and/or protected all openings to maintain the required fire separations | Within 3 months |

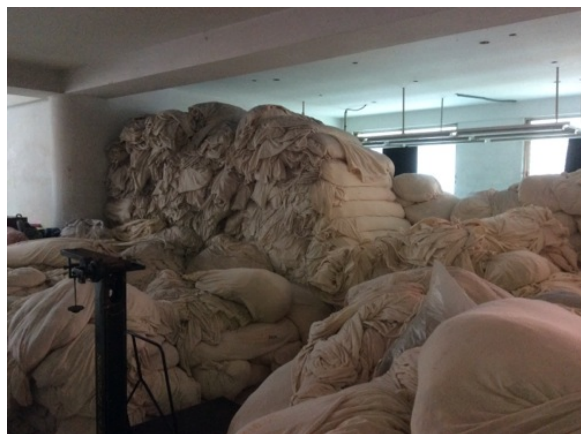
| F-2 | Fire Rated Construction | Areas used for combustible storage on the ground, first, second and ninth floors are not separated by fire-rated construction. | <p>Provide dedicated storage rooms separated by minimum 1-hr fire-rated construction.</p> <p>Where separate storage rooms are not feasible, provide defined storage areas and limit the storage arrangement as follows:</p> <ul style="list-style-type: none"> <li>- Maximum height of 2.4m and maximum area of 23m<sup>2</sup></li> <li>- If sprinkler protected: maximum height of 3.66m and maximum area of 93m<sup>2</sup></li> </ul> <p>Separate areas of unenclosed combustible storage by a minimum clear distance of 3m.</p> | Within 3 months |

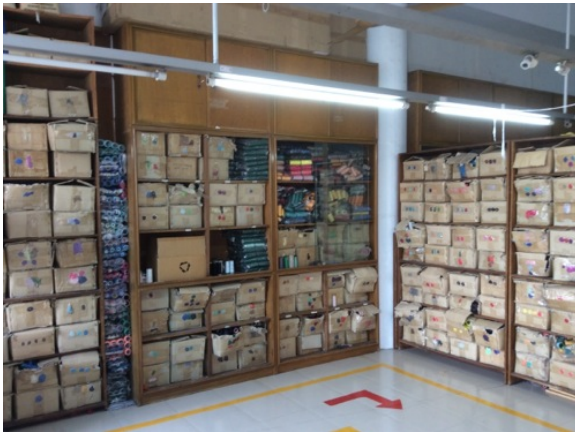
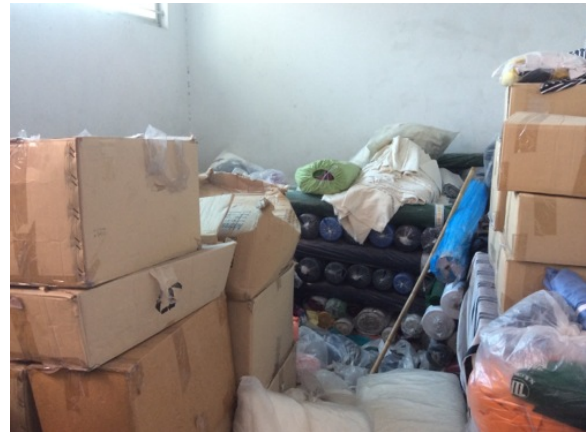
| F-3 | Fire Rated Construction | Storage rooms used for combustible storage on the third through seventh floors are not separated by fire-rated construction. | Provide dedicated storage rooms separated by minimum 1-hr fire-rated construction. | Within 3 months |

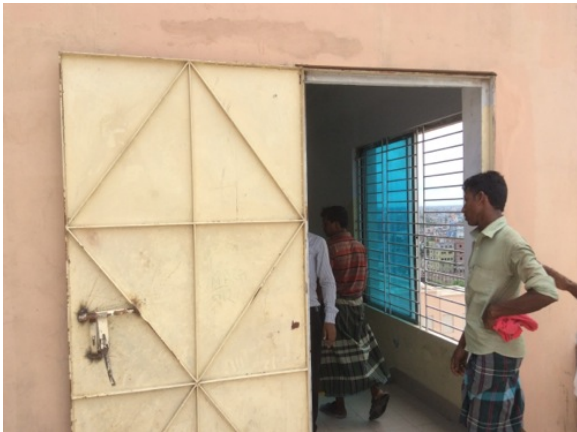
| F-4 | Fire Rated Construction | The exit stairs are not separated from work areas, and other spaces on each floor by fire-rated construction. This was reflected throughout the building on all floors. | <p>Provide minimum 1.5-hr fire rated doors and seal all unprotected openings to separate the exit stairs from work areas and other building spaces on all floor levels. Ensure that the fire doors are self-closing and positive latching and that they are provided with fire exit (panic) hardware where serving production floors.</p> <p>If fire doors are required to be held open for functional reasons, provide automatic-closing devices tied to the fire alarm system.</p> | Within 3 months |

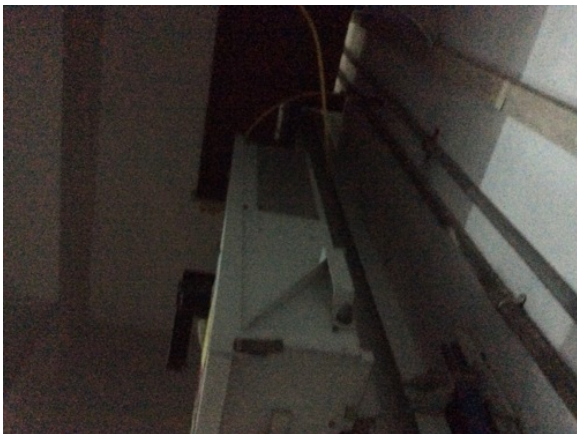
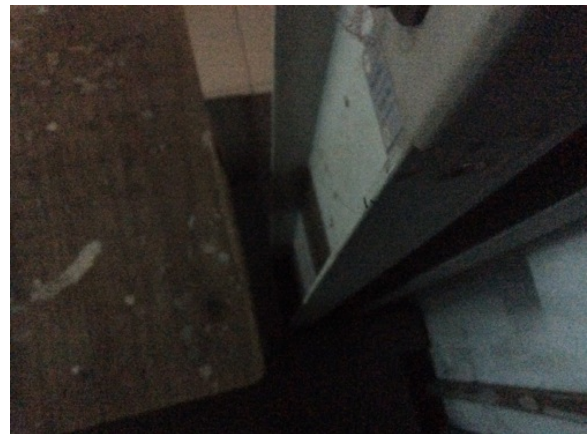
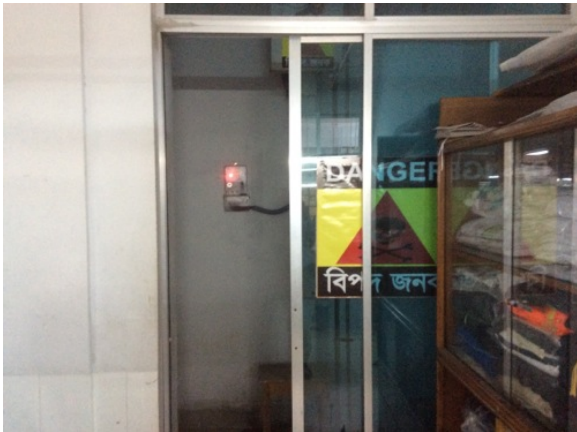
| F-5 | Fire Rated Construction | Unsealed penetrations and openings on all floors are located in the fire-rated floor/ceiling assemblies. | Provide a minimum 2-hr fire-rated shaft to separate the utility risers from each floor level. | Within 3 months |

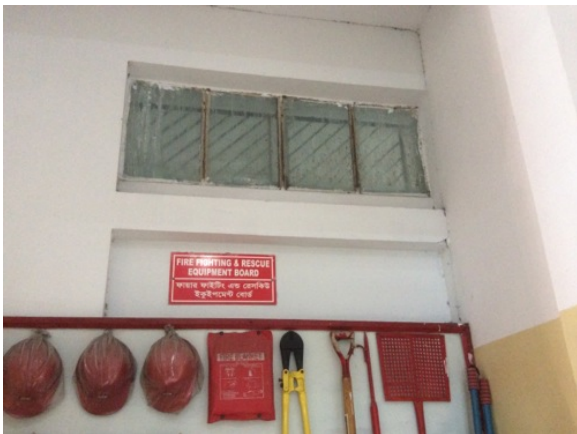
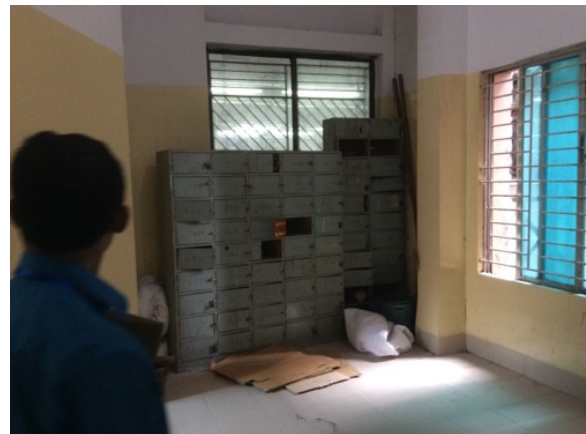
| F-6 | Fire Rated Construction | Unsealed penetrations and openings on all floors except the ground floor are located in each exit stair enclosure. | Seal all penetrations and openings in exit stair enclosure walls to maintain the fire separation. | Within 3 months |

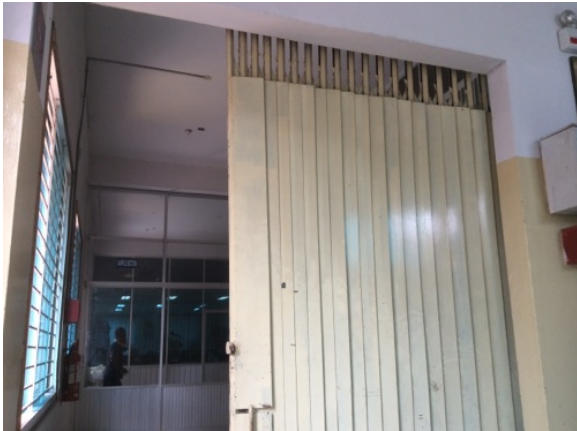
| F-7 | Egress | Egress doors / gates with locking features are provided at building exits, exit stairs, along egress routes, and exit discharge. This was reflected throughout the building on all floors. | Remove locking features from all egress doors / gates.<br><br>If locks are required for security reasons, utilize special door locking features complying with NFPA 101. | Immediate |

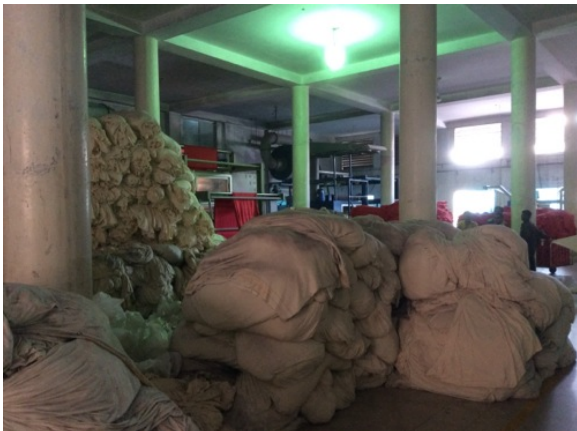
| F-8 | Egress | Storage was located in the egress path on various floors. | Keep egress paths and stairs clear of storage. | Immediate |

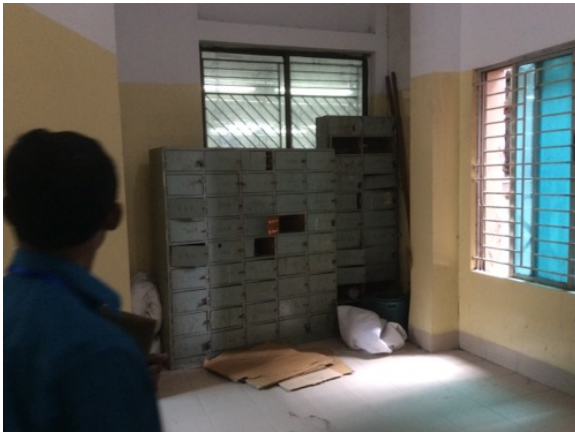
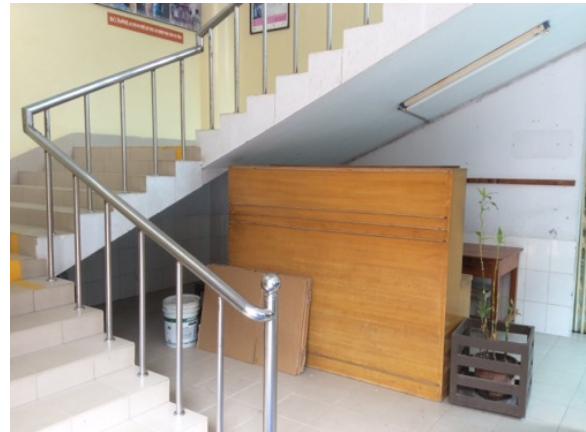
| F-9 | Egress | Storage was located in each exit stair, on all floors. | Remove all storage from exit stairs and egress paths. | Immediate |

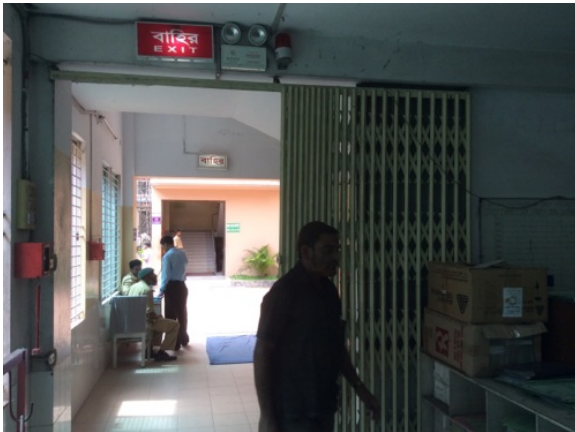
| F-10 | Egress | Collapsible gates / sliding doors are provided at building exits, exit stairs, along egress routes, and exit discharge. This was reflected throughout the building on all floors. | Replace all gates / sliding doors along the means of egress with side-hinged, swinging egress doors.<br><br>If locks are required for security reasons, utilize special door locking features complying with NFPA 101. | Within 1 month |

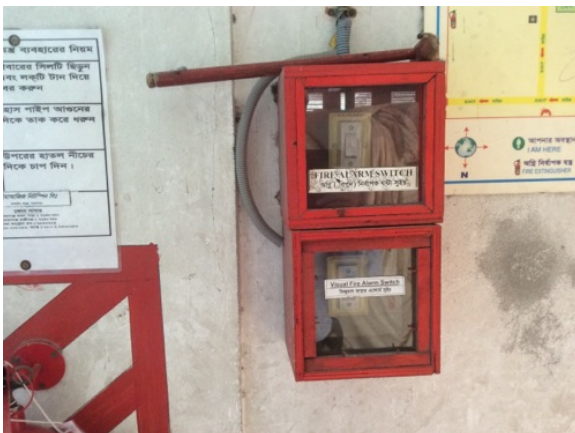
| F-11 | Fire Protection | The fire alarm system is antiquated, not a listed system, and does not provide alarm and notification features consistent with acceptable standards. | Replace the fire alarm system with a new, listed addressable fire alarm system in accordance with NFPA 72. | Design within 4 months, install within 9 months |

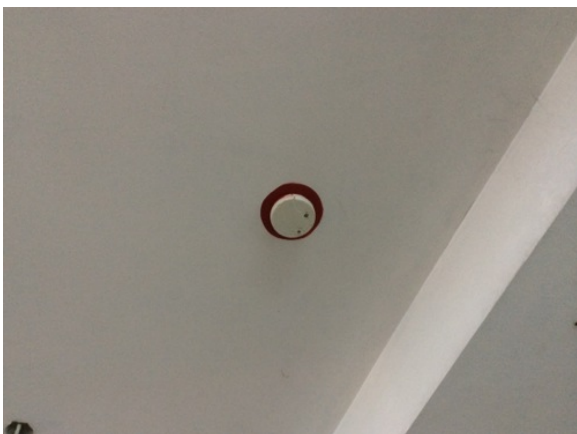
| F-14 | Fire Protection | The building is equipped with single-station smoke alarms. Smoke alarm activation sounds only a local alarm and does not provide automatic fire alarm notification of occupants. | Remove single-station smoke alarms. Provide automatic smoke detection throughout the building, tied into the fire alarm system, in accordance with NFPA 72. | Within 6 months |

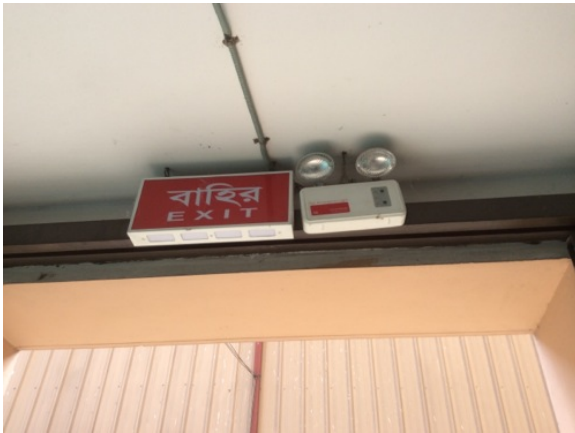
| F-15 | Egress Lighting | Exit signage not illuminated (burned out, broken, etc.). This was reflected throughout the building on various floors. | Regularly inspect all exit signage and replace/install lights as needed to illuminate signs. | Within 1 month |

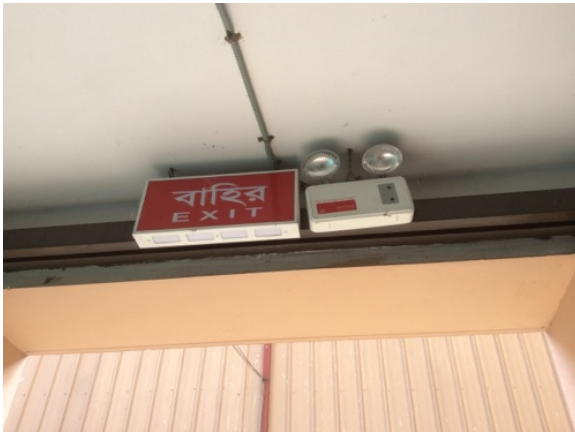
| F-16 | Egress Lighting | Manual on-off switch is provided for emergency lighting units. This was reflected throughout the building in various locations. | Remove manual on/off switches from emergency lighting units to prevent them from being switched off. | Within 1 month |
