# **FIRE SAFETY INSPECTION REPORT**

**NATURAL DENIMS LTD**  
**TONGA BARI, ASHULIA, SAVAR**

**ACCORD**  
on Fire and Building Safety in Bangladesh

July 16, 2014

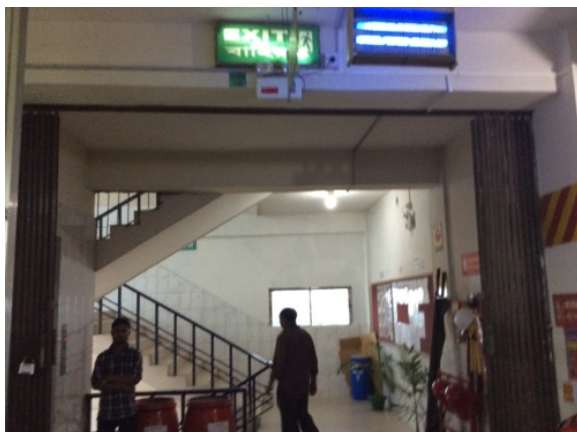
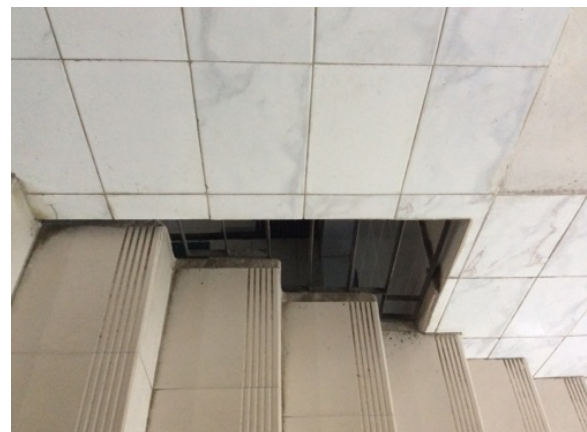
| No. | Category | Finding | Recommendation | Remediation Timeframe |
|---|---|---|---|---|
| F-1 | Fire Rated Construction | The exit stairs are not separated from work areas on each floor by fire-rated construction. | <p>Provide minimum 1.5-hr fire rated doors and seal all unprotected openings to separate the exit stairs from work areas and other building spaces on all floor levels. Ensure that the fire doors are self-closing and positive latching and that they are provided with fire exit (panic) hardware where serving production floors.</p> <p>If fire doors are required to be held open for functional reasons, provide automatic-closing devices tied to the fire alarm system.</p> | Within 3 months |

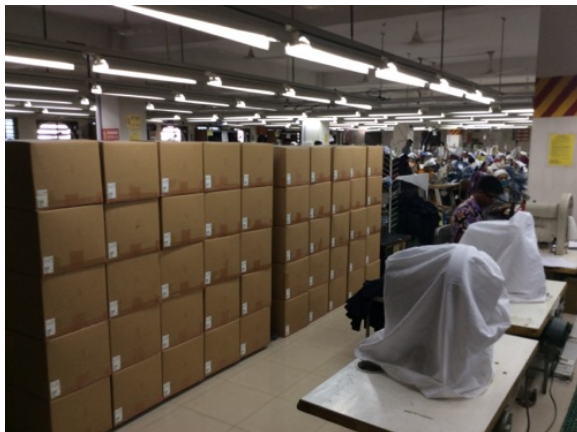
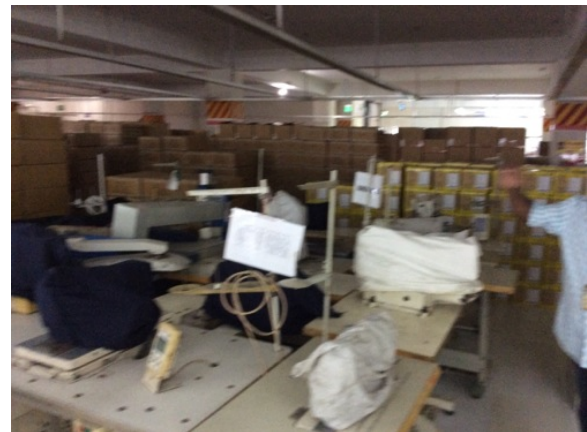
| F-2 | Fire Rated Construction | <p>Areas used for combustible storage are not separated by fire-rated construction.</p> <p>Location: 6th floor.</p> | <p>Provide dedicated storage rooms separated by minimum 1-hr fire-rated construction.</p> <p>Where separate storage rooms are not feasible, provide defined storage areas and limit the storage arrangement as follows:</p> <ul style="list-style-type: none"> <li>- Maximum height of 2.4m and maximum area of 23m<sup>2</sup></li> <li>- If sprinkler protected: maximum height of 3.66m and maximum area of 93m<sup>2</sup></li> </ul> <p>Separate areas of unenclosed combustible storage by a minimum clear distance of 3m.</p> | Within 3 months |

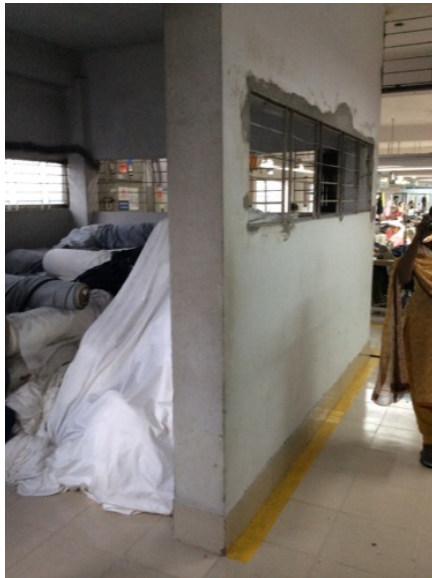
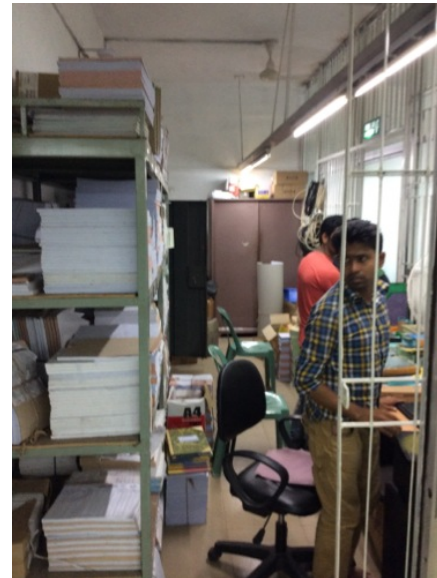
| F-3 | Fire Rated Construction | <p>Rooms used for combustible storage are not separated by fire-rated construction.</p> <p>Location: 4th through 6th floors.</p> | <p>Provide dedicated storage rooms separated by minimum 1-hr fire-rated construction.</p> | Within 3 months |

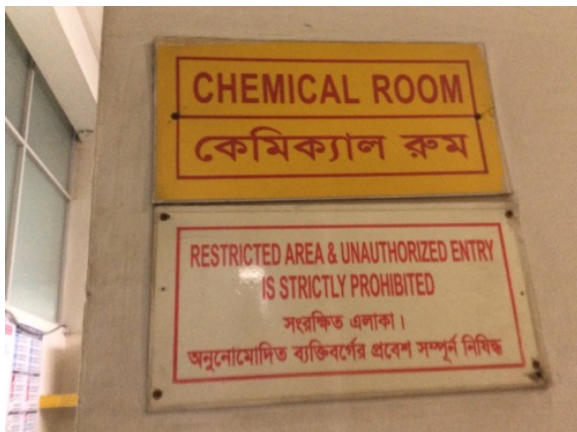
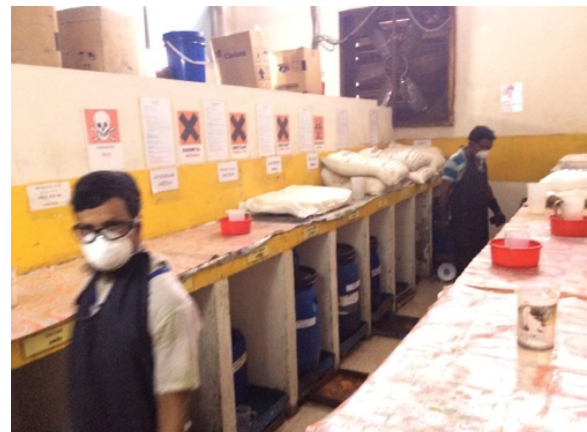
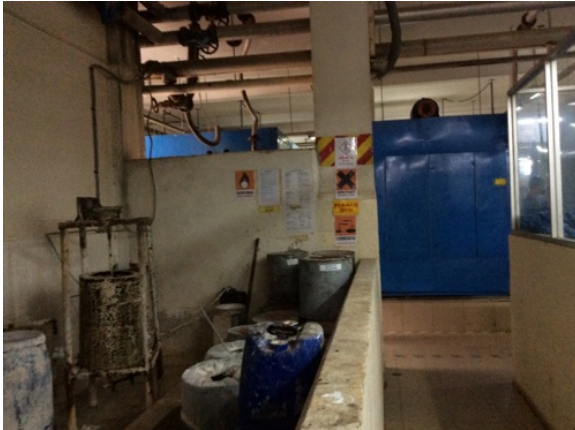
| F-4 | Fire Rated Construction | Hazardous materials / flammable liquid storage area is not separated by fire-rated construction (walls, openings, non-rated doors, penetrations). | Separate the hazardous materials / flammable liquid storage rooms by a minimum 2-hr fire-rated construction. Seal and/or protected all openings to maintain the required fire separations. | Within 3 months |
| | | Location: Chemical room and bleach mixing area on ground floor adjacent to the northeast (#3) stair. | | |

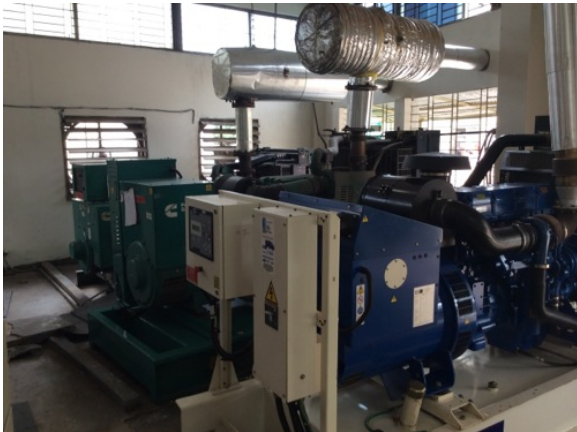
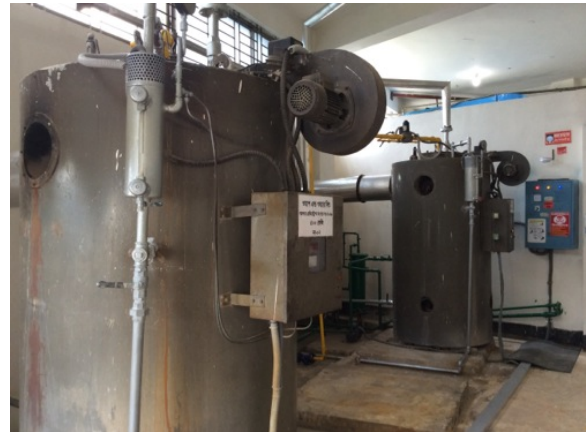
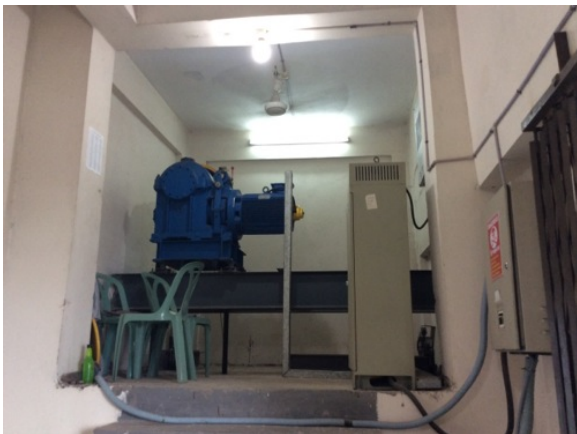
| F-5 | Fire Rated Construction | <p>The boiler, generator, transformer, and elevator equipment rooms are not separated by fire-rated construction (openings, non-rated doors, penetrations).</p> <p>Location: The boiler, generator, and transformer rooms are on the ground floor along the east exterior wall. The elevator equipment room is open to the southwest stair (#1) at the roof.</p> | <p>Separate the boiler, generator, transformer, and elevator equipment rooms by a minimum 2-hr fire-rated construction. Seal and/or protected all openings to maintain the required fire separations</p> | <p>Within 3 months</p> |

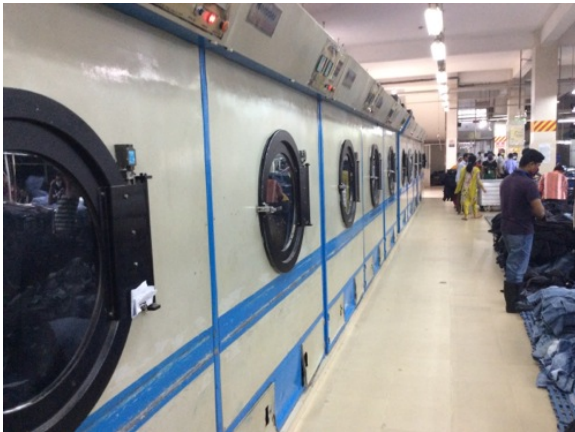
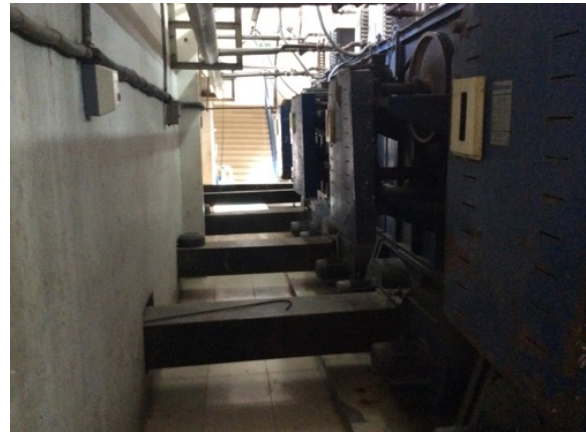
| F-6 | Fire Rated Construction | The gas-fired dryer area is not separated by fire-rated construction (walls, openings, non-rated doors, penetrations). | Separate the gas-fired dryers area by a minimum 2-hr fire-rated construction. Seal and/or protected all openings to maintain the required fire separations | Within 3 months |
| | | Location: Ground floor on west side and near the northwest (#2) exit stair. | | |

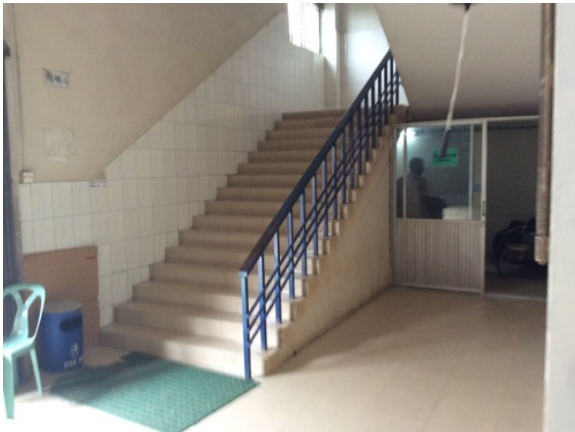
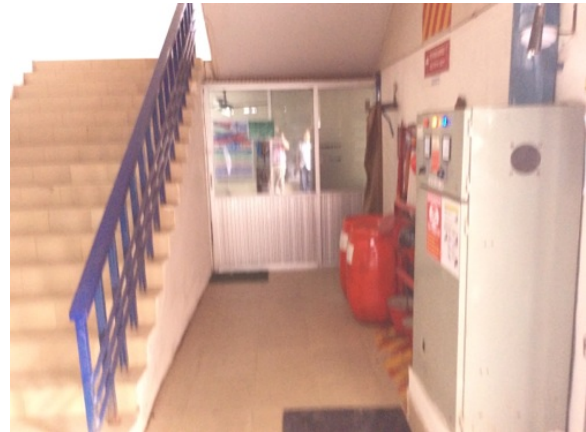
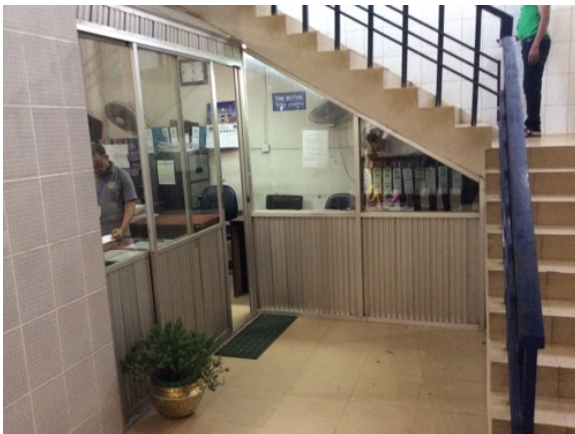
| F-7 | Fire Rated Construction | <p>The offices under all three stairs are not separated by fire-rated construction (walls, openings, non-rated doors, penetrations).</p> <p>Location: Ground floor under all three (3) exit stairs.</p> | <p>Separate the offices from the stairs by a minimum 2-hr fire-rated construction. Seal and/or protected all openings to maintain the required fire separations. Provide minimum 1.5-hr fire rated doors Ensure that the fire doors are self-closing and positive latching.</p> <p>or</p> <p>Remove offices built under the three (3) exit stairs at ground floor.</p> | Within 3 months |

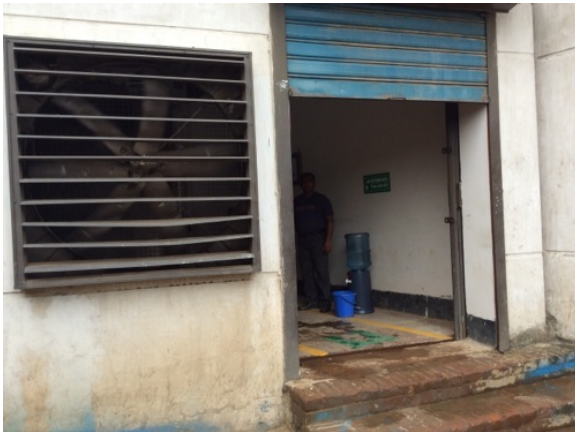
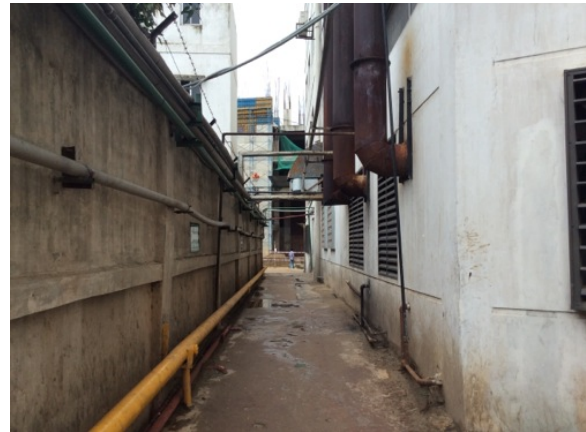
| F-8 | Fire Rated Construction | The exit discharge path serving the northeast exit is less than 10 ft wide and is not separated from the building interior. | Seal all penetrations and openings to the interior of the building along the discharge path, up to a height of 10 ft., to provide a minimum 1-hr fire separation. | Within 6 months |

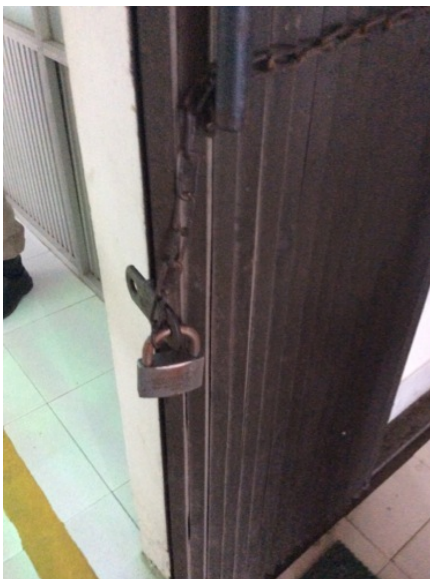
| F-9 | Egress | <p>Egress doors / gates with locking features are provided at building exits, exit stairs, and along egress routes.</p> <p>Location: All floors.</p> <p>All gates/doors were open and unlocked during the inspection.</p> | <p>Remove locking features from all egress doors / gates.</p> <p>If locks are required for security reasons, utilize special door locking features complying with NFPA 101.</p> | Immediate |

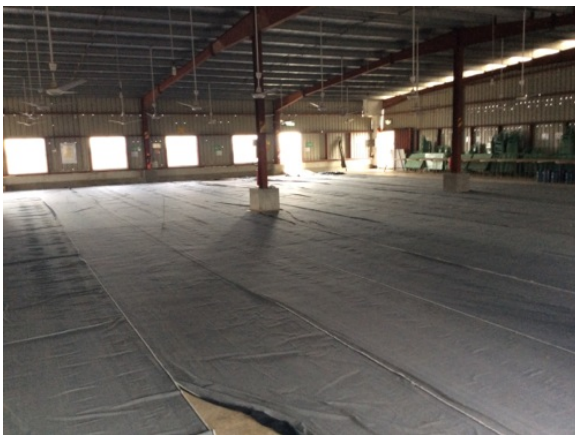
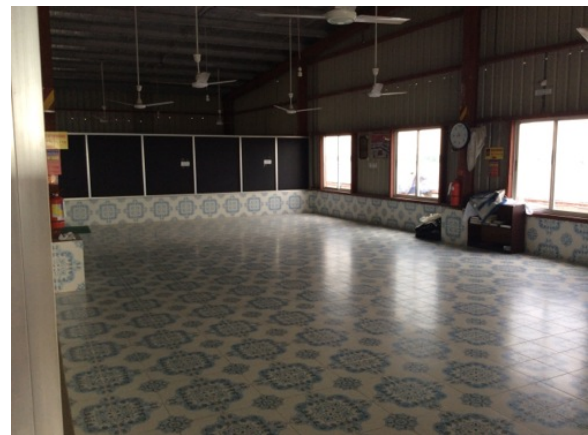
| F-10 | Egress | <p>Exit capacity is not adequate for the occupant load.</p> <p>Location: The roof has an available occupant load capacity of 400 and a reported load of 500 occupants for the dining and prayer rooms. The 1st floor has an available occupant load capacity of 600 and a reported load of 648.</p> | <p>Reduce occupant load to not more than available exit capacity of 400 on the roof and not more than 600 on the 1st floor.</p> | Immediate |

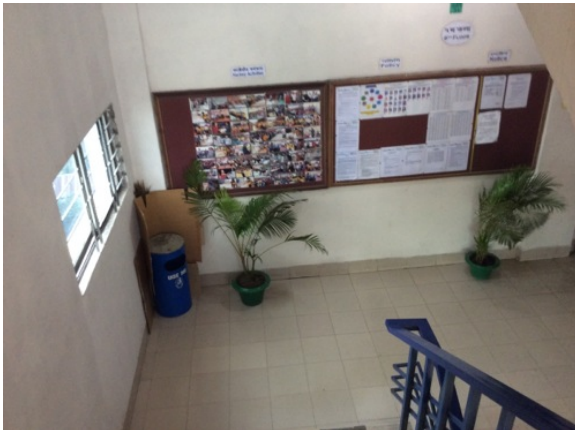
| F-11 | Egress | <p>Storage was located in the exit stair.</p> <p>Location: All stairs at all floors.</p> | <p>Remove all storage from exit stairs and egress paths.</p> | Immediate |

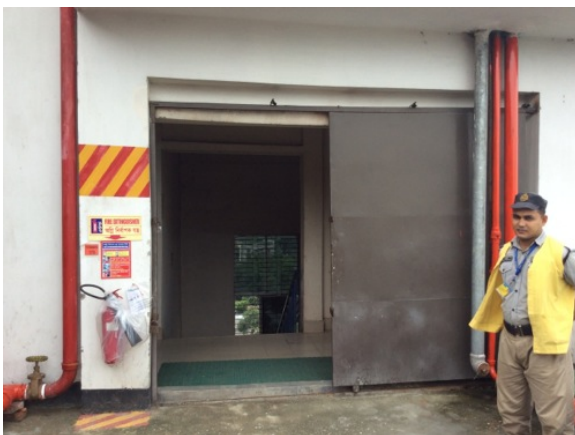
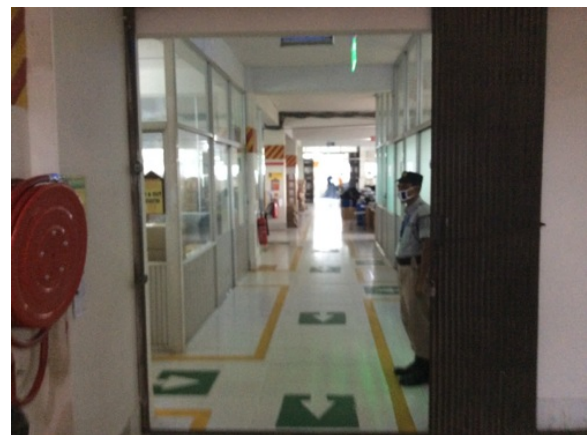
| F-12 | Egress | <p>Collapsible gates / sliding doors and overhead coiling doors are provided at building exits, exit stairs, and along egress routes.</p> <p>Location: All floors.</p> | <p>Replace all gates / sliding doors and overhead coiling doors along the means of egress with side-hinged, swinging egress doors.</p> <p>If locks are required for security reasons, utilize special door locking features complying with NFPA 101.</p> | Within 1 month |

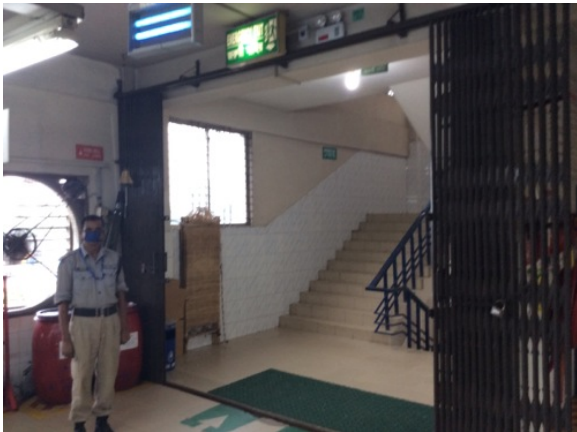
| F-16 | Egress Lighting | Emergency Evacuation Plans not provided at exit.<br><br>Location: Northwest (#2) exit stair at all floors. | Provide Emergency Evacuation Plans at exits to the exterior and all doors to the exit stairs. | Within 1 month |
