# FIRE SAFETY INSPECTION REPORT

## OXFORD SHIRTS LTD.

ACCORD ID: 12772

## Fire Safety Inspection Report

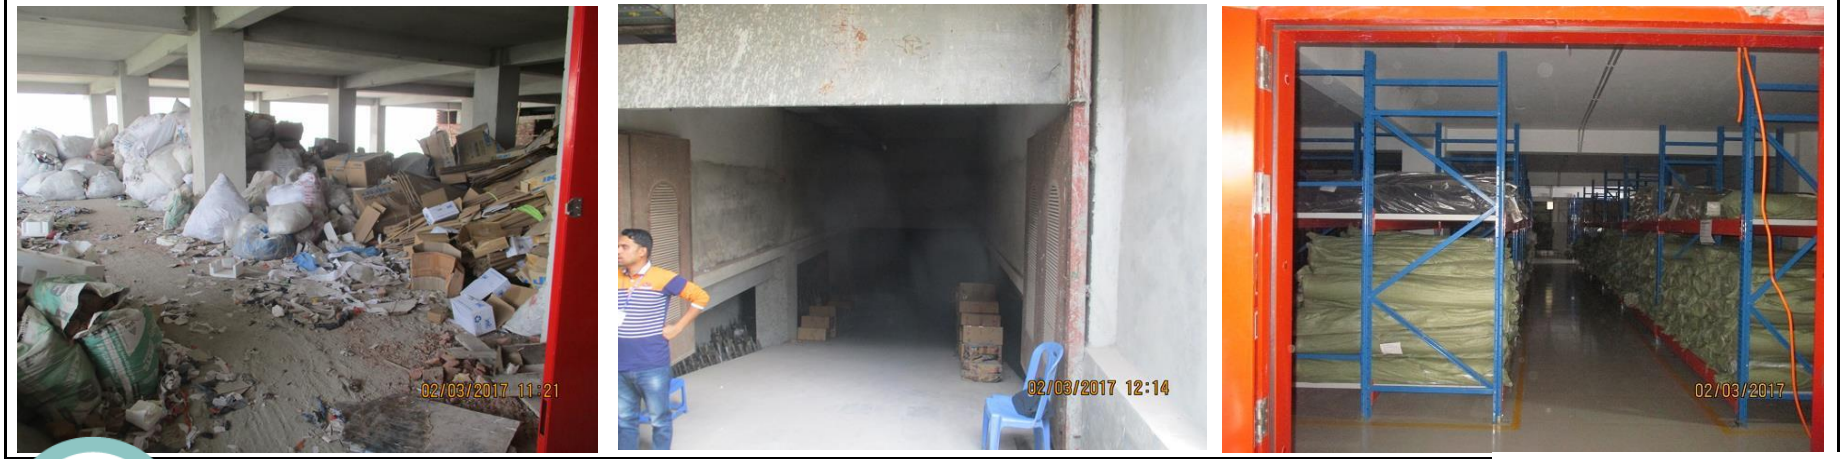
Sl No.	Category	Findings	Required Action	Remediation Time Frame
F-1	Fire Rated Construction	<p>Rooms used for combustible storage are not separated by fire rated construction.</p> <p><b>Location:</b> Wastage store on 8th floor, raw material warehouse on ground floor and wastage store on basement.</p>	<p>Separate the dedicated storage rooms by minimum 1-hr fire-rated construction. Provide 0.75 hr. fire rated door and seal all penetrations and openings by 1 hr. fire rated fire rated barrier construction.</p>	<p>Within 3 months</p>

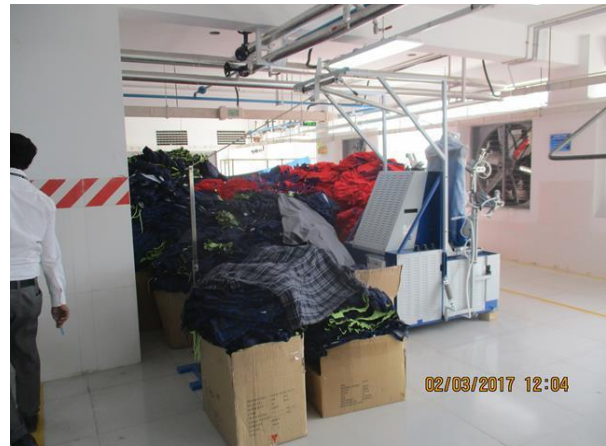
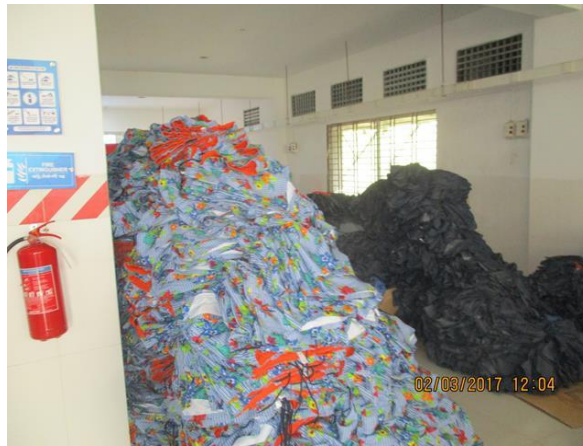
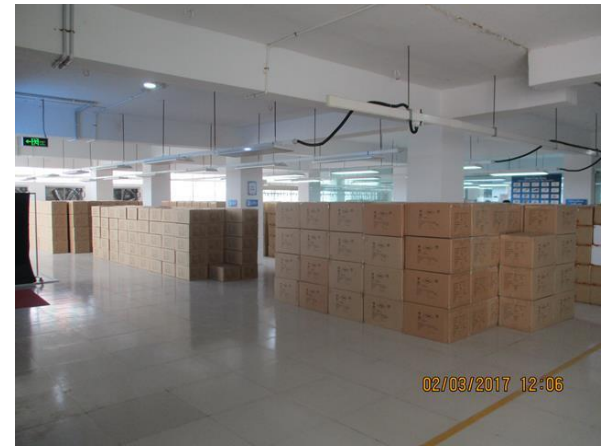
F-2	Fire Rated Construction	<p>Areas used for combustible storage open to the factory are not separated by fire rated construction.</p> <p><b>Location:</b> 2nd floor of the building.</p>	<p>Separate the dedicated storage rooms by minimum 1-hr fire-rated construction. Provide 0.75 hr. fire rated door and seal all penetrations and openings by 1 hr. fire rated fire rated barrier construction.</p> <p>Where separate storage rooms are not feasible, provide defined storage areas and limit the storage arrangement as follows: - Maximum height of 2.45m (8ft.) and maximum area of 23m<sup>2</sup> (250 ft<sup>2</sup>)</p> <p>- If sprinkler protected: maximum height of 3.66m (12ft.) and maximum area of 93m<sup>2</sup> (305ft<sup>2</sup>). Separate areas of unenclosed combustible storage by a minimum clear distance of 3m (10ft.).</p>	Within 3 months
-----	-------------------------	--	---	-----------------

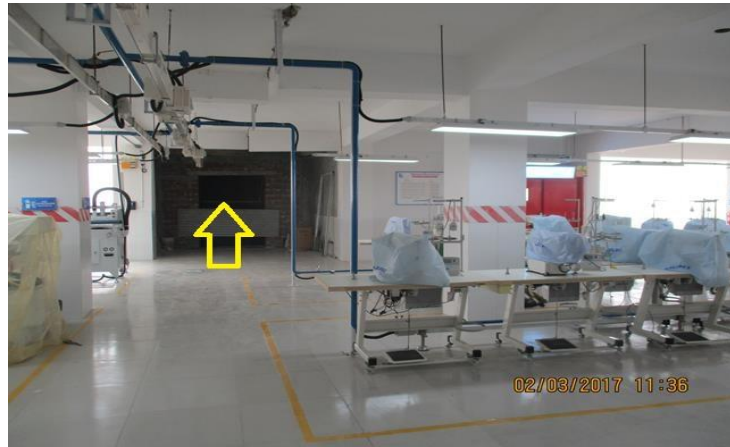
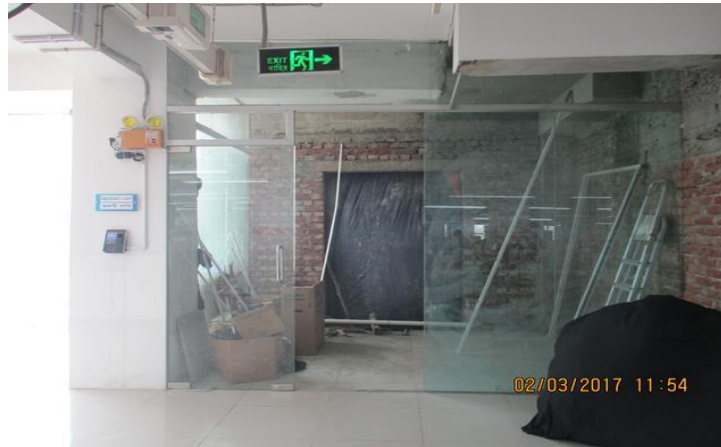
F-3	Fire Rated Construction	<p>Elevator shaft is directly open into production floor without proper fire separation (Door is not fire rated).</p> <p><b>Location:</b> Cargo lift near north-west exit stair.</p>	<p>Ensure minimum 1.5-hr fire rating for the doors of elevator shafts otherwise close the shafts area with 2-hr fire rated construction barrier and 1.5-hr fire rated doors.</p>	Within 3 months
-----	-------------------------	--	--	-----------------

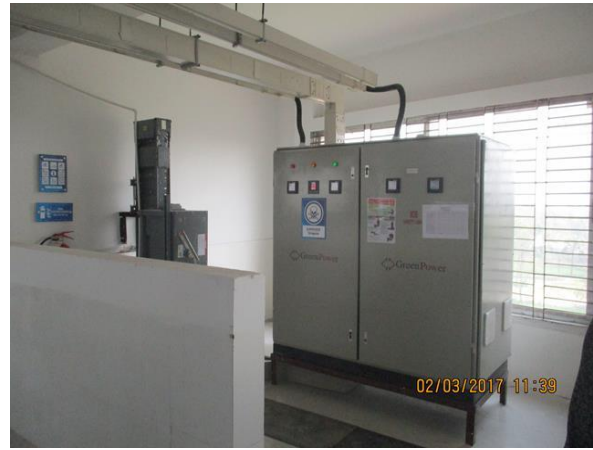
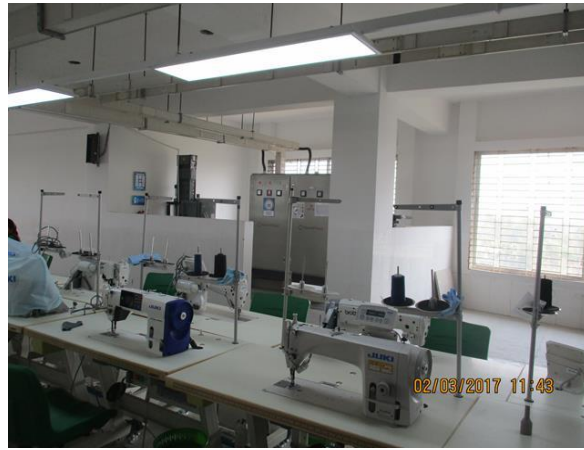
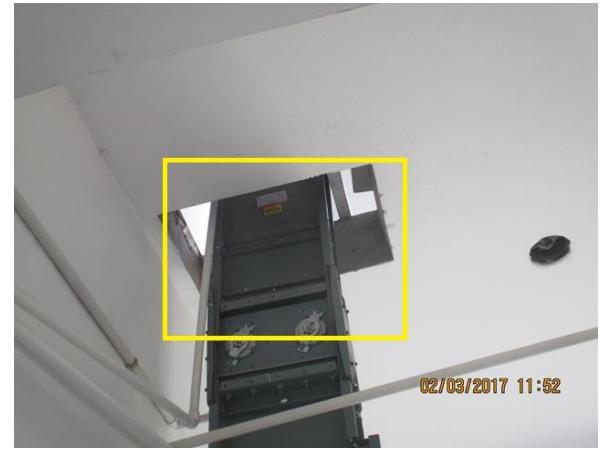
F-4	Fire Rated Construction	<p>Unsealed penetrations and openings are located in the fire-rated floor/ceiling and wall assemblies.</p> <p><b>Location:</b> A. Electrical riser on every floor near north-east exit stair, B. Penetration on wall for transformer room (Ground floor and north-east corner utility building).</p>	<p>Seal all penetrations and openings in floor/ceiling assemblies to maintain the fire separation. For A location the entire electrical riser including other panels area shall be considered as a room for fire separation with minimum 2-hr fire rating.</p>	Within 1 months
-----	-------------------------	--	--	-----------------

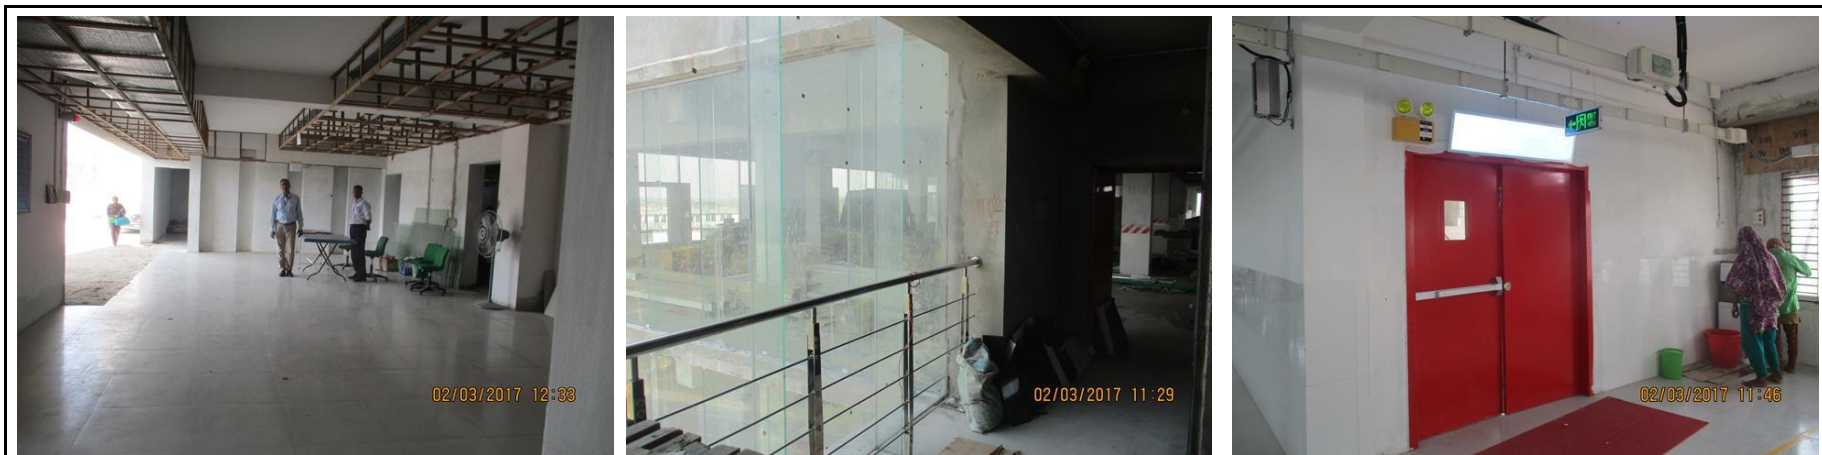
F-5	Fire Rated Construction	The exit stair enclosures are not separated from work areas and other spaces on each floor by fire-rated construction. Moreover, exit passageway for south-west stair is not separated by fire rated construction on ground floor.	<p>The exit stair enclosure shall be provided with a minimum 1-hr fire resistance rating for buildings with 3 or fewer stories and a minimum of 2- hr. fire resistance rating for buildings 4 or more stories. Provide 0.75 hr. fire rated door and seal all penetrations and openings by 1 hr. fire rated fire rated barrier construction for building with 3 or fewer stories. Provide 1.5 hr. fire rated door and seal all penetrations and openings by 2 hr. fire rated fire rated barrier construction for building with 4 or more stories.</p> <p>Provide a fire-resistive rated assembly between the exterior exit stairs and the building up to 10 ft. beyond the end of the stair to achieve the required separation. The rated assembly shall be approved and/or designed by a qualified fire protection engineer.</p> <p>Ensure that the fire doors are self-closing and positive latching and that they are provided with fire exit (panic) hardware where serving production floors. If fire doors are required to be held open for functional reasons, provide automatic closing devices tied to the fire alarm system.</p>	Within 3 months

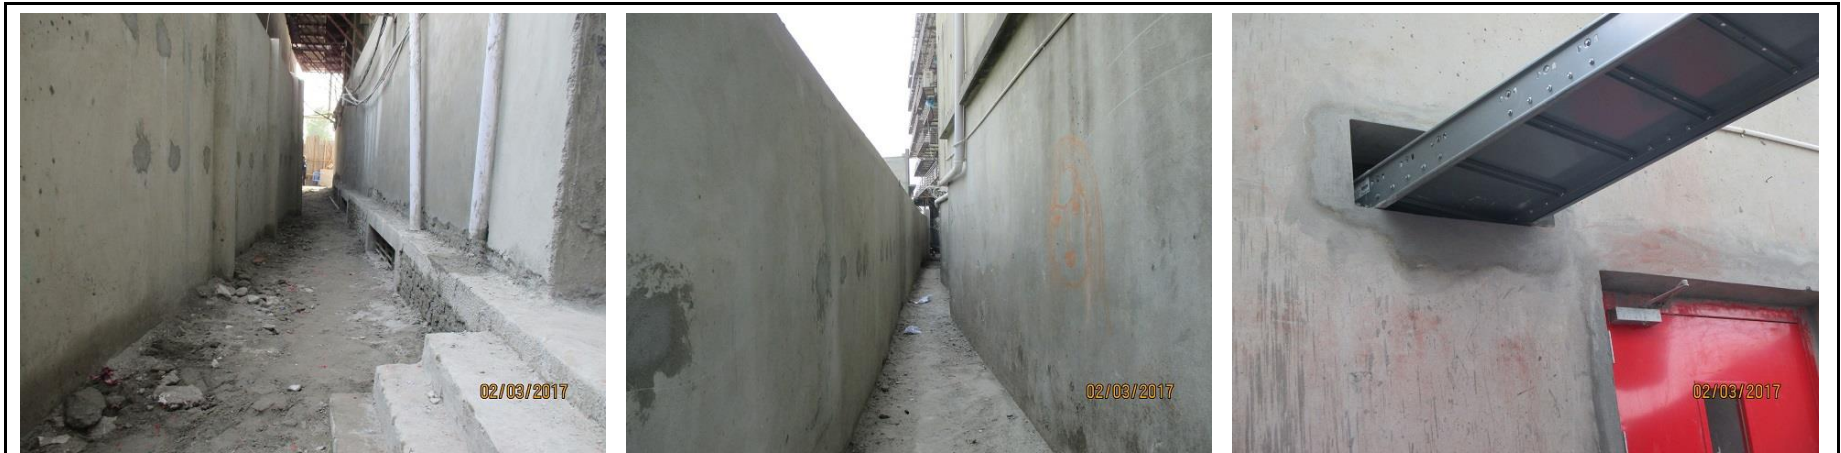
F-6	Egress	<p>The exit discharge path/egress court for south-east, north-east and north-east stairs are less than 44 inch wide and not separated from the building interior due to unprotected openings for transformer rooms.</p>	<p>The minimum width of exit passageway/corridor shall be 44 inch. Seal all penetrations and openings to the interior of the building along the discharge path up to a height of 10 ft. to provide a minimum 2-hr fire separation in the case of egress court width less than 10 ft.</p>	<p>Within 3 months</p>
-----	--------	---	--	------------------------

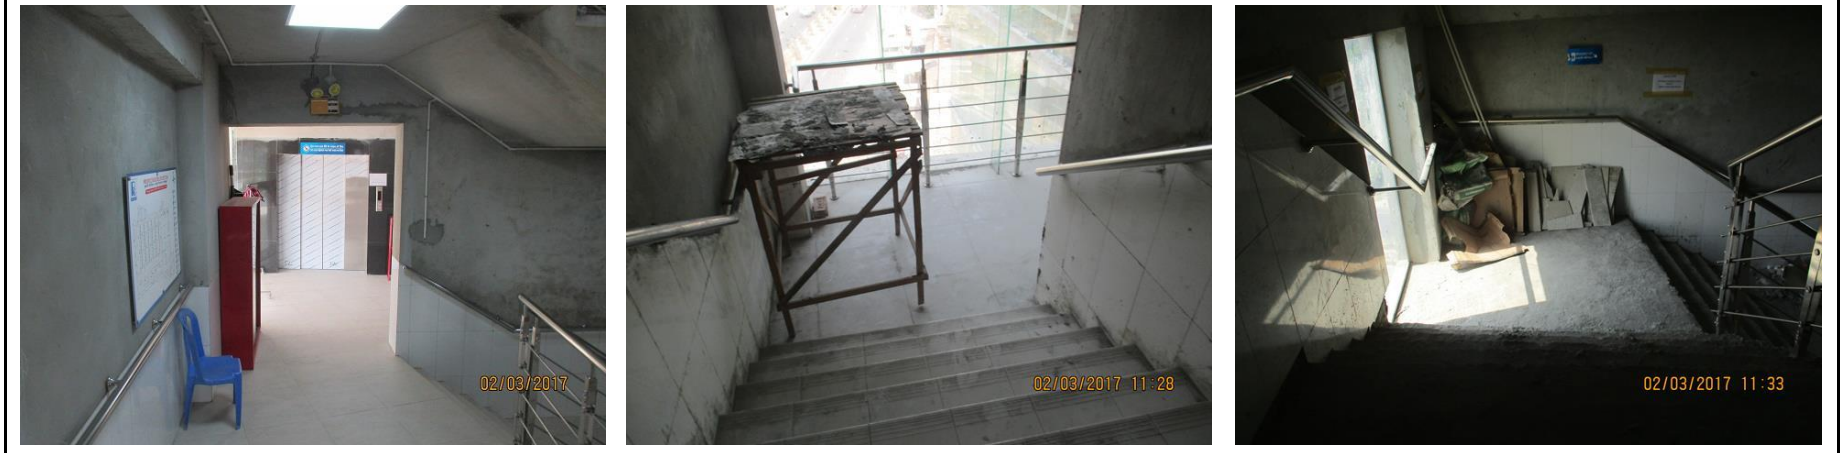
F-7	Egress	Storage was located in the exit stair on most of the floors.	Remove all storage from exit stairs and egress paths.	Immediately
-----	--------	--	---	-------------

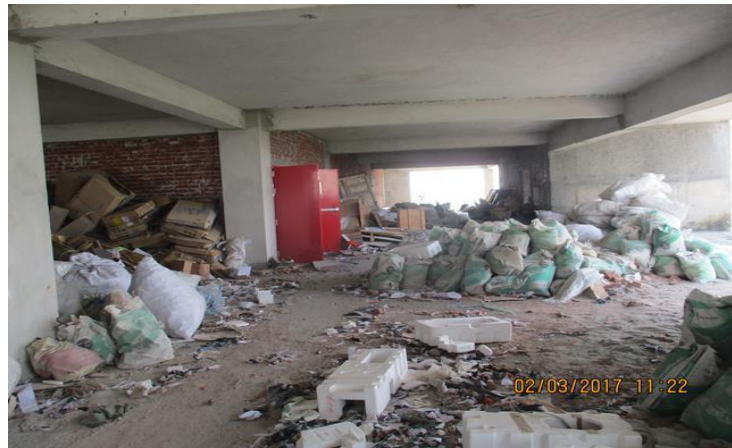
F-11	Egress Lighting	Exit signage was not provided along a path of egress for 6th to 8th floors .	Provide exit signs above all building exits to the exterior, all doors to the exit stairs and along all paths of travel where a change of direction is not obvious.	Within 1 month
------	-----------------	--	---	----------------

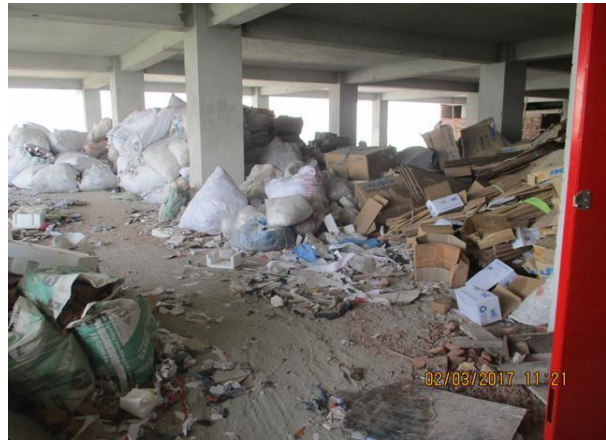
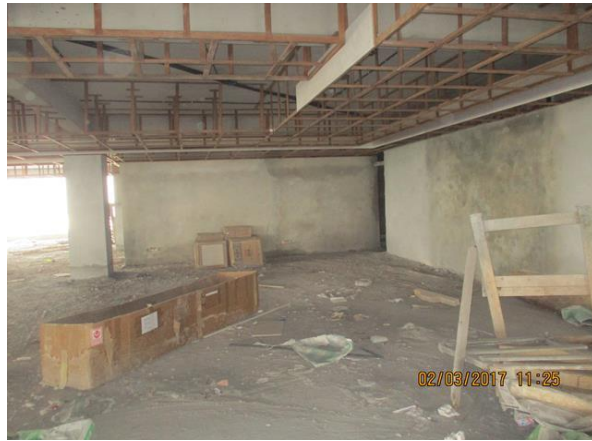
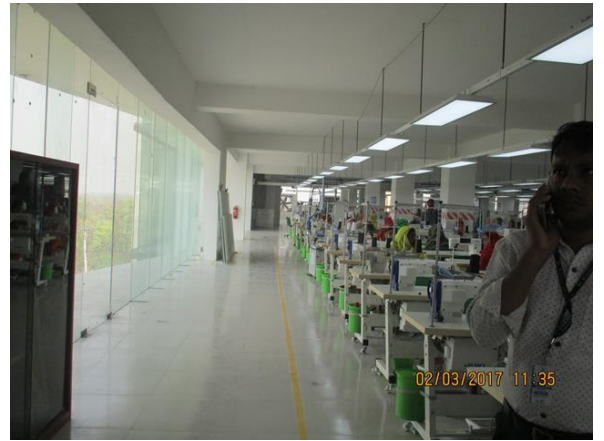
F-12	Egress Lighting	Based on the number and location of emergency lights observed, adequate illumination levels are not anticipated along egress routes and at exit stairs on 6th to 8th floors. <b>Note:</b> The noted floors are not fully occupied yet where finishing works are going on.	Test the emergency lighting system on each floor and provide additional emergency fixtures to supply adequate illumination along the means of egress. Provide a minimum illumination of 10 lux at the floor level within exit stairs and along exit discharge paths and a minimum 2.5 lux along exit access aisles.	Within 3 months
------	-----------------	---	---	-----------------

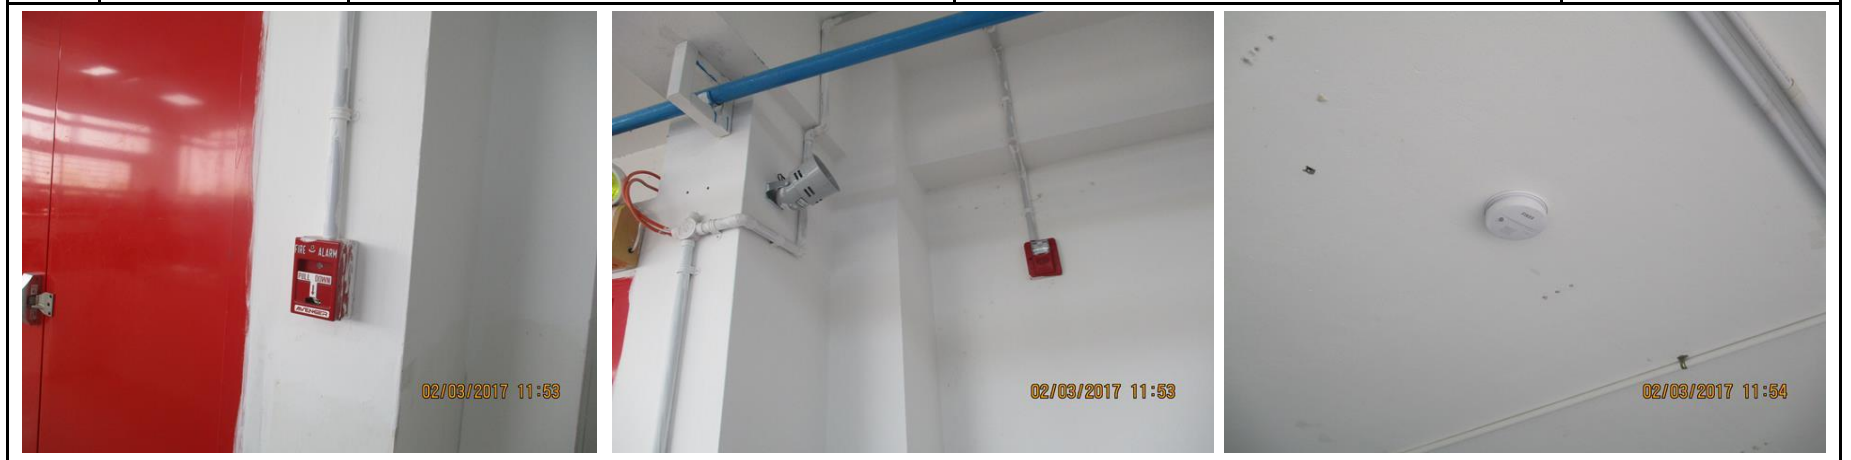
F-13	Fire Detection and Alarm System	The fire detection and alarm system is not installed as per NFPA-72, the available system and does not provide alarm and notification features consistent with acceptable standards.	<p>Install the fire detection and alarm system with a new, listed addressable fire alarm system in accordance with NFPA 72.</p> <p>Design shall be submitted to ACCORD Chief Safety Inspector for review prior to installation of the system.</p>	Design within 4 months and installation within 9 months.
------	---------------------------------	--	---	--

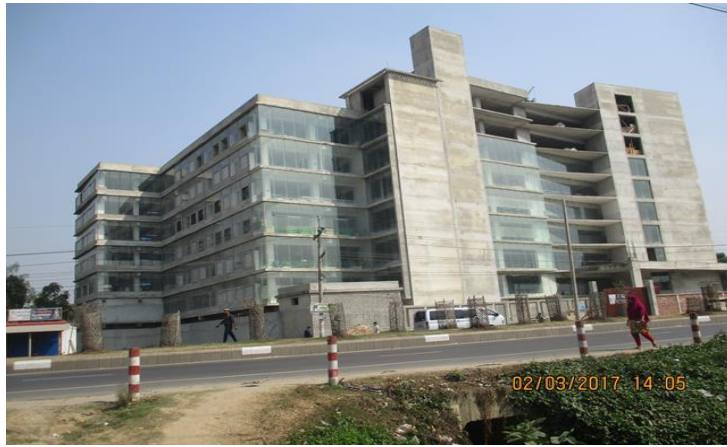
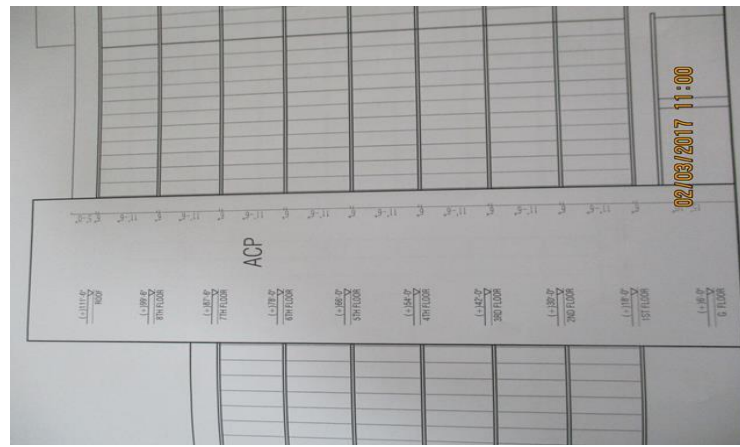
F-14	Fire Detection and Alarm System (ITM).	Inspection, testing and maintenance (ITM) for the fire detection and alarm system is not in accordance with NFPA 72.	Inspect, test and maintain the fire detection and alarm system and keep written records on-site, in accordance with NFPA 72.	Within 03 months (After complete installation)
F-15	Water base Fire Protection System	The existing high-rise building with an occupiable floor greater than 23 m (75 ft) above the finished grade is not protected with an approved automatic sprinkler system. The large occupant loads, heavy fuel loading, and anticipated extended egress times warrant sprinkler protection.	Provide an automatic sprinkler protection along with required hose system throughout the building in accordance with NFPA 13, 14, 20, 22 and 24.  Design shall be submitted to ACCORD Chief Safety Inspector for review prior to installation of the system.	Design within 4 months and installation within 9 months
