# **FIRE SAFETY INSPECTION REPORT**

## **ARABI FASHIONS**

**BOKRAN, MONIPUR, MIRZAPUR, GAZIPUR - 1703,  
BANGLADESH.**

April 24, 2014

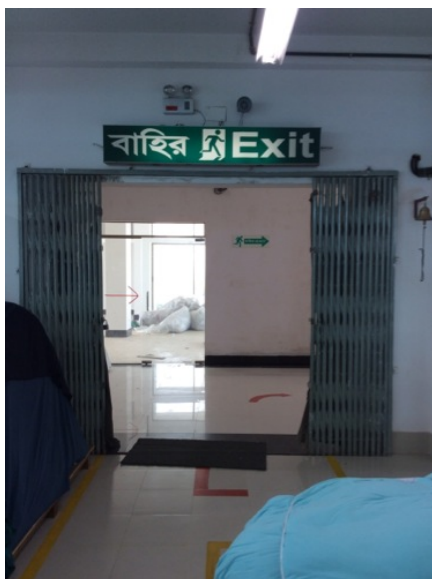
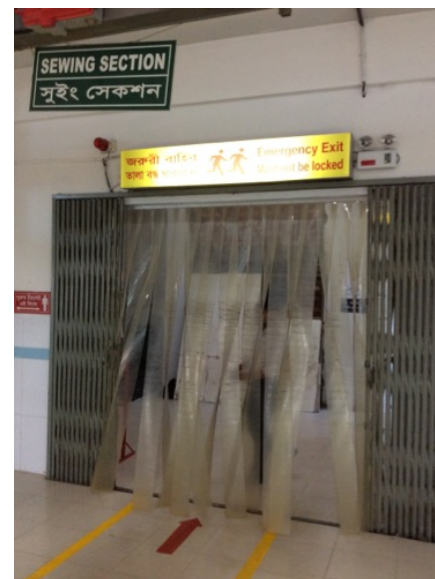
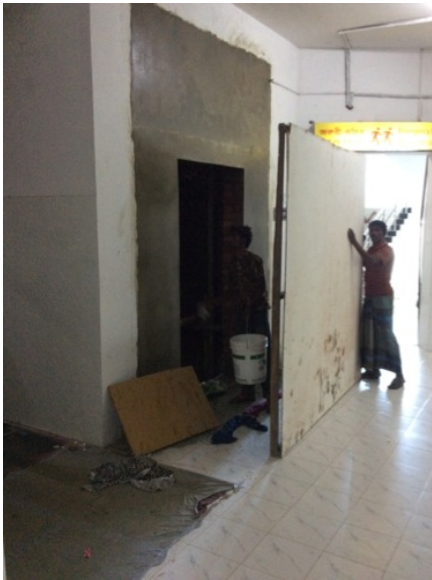
| No. | Category | Finding | Recommendation | Remediation Timeframe |
|---|---|---|---|---|
| F-1 | Fire Rated Construction | The exit stairs are not separated from work areas and other spaces on each floor by fire-rated construction. | <p>Provide minimum 1.5-hr fire rated doors and seal all unprotected openings to separate the exit stairs from work areas and other building spaces on all floor levels. Ensure that the fire doors are self-closing and positive latching and that they are provided with fire exit (panic) hardware where serving production floors.</p> <p>If fire doors are required to be held open for functional reasons, provide automatic-closing devices tied to the fire alarm system.</p> | Within 3 months |

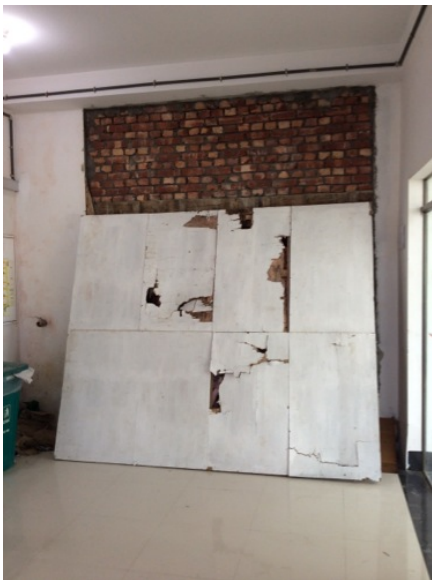
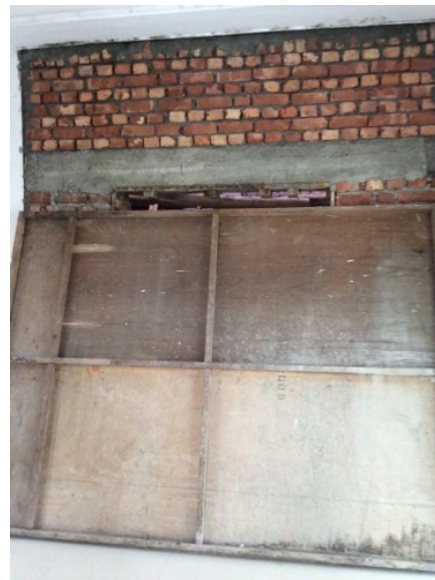
| F-2 | Fire Rated Construction | Elevator shafts are left unfinished with opening that connects all floors but is not fully enclosed. | Provide 1.5 HR rated doors at floors and complete shaft construction | Within 3 months |

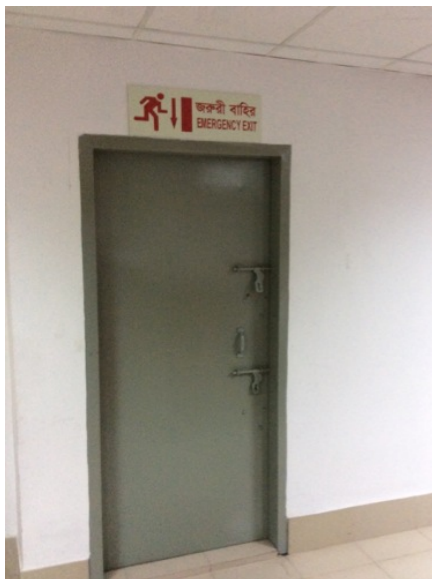
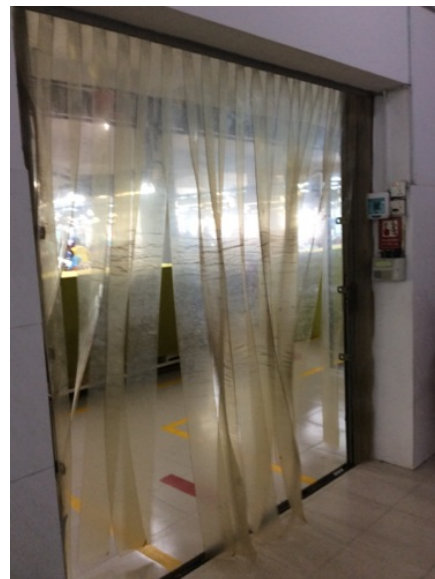
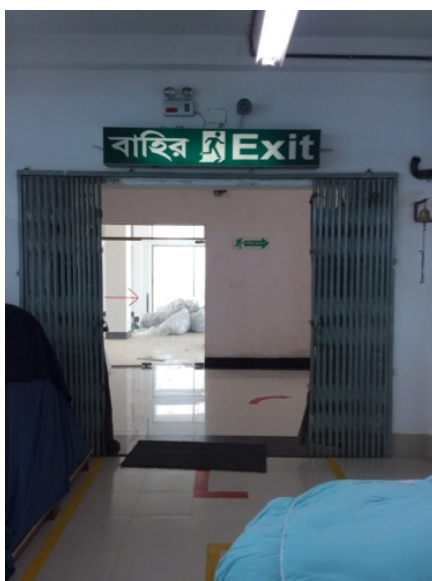
| F-3 | Egress | <p>Egress doors/collapsible gates with locking features are provided at building exits, exit stairs, along egress routes, exit discharge.</p> <p>All gates were open and unlocked during the inspection a few doors were locked.</p> | <p>Remove locking features from all egress doors / gates.</p> <p>If locks are required for security reasons, utilize special door locking features complying with NFPA 101.</p> | Immediate |

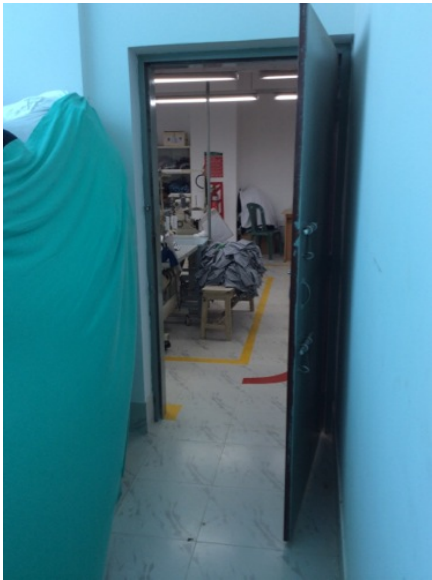
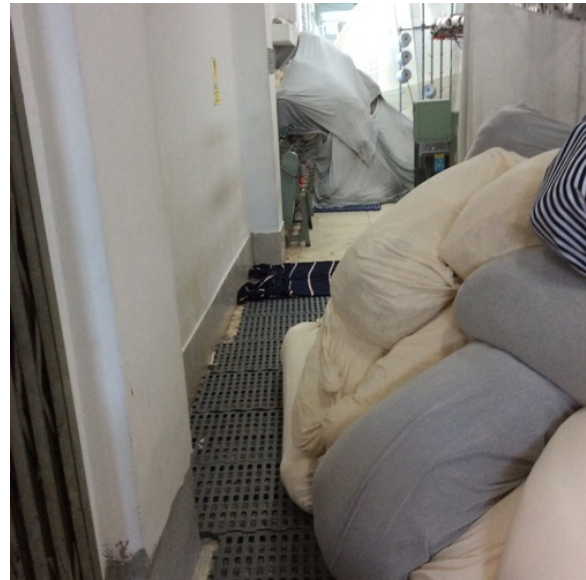
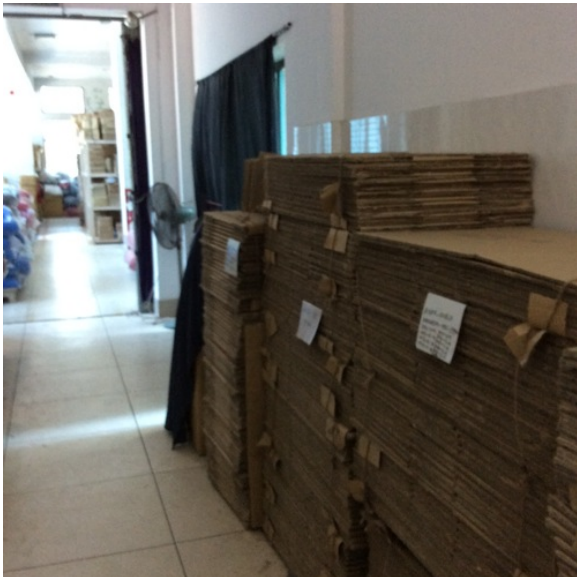
| F-4 | Egress | Storage was located in the egress path at multiple locations | Keep egress paths and stairs clear of storage. | Immediate |

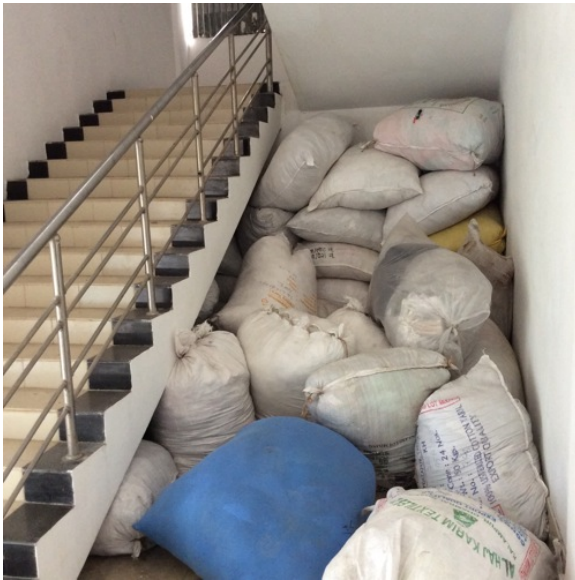
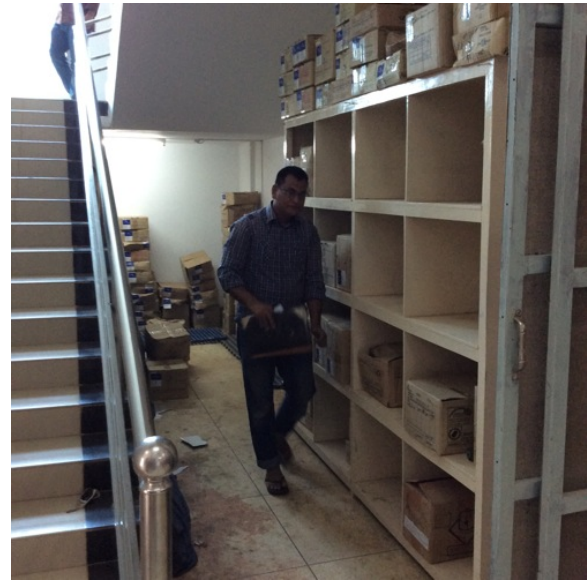
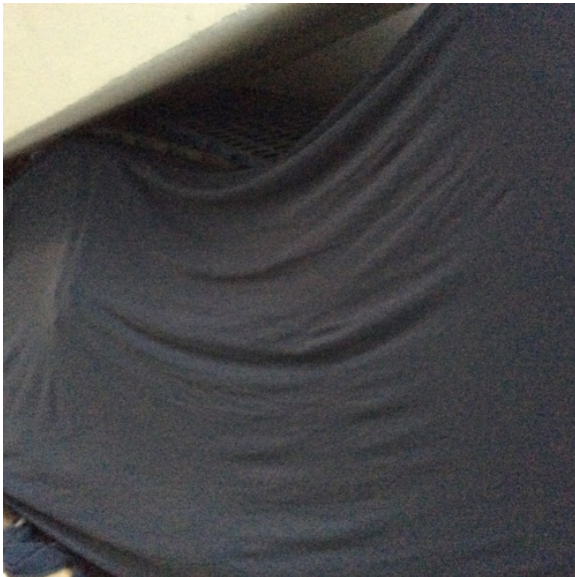
| F-5 | Egress | Storage was located in all the exit stairs | Remove all storage from exit stairs and egress paths. | Immediate |

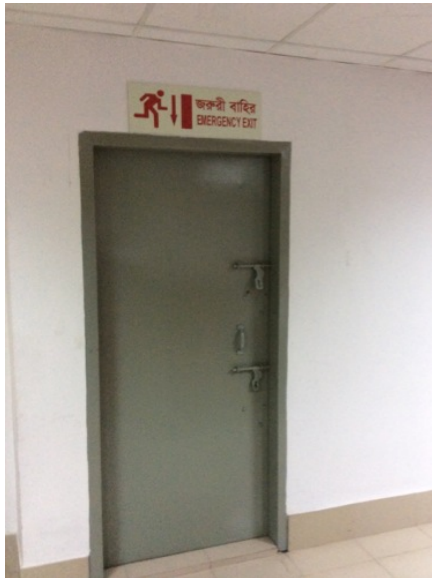
| F-6 | Egress | Egress door with exit sign on the fourth floor was locked. | Remove locking features from all egress doors.<br><br>If locks are required for security reasons, utilize special door locking features complying with NFPA 101. | Immediate |

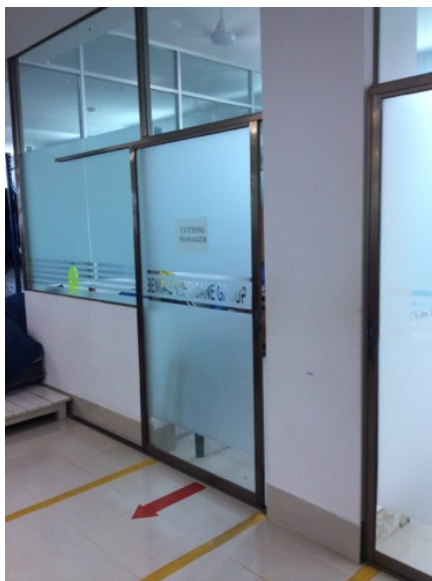
| F-7 | Egress | Manager and supervisors offices along the factory floors have sliding doors on floors 2, 3, & 4. | <p>Replace all sliding doors along the means of egress with side-hinged, swinging egress doors.</p> <p>If locks are required for security reasons, utilize special door locking features complying with NFPA 101.</p> | Within 1 month |

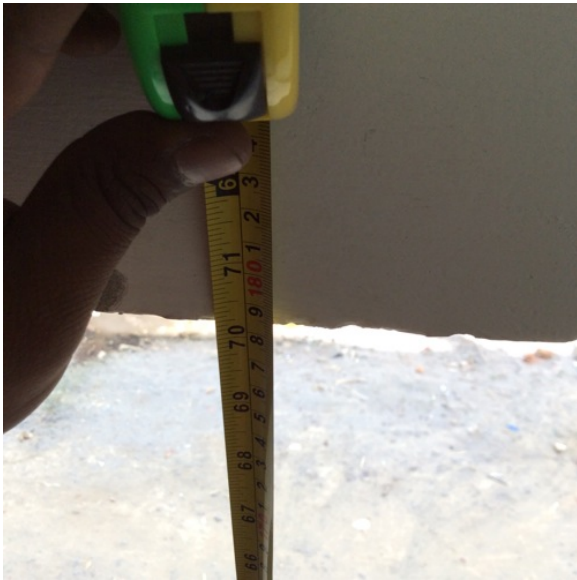
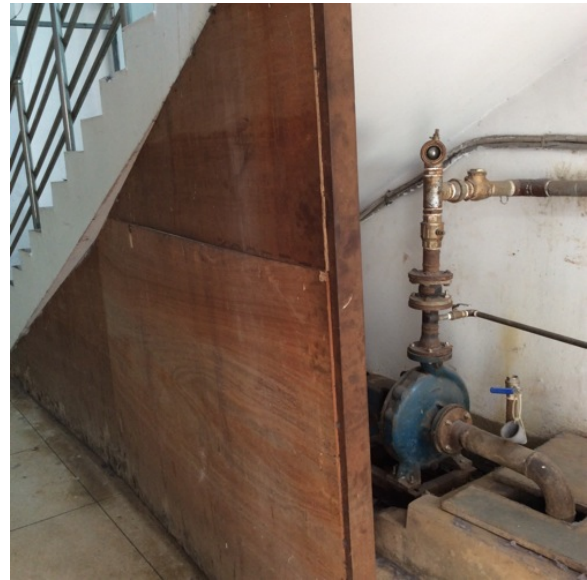
| F-8 | Egress | Clear height less than optimum at northwest exit stair discharge. | Provide minimum 80 inches clear opening for exit discharge. | Within 1 month |

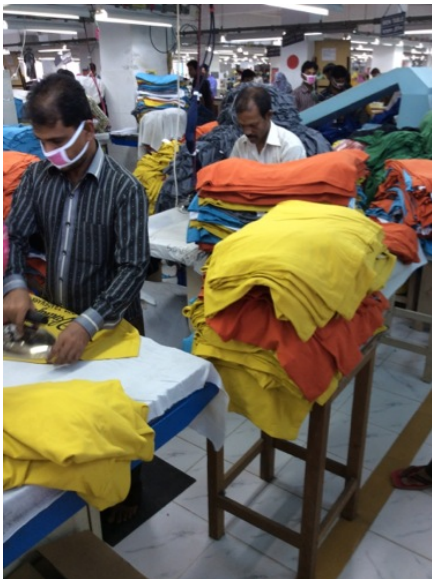
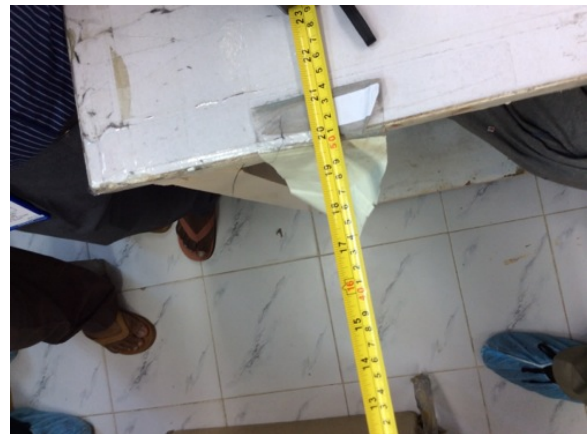
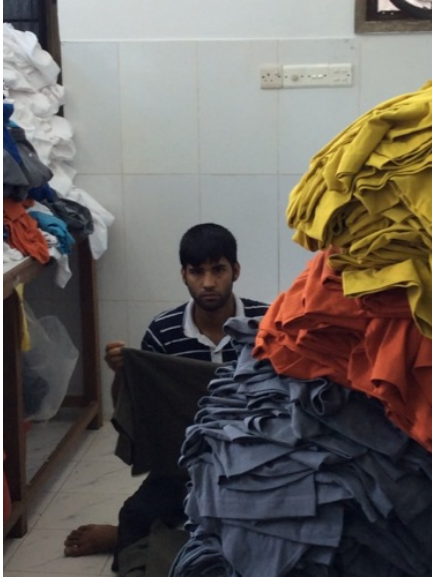
F-9 Egress

The width of egress aisles is less than 36-inches in multiple locations especially in ironing and finishing.

Provide minimum aisle widths of 36-in.

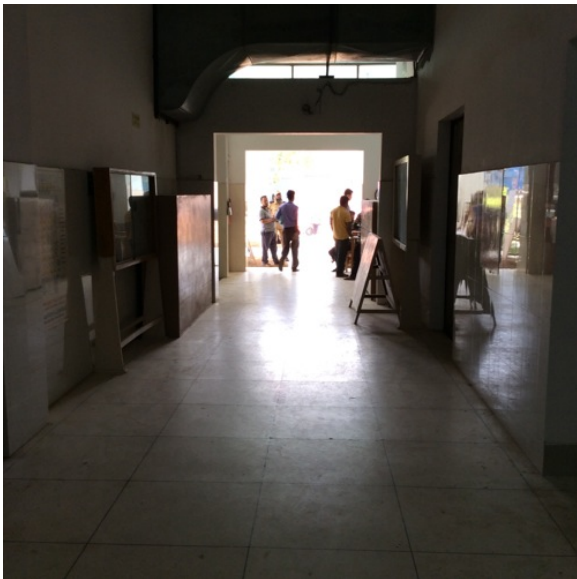
| F-10 | Egress | South-east exit stair discharges inside the building. | Provide 2-hr fire-rated separation between the stair discharge and the room/areas located along the egress path from the stair. | Within 6 months |

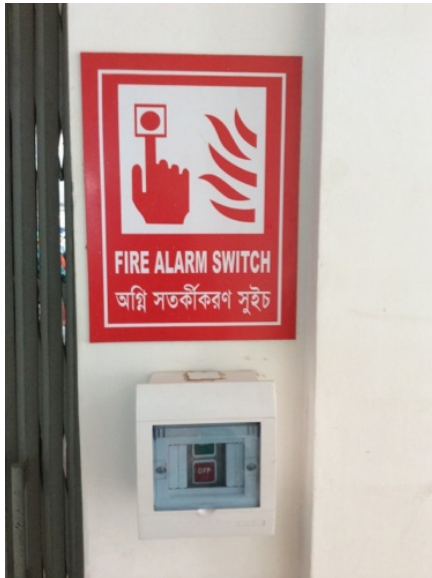
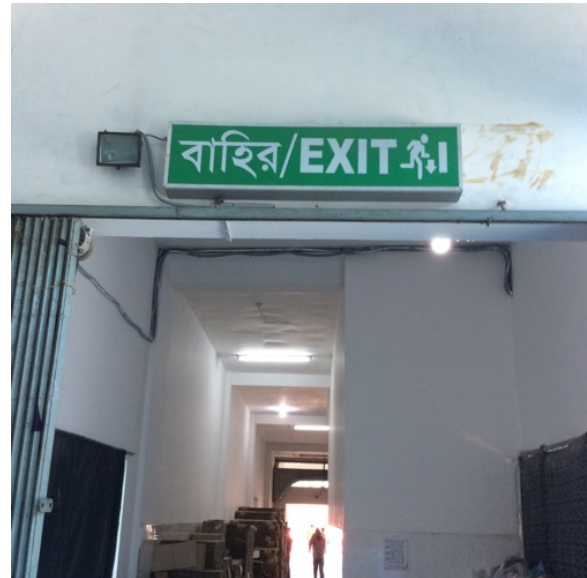
| F-11 | Fire Protection | The fire alarm system is antiquated, not a listed system, and does not provide alarm and notification features consistent with acceptable standards. | Replace the fire alarm system with a new, listed addressable fire alarm system in accordance with NFPA 72. | Design within 4 months, install within 9 months |

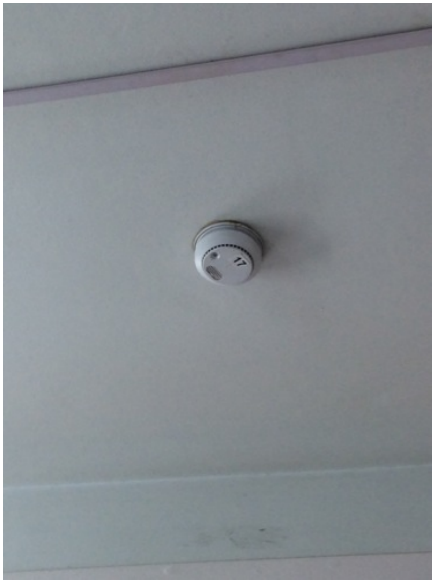
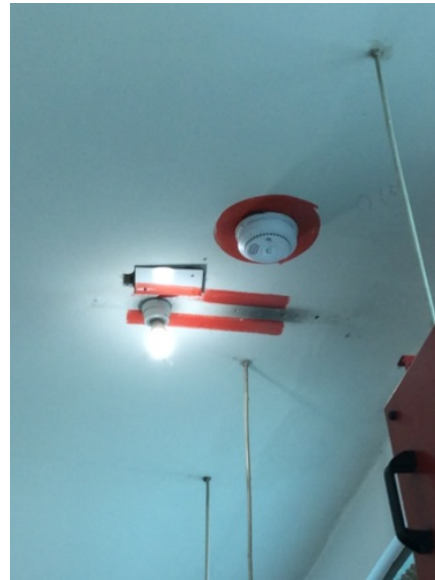
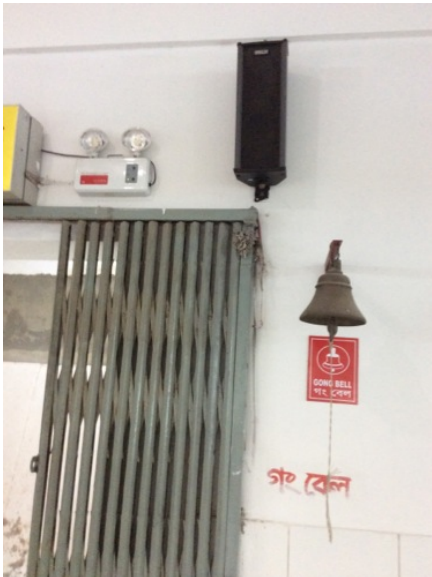
| F-13 | Fire Protection | The building is equipped with single-station smoke alarms. Smoke alarm activation sounds only a local alarm and does not provide automatic fire alarm notification of occupants. | Replace the single-station smoke alarms with automatic smoke detectors tied into the fire alarm system. Configure the fire alarm system to initiate occupant notification upon activation of any two smoke detectors in addition to the manual fire alarm stations. | Within 6 months |

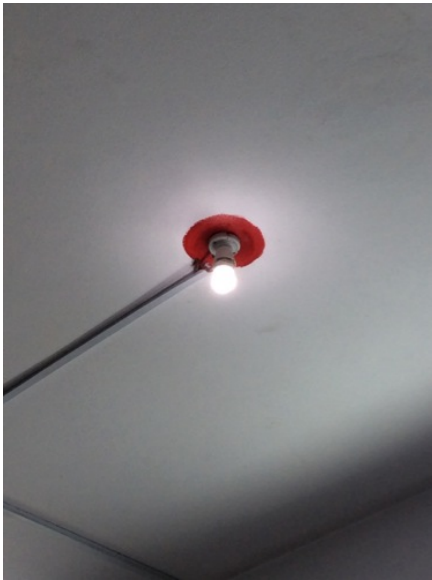
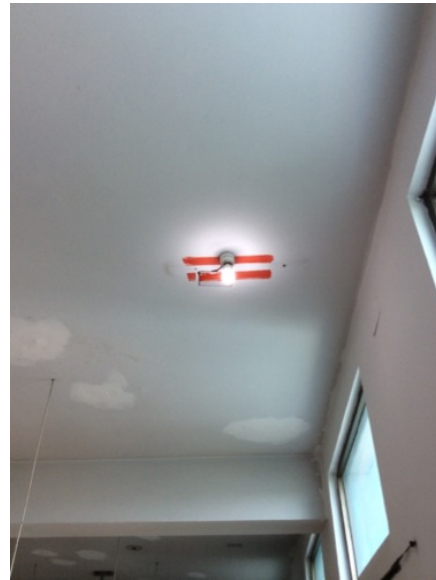
| F-14 | Egress Lighting | Based on the number and location of emergency lights observed, adequate illumination levels are not anticipated along egress routes. | Test the emergency lighting system on each floor and provide additional emergency fixtures to provide adequate illumination along the means of egress. Provide a minimum illumination of 10 lux at the floor level within exit stairs and exit discharge paths and minimum 2.5 lux along exit access aisles. | Within 3 months |
