# **FIRE SAFETY INSPECTION REPORT**

**Factory Name: Flamingo Fashions Limited (Unit:2)**

**ACCORD ID: 12756**

**ADDRESS: Mariali, Joydebpur, Gazipur, Bangladesh.**

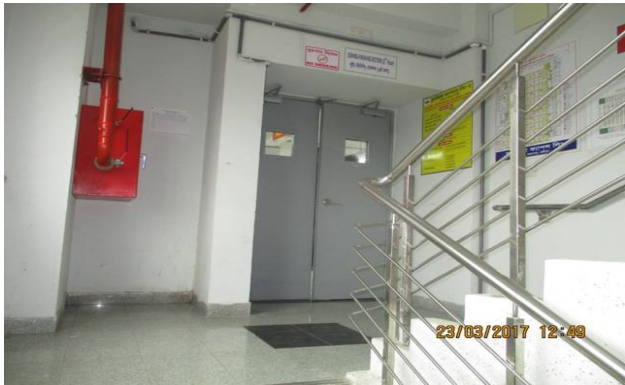
| SI No. | Category | Findings | Required Action | Remediation Time Frame | Pictorial Evidence |
|---|---|---|---|---|---|
| 1 | Fire Rated Construction (Building A & B) | All exit stairs are not separated from work areas and other spaces on each floor by fire rated construction. Fire doors have been installed but Factory shall ensure that installed fire doors accessories are working properly and doors are always closed until the installation of magnetic door holder device and interfaced with FACP at required locations. Factory has to submit the checklist and certification regarding the fire rating of the total door set. | Provide minimum 1.5-hr fire rated doors and seal all unprotected openings to separate the exit stairs from work areas and other building spaces on all floor levels. Ensure that the fire doors are self-closing and positive latching and that they are provided with fire exit (panic) hardware where serving production floors. If fire doors are required to be held open for functional reasons, provide automatic closing devices tied to the fire alarm system. | Within 3 months | |

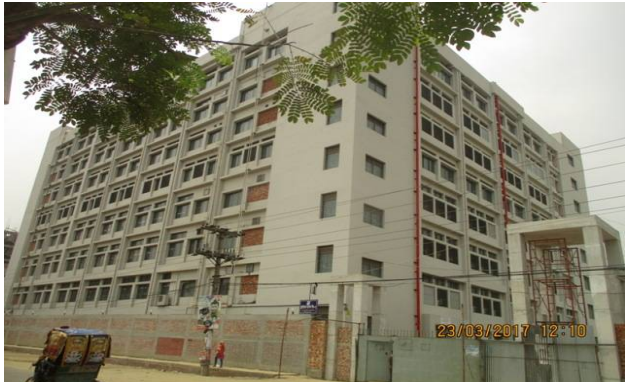
| Sl No. | Category | Findings | Required Action | Remediation Time Frame | Pictorial Evidence |
|---|---|---|---|---|---|
| 3 | Fire Protection<br>(Building: A) | The existing high-rise building with an occupiable floor greater than 23 m (75 ft) above the finished grade is not protected with an approved automatic sprinkler system. The large occupant loads, heavy fuel loading, and anticipated extended egress times warrant sprinkler protection. | Install Sprinkler system alongwith required Standpipe system as per NFPA 13, 14, 20, 22 & 24. Submit the Design & Drawing to ACCORD for review. | 6 months for design and 12 months for installation | |
