FIRE SAFETY INSPECTION REPORT

Knit Horizon Ltd.

ACCORD ID: 12524

Holding-36/1, Block-E, Boherarchala, Sreepur, Gazipur

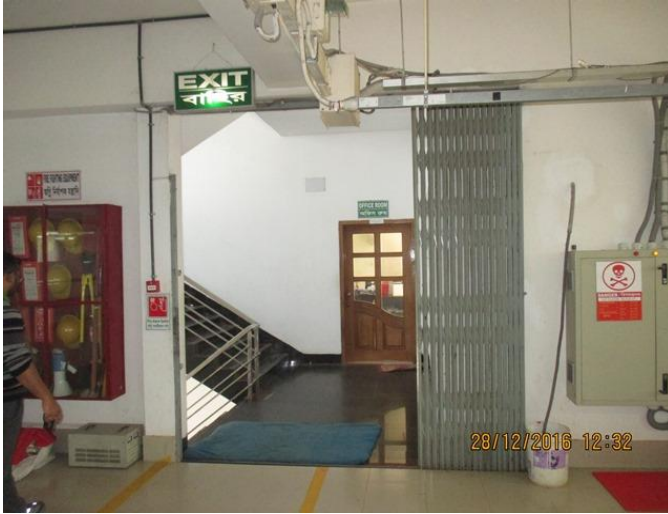
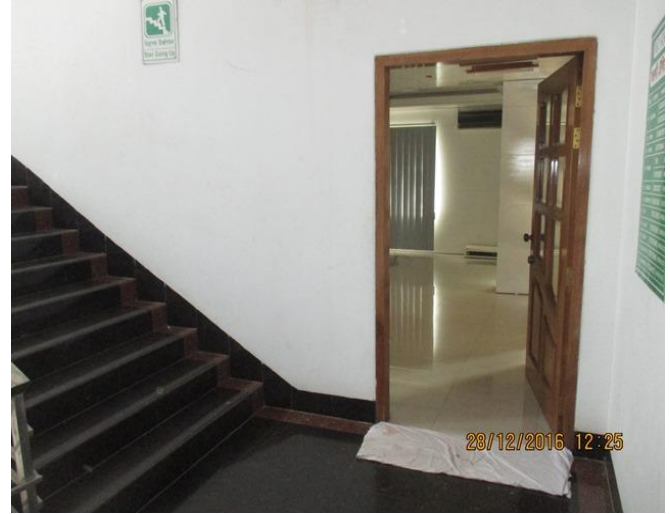
No.	Category	Finding	Recommendation	Remediation Timeframe
F-1	Fire Rated Construction	Exit stairs are not separated from work areas & other spaces on each floor by fire-rated construction due to unprotected openings and penetrations.	<p>Separate the exit stairs from work areas and other building spaces on all floor levels by minimum 2- hr fire-rated construction. Provide minimum 1.5- hr fire rated doors and seal all unprotected openings and penetrations to maintain the fire separation.</p> <p>Ensure that all fire doors are self-closing and positive latching, and are provided with fire exit (panic) hardware where serving production floors or assembly occupancies.</p> <p>If fire doors are required to be held open for functional reasons, provide automatic-closing devices tied to the fire alarm system.</p>	Within 3 months

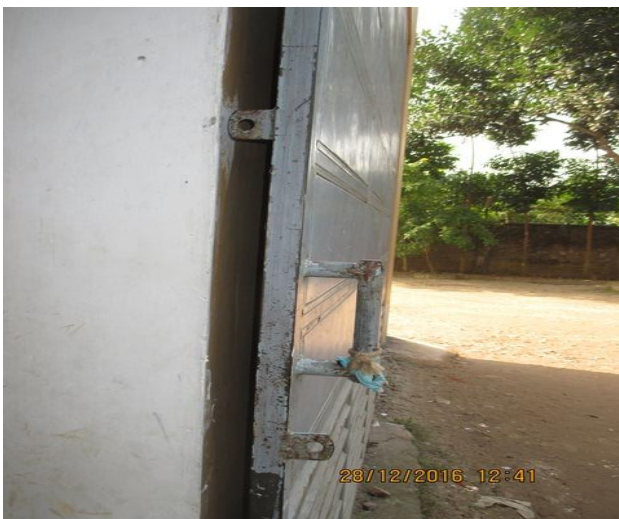
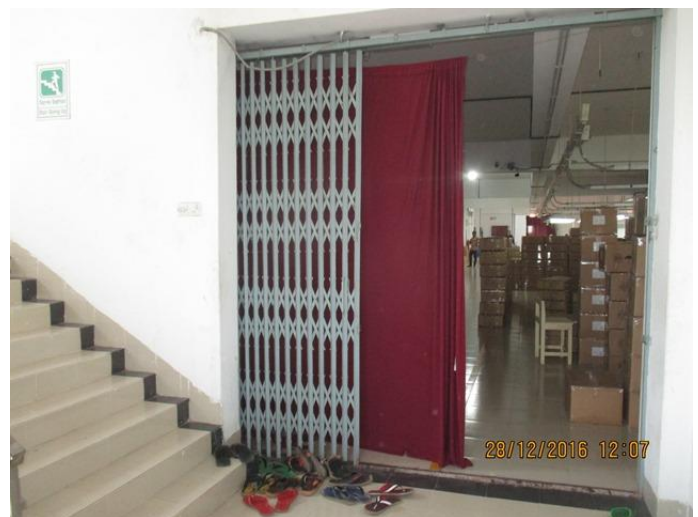
F-2 Egress Egress gates on the all floor with locking features are provided at all exits & exit discharge.

Remove locking features from all egress gates.

Immediately

If locks are required for security reasons, utilize special door locking features complying with ACCORD standard 6.8.2.

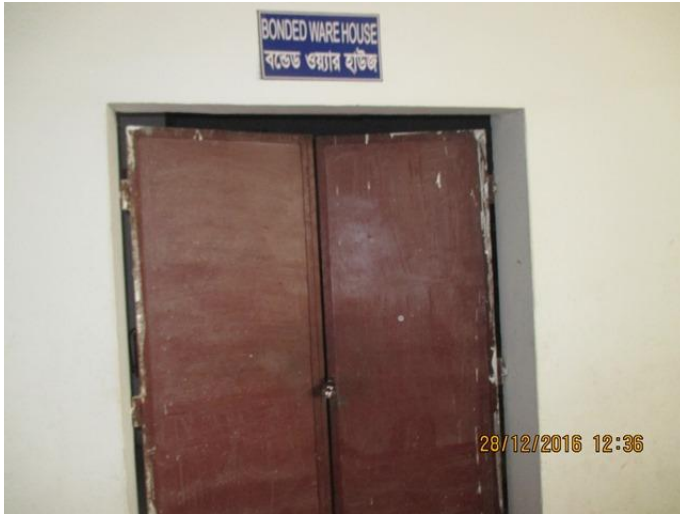
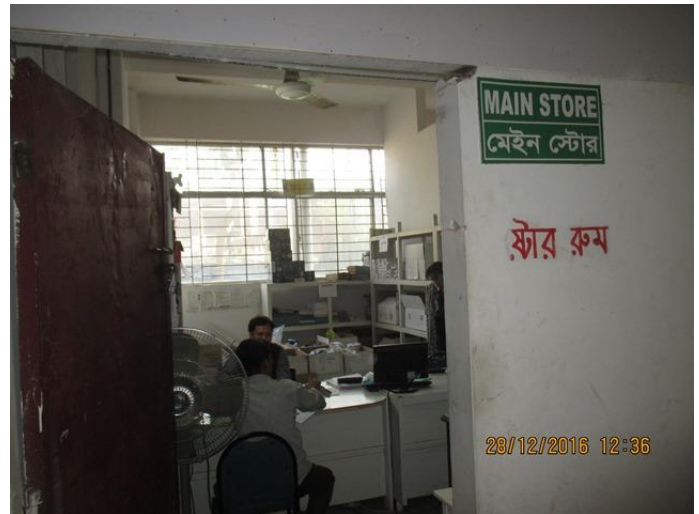
F-3	Fire Rated Construction	Room on the ground floor used for combustible storage is not separated by a minimum 1-hr fire-rated construction.	Provide dedicated storage rooms separated by minimum 1-hr fire-rated construction.	Within 3 months
-----	-------------------------	---	--	-----------------

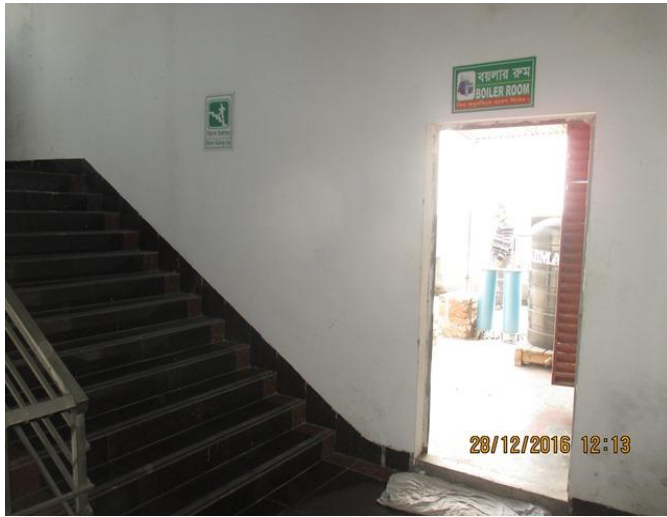
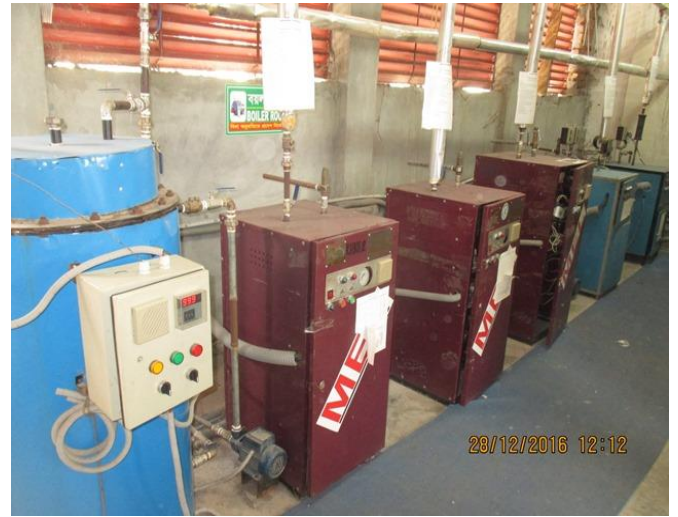
F-4	Fire Rated Construction	The boiler room on the 4 th floor is not separated from the exit stair by fire-rated construction.	Separate the boiler room by a minimum 2-hr fire-rated construction. Seal and/or protect all openings to maintain the required fire separations. Provide proper ventilation and consult a qualified engineer. If applicable: When located to the exterior of a building, separate the boiler by a minimum distance of 3m (10 ft).	Within 3 months
-----	-------------------------	---	---	-----------------

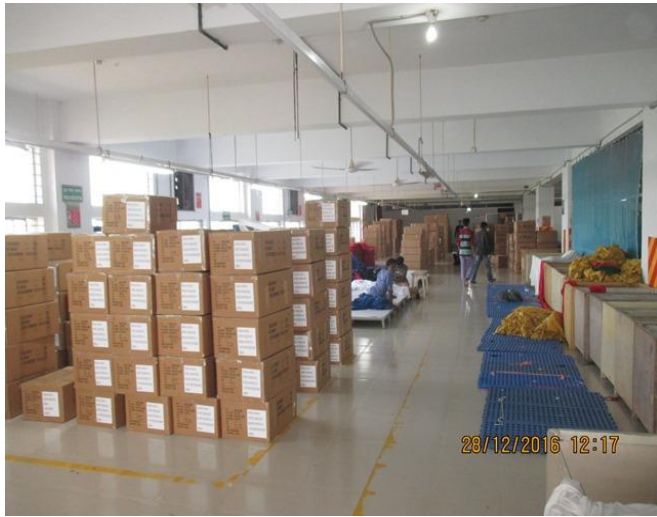
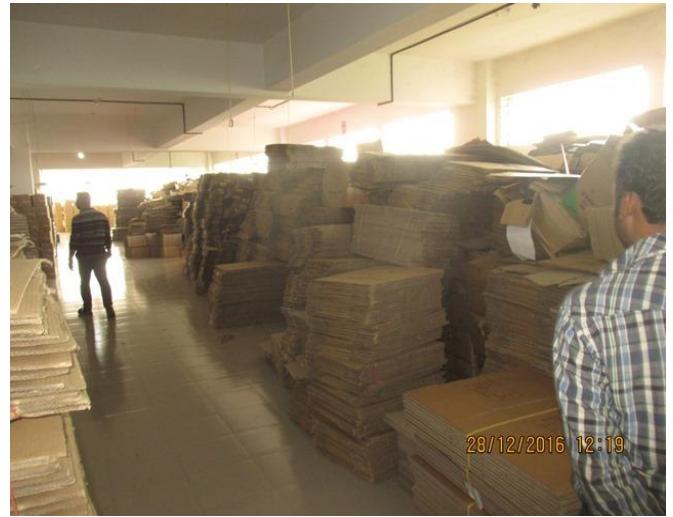
F-5 Fire Rated Construction

Areas on the ground, 3rd and 4th floor used for combustible storage open to the factory are not properly defined and/or not within limits.

Provide defined storage areas and limit the storage arrangement as follows:

Maximum height of 2.45m (8 ft) and maximum area of 23 m² (250 ft²).

If sprinkler protected: maximum height of 3.66m (12 ft) and maximum area of 93m² (1000 ft²).

Separate the areas of unenclosed combustible storage by a minimum clear distance of 3 m (10 ft).

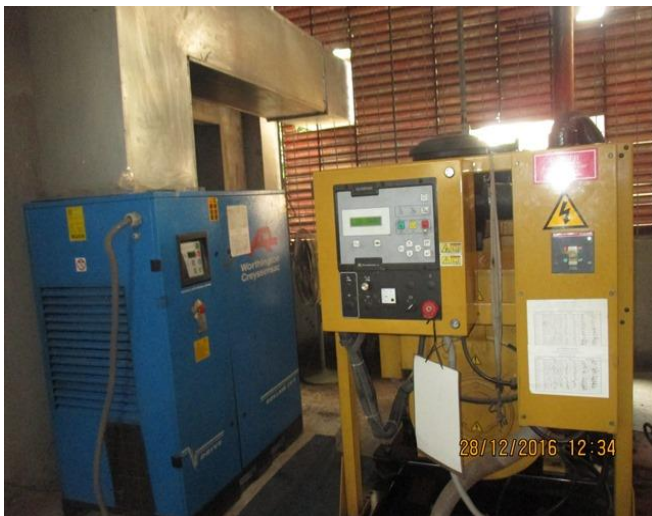
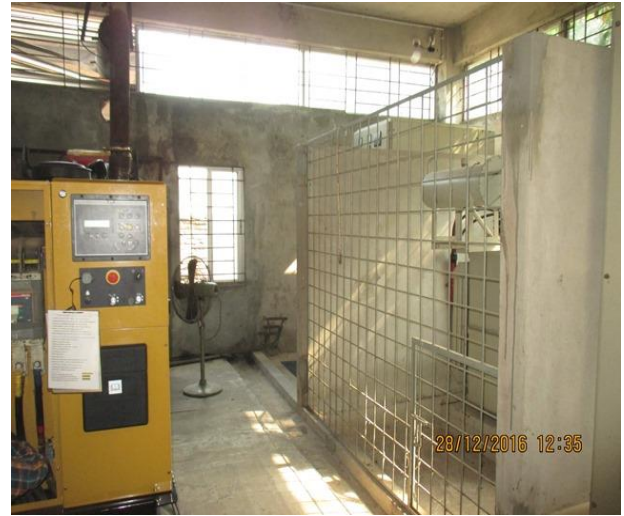
F-6 Fire Rated Construction

The generator room, sub-station room and transformer room on the ground floor is not separated by fire rated construction.

Separate the generator room, sub-station, and transformer room by a minimum 2-hr fire rated construction. Seal or/and protected all non openings and penetrations to maintain the required rating.

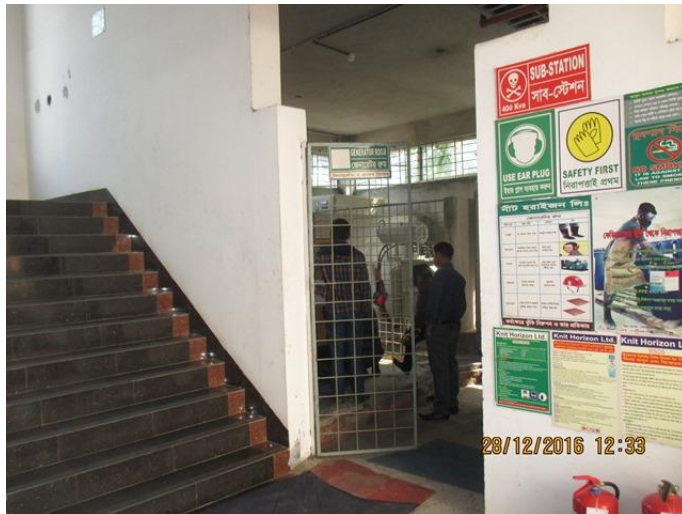
F-7	Fire Rated Construction	Generator and sub-station room and at ground floor discharges directly into the exit stair discharge.	Openings from exit enclosure to sub-station, generator and transformer spaces shall be provided with a vestibule with fire rated construction and openings. Provide a 1.5 hr. fire rated door on the exit stair side and a 1-hr. fire rated door on the generator, sub-station room side. Ensure that the fire rating of the vestibule construction matches that of the exit stair enclosure.	Within 3 months
-----	-------------------------	---	--	-----------------

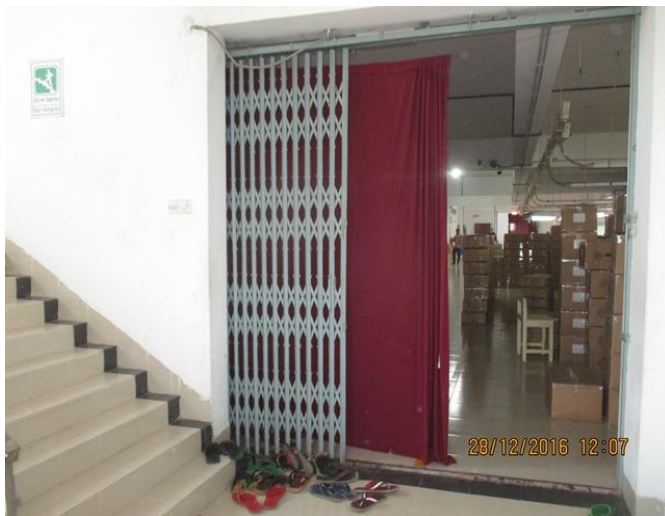
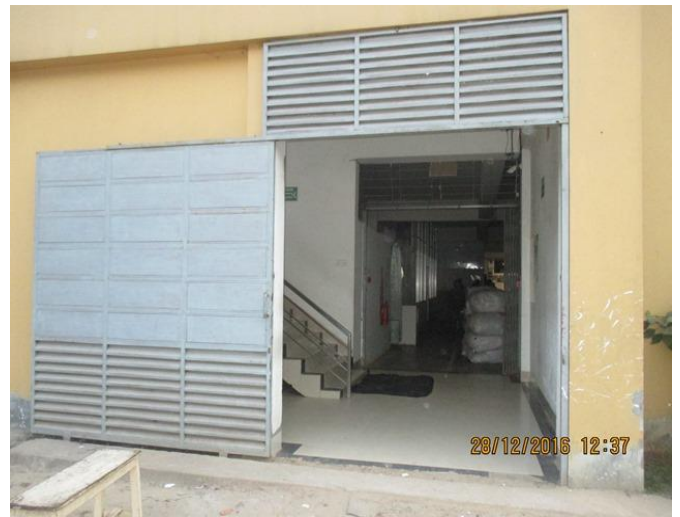
F-8	Egress	Collapsible gates, sliding doors and roll down shutter type doors are provided at the building exits, exit stairs, along egress routes and exit discharge.	Replace all gates, sliding doors and rolling shutters along the means of egress with side-hinged, swinging egress doors. If locks are required for security reasons, utilize special door locking features complying with NFPA 101.	Within 1 month
-----	--------	--	--	----------------

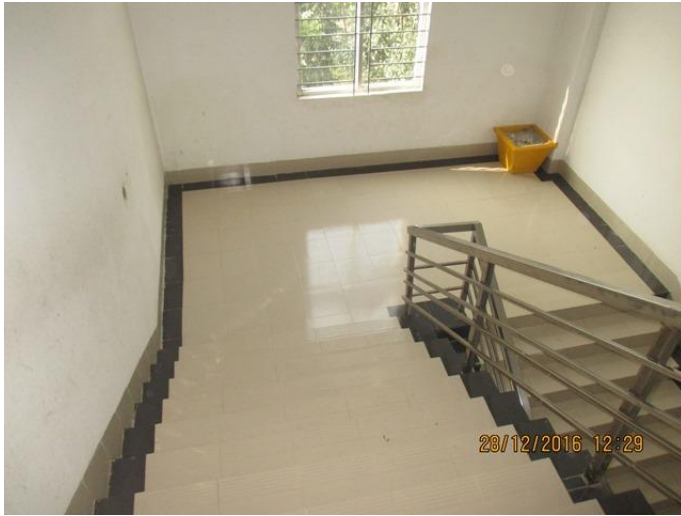
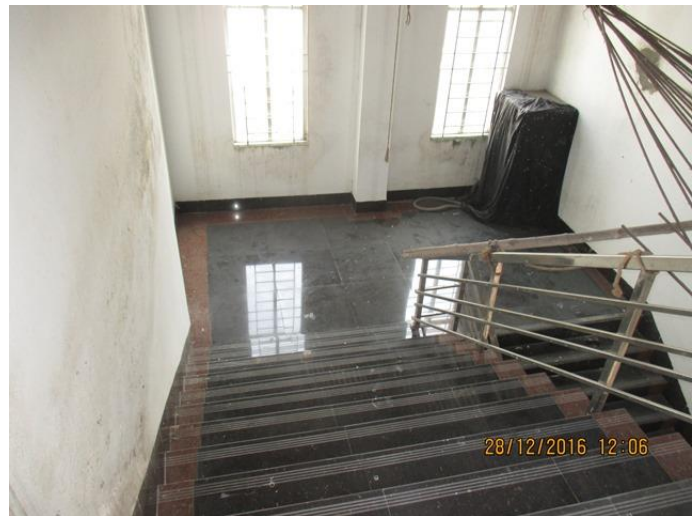
F-9	Egress	Handrails are not provided on both sides of both exit stairs.	Provide handrails on both sides of the exit stair. New handrails shall have a minimum height of 865 mm (34 in.) and a maximum height of 965 mm (38 in.) as measured from the leading edge of the tread. Intermediate handrails shall be provided when the stair width exceeds 2.2 m (87 in.)	Within 3 months
-----	--------	---	---	-----------------

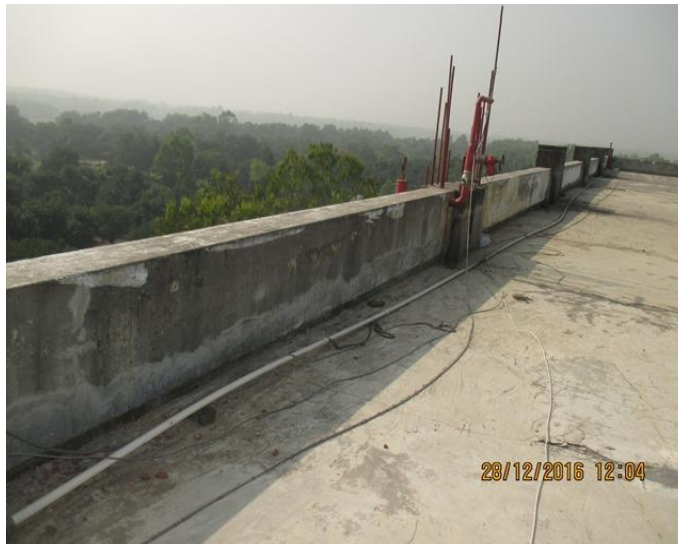
F-10 Egress

Occupiable roof is not provided with an adequate parapet / guard rail.

All occupiable roofs shall be provided with parapets or guards with a minimum height of 1067 mm (42 in.)

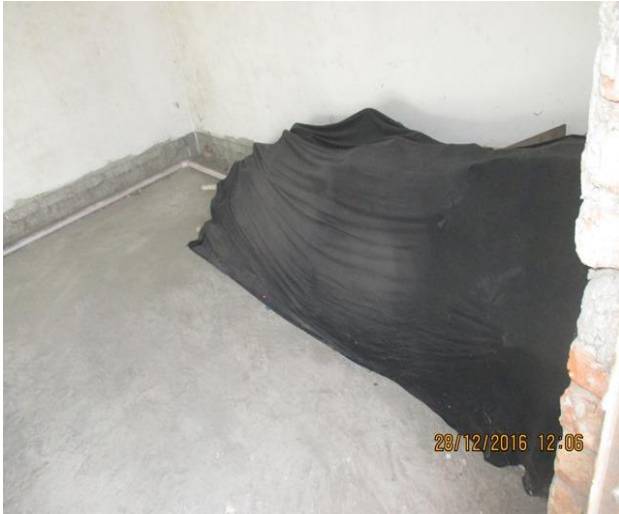
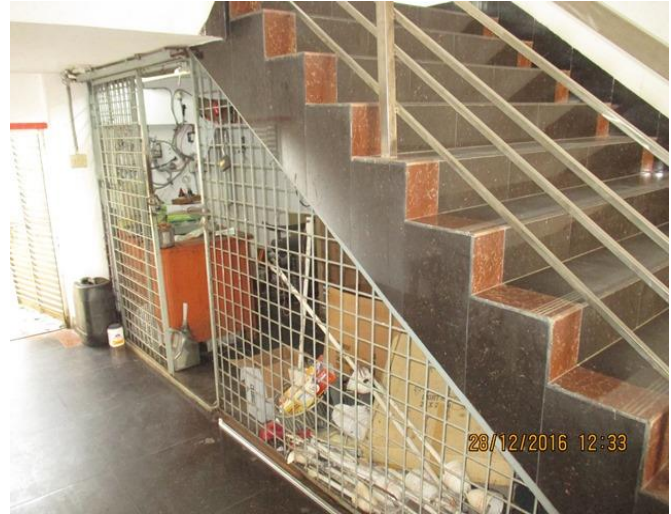
F-11	Egress	Storage was located in the exit stairs.	Remove all storage from exit stairs and egress paths.	Immediately
------	--------	---	---	-------------

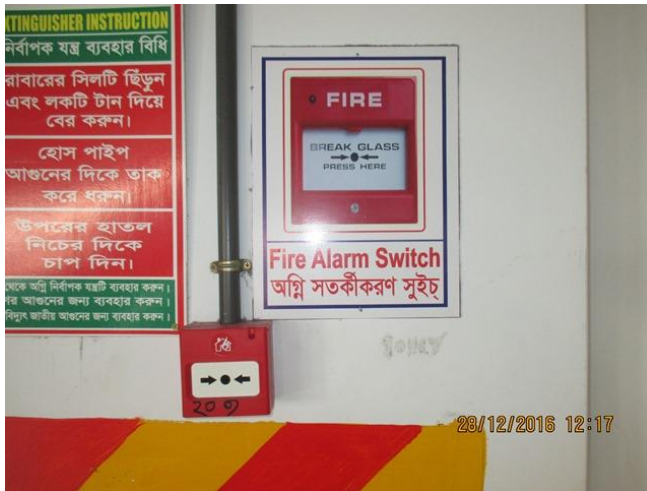
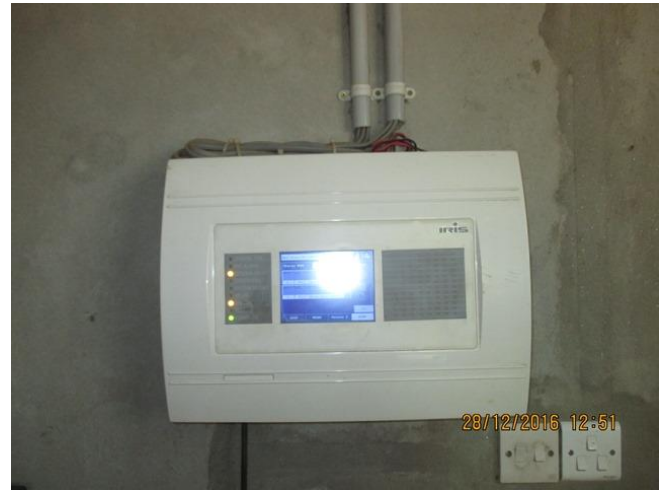
F-13	Fire Protection	The fire alarm system installation requires detailed review to confirm compliance with NFPA 72 and ACCORD standards.	Submit as-built drawings, testing records, equipment certification and other relevant documentation to the ACCORD for review and approval.	Design within 1 month Modify within 6 months (If required)
------	-----------------	--	--	--

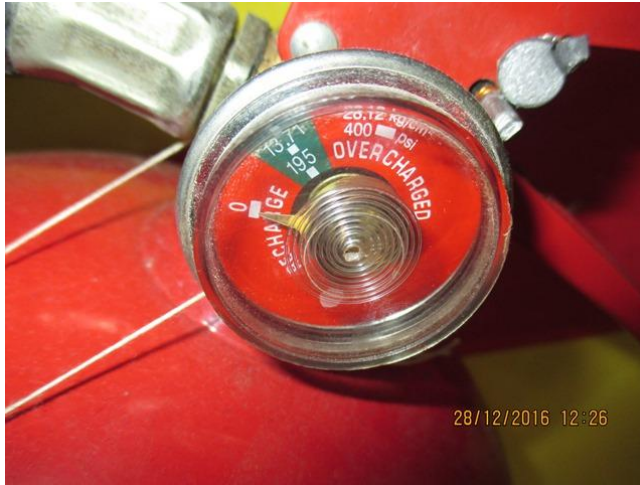
F-17	Fire Protection	Inspection, testing and maintenance of portable fire extinguishers is not in accordance with NFPA 10.	Inspect, test and maintain the portable fire extinguishers and keep written records on-site, in accordance with NFPA 10.	Within 1 month
------	-----------------	---	--	----------------

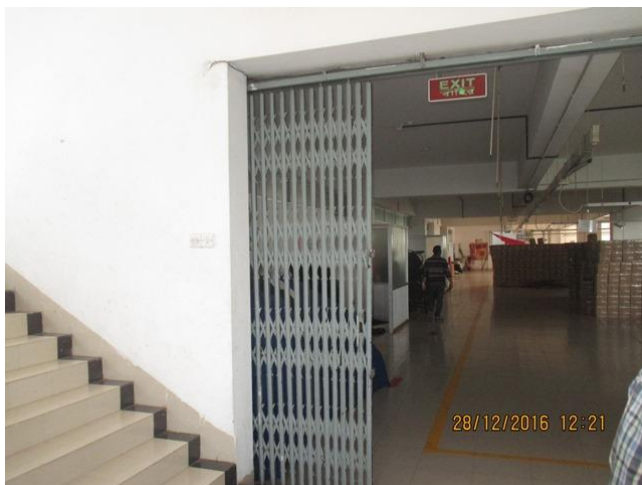
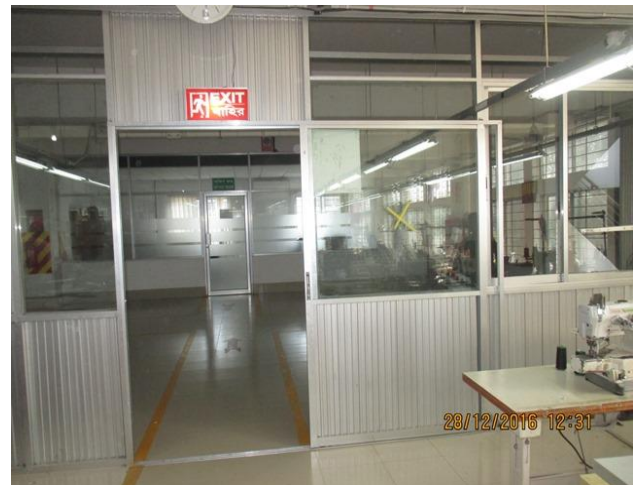
F-18	Egress Lighting	Some lighted exit signs were two-sided, so that they indicated an exit where there were none. At various locations.	Insure that lighted exit signs are only visible from the side that directs people toward an exit path.	Immediate
------	-----------------	--	--	-----------

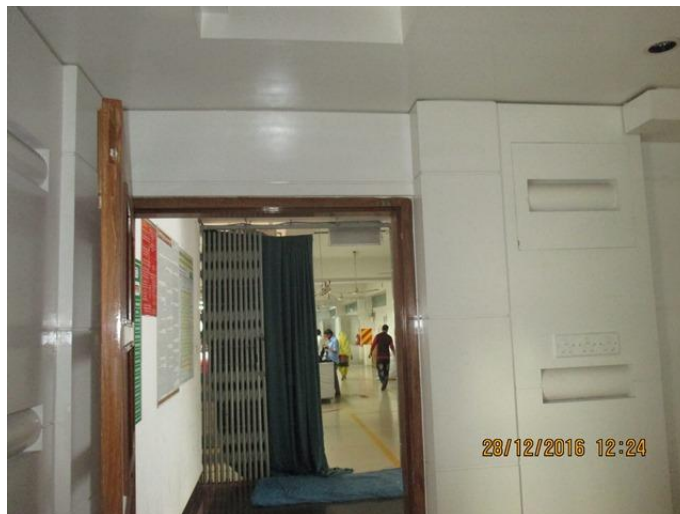
F-19	Egress Lighting	Exit sign not provided at office exits.	Lighted exit signs shall be placed at entrance to an exit. Additional exit signs shall be placed throughout the facility anywhere the continuation of the egress is not obvious. Lighted exit signs shall be provided with either battery backup or uninterruptable power supply systems and shall be continuously illuminated.	Within 1 month
------	-----------------	---	---	----------------
