# **FIRE SAFETY INSPECTION REPORT**

## **INTERNATIONAL CLASSIC COMPOSITE LTD (ICC)**

**NAOJUR, KODDA JOYDEBPUR, GAZIPUR**

March 27, 2014

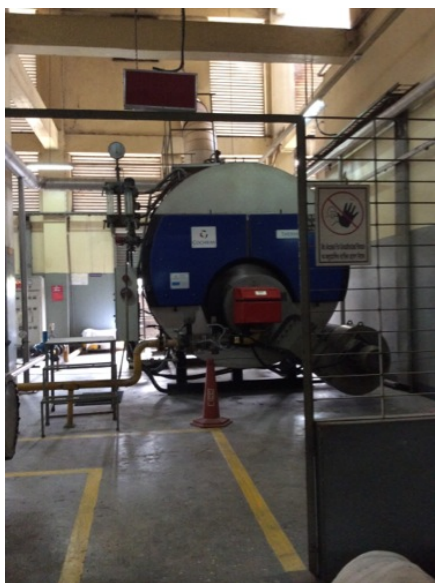
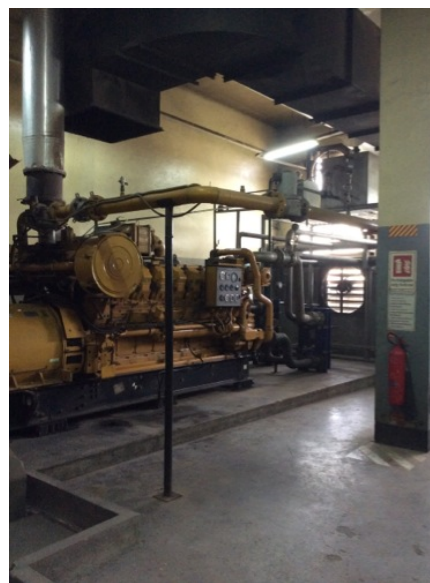
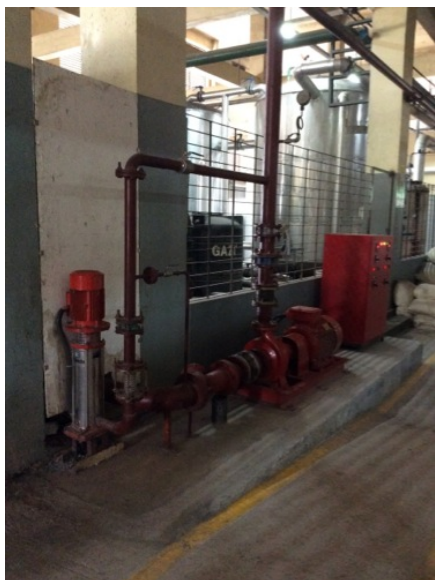
| No. | Category | Finding | Recommendation | Remediation Timeframe |
|---|---|---|---|---|
| F-1 | Fire Rated Construction | The basement floor generator, boilers, and fire pump are not separated by fire-rated construction (openings, non-rated doors, penetrations). | Separate the generator, boilers, and fire pump by minimum 2-hr fire-rated construction. Seal and/or protected all openings to maintain the required fire separations | Within 3 months |

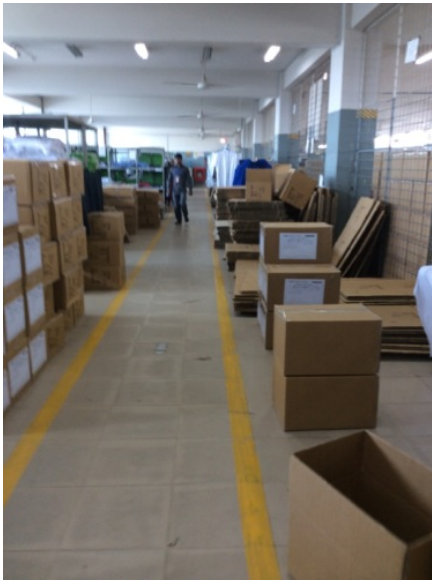
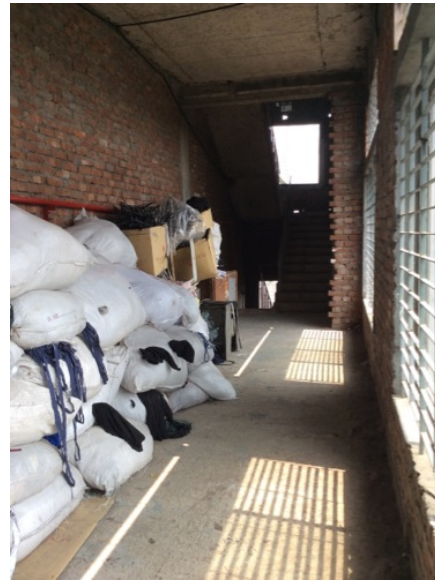
| F-2 | Fire Rated Construction | Areas used for combustible storage are not separated by fire-rated construction.<br>Locations include floors 1, 2, 3, and 4. | Provide dedicated storage rooms separated by minimum 1-hr fire-rated construction.<br><br>Where separate storage rooms are not feasible, provide defined storage areas and limit the storage arrangement as follows:<br>- Maximum height of 2.4m and maximum area of 23m <sup>2</sup><br><br>Separate areas of unenclosed combustible storage by a minimum clear distance of 3m. | Within 3 months |

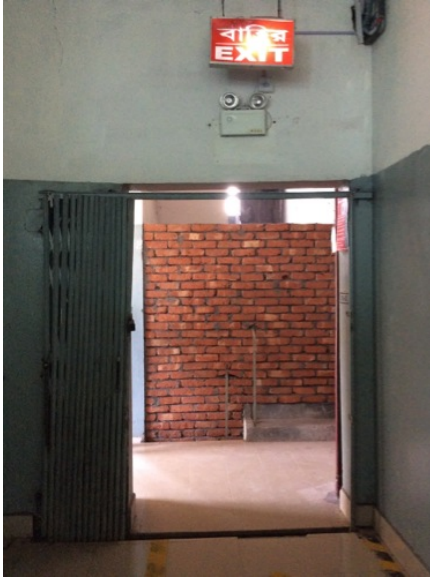
| F-3 | Fire Rated Construction | The exit stairs are not separated from each floor by fire-rated construction. | <p>Provide minimum 1.5-hr fire rated doors and seal all unprotected openings to separate the exit stairs from work areas and other building spaces on all floor levels. Ensure that the fire doors are self-closing and positive latching and that they are provided with fire exit (panic) hardware where serving production floors.</p> <p>If fire doors are required to be held open for functional reasons, provide automatic-closing devices tied to the fire alarm system.</p> | Within 3 months |

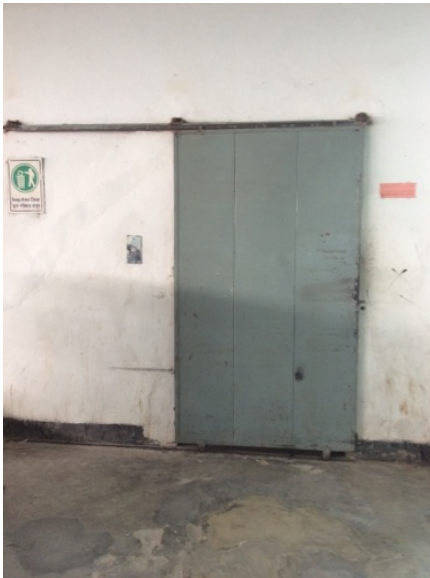
| F-4 | Fire Rated Construction | Unsealed penetrations and openings are located in the elevator shaft ways. | Provide minimum 1.5-hr fire rated doors and seal all unprotected openings to elevator shafts. | Within 3 months |

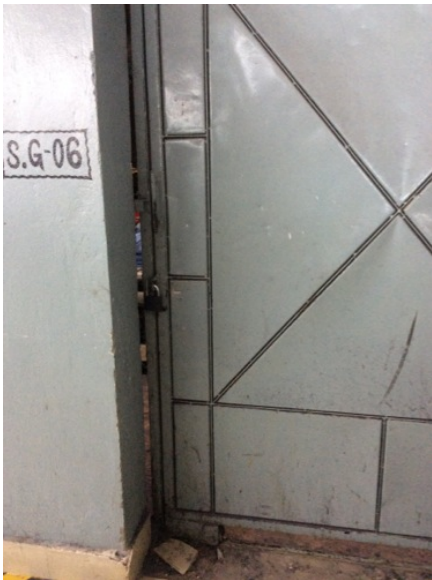
| F-5 | Egress | <p>Egress doors / gates with locking features are provided at building exits, exit stairs, along egress routes, and means of exit discharge.</p> <p>Not all gates/doors within the factory were open and unlocked during the inspection.</p> | <p>Remove locking features from all egress doors / gates including Market entrances/exits that serve the high-rise.</p> <p>If locks are required for security reasons, utilize special door locking features complying with NFPA 101.</p> | Immediate |

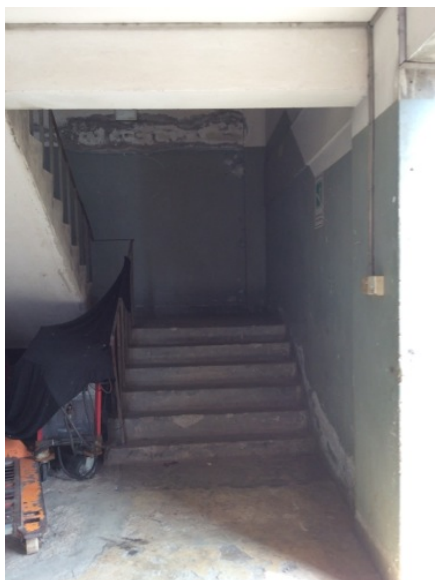
| F-6 | Egress | <p>Combustible storage (e. g. trash cans) was located in the exit stairs.</p> | <p>Remove all storage from exit stairs and egress paths.</p> | Immediate |

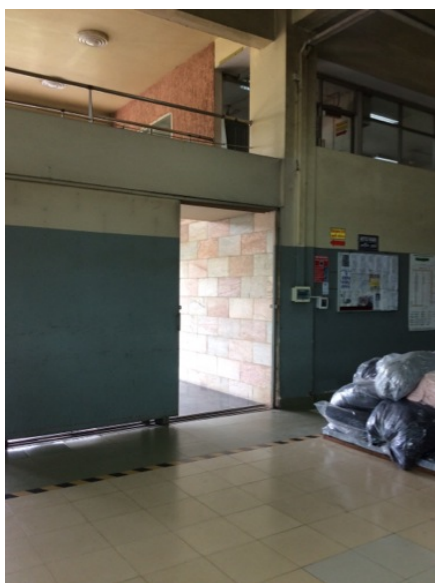
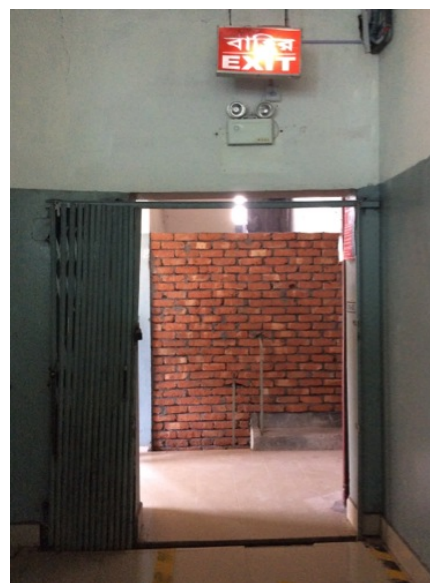
| F-7 | Egress | Collapsible gates / sliding doors are provided at building exits, exit stairs, along egress routes, and means of exit discharge. | Replace all gates / sliding doors along the means of egress with side-hinged, swinging egress doors. If locks are required for security reasons, utilize special door locking features complying with NFPA 101. | Immediate |

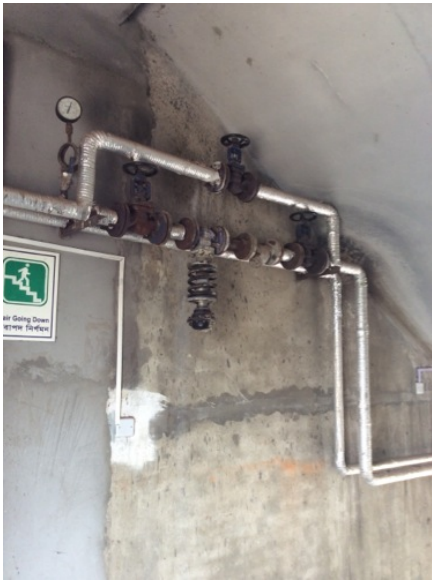
| F-8 | Egress | Steam piping is routed through the exit stairwell. | Re-route steam pipe work outside of exit enclosure. | Within 3 months |

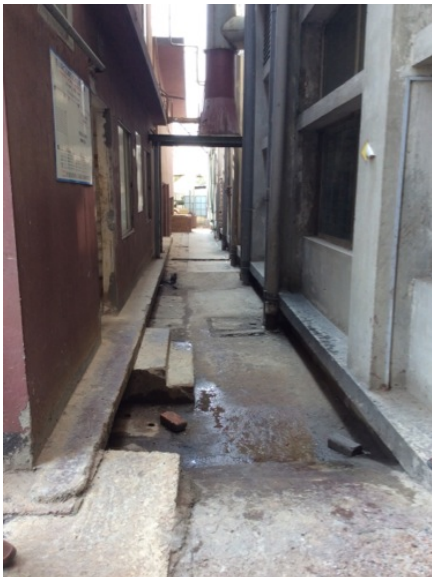
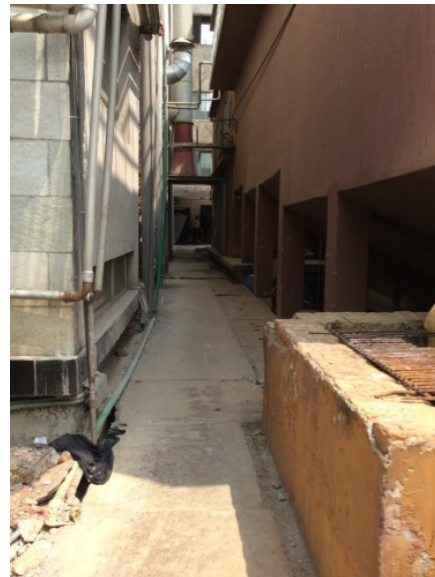
| F-9 | Egress | The pathway from the east exit stairwell to the assembly area is a 5 ft wide uneven pathway between the factory and the water treatment plant. The pathway is exposed to multiple unprotected openings from the factory area. | Provide minimum 2-hour fire rated separation between the factory and the exit passageway. | Within 3 months |

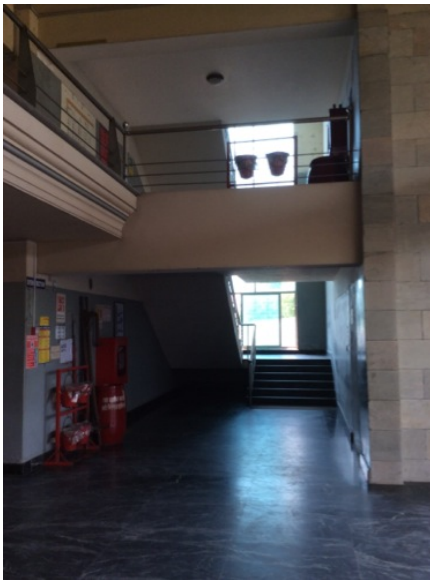
| F-10 | Egress | <p>The southwest exit stair discharges inside the building to the entrance lobby on the ground floor.</p> <p>The west stair serving the basement and mezzanine level discharges on the ground floor into the factory area.</p> | Provide 2-hr fire-rated exit passageways from each stairwell leading directly outside. | Within 6 months |

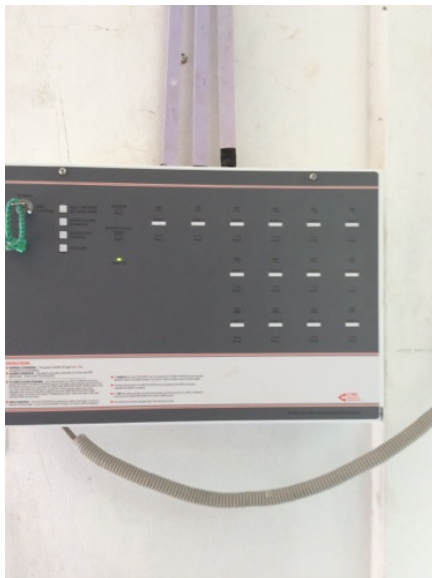
| F-12 | Fire Protection | <p>The manual fire alarm system is antiquated, not a listed system, and does not provide alarm and notification features consistent with acceptable standards. The automatic fire alarm system is a zoned (not addressable) system served by a conventional fire alarm panel that did not appear to be a listed system. System smoke detectors do not provide full coverage automatic smoke detection in all areas.</p> | <p>Replace the fire alarm system with a new, listed addressable fire alarm system in accordance with NFPA 72.</p> | <p>Design within 4 months, install within 9 months</p> |

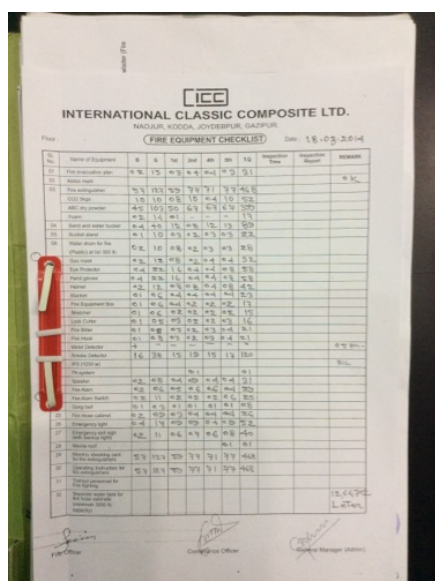
| F-13 | Fire Protection | <p>Inspection, testing, and maintenance records for the fire alarm system were not in accordance with NFPA 72.</p> | <p>Inspect, test and maintain the fire alarm system, and keep written records on-site, in accordance with NFPA 72.</p> | <p>Within 3 months</p> |
