# **FIRE SAFETY INSPECTION REPORT**

**STITCHTONE APPARELS LTD.**

**18/19 STRAND ROAD, CHAMPA TOWER, MAZIRQHAT**

May 26, 2014

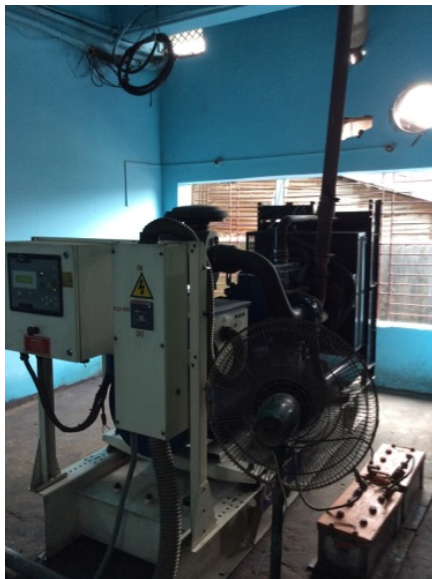
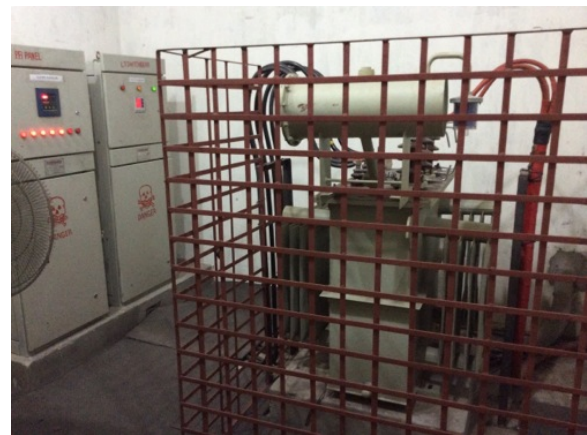
| No. | Category | Finding | Recommendation | Remediation Timeframe |
|---|---|---|---|---|
| F-1 | Fire Rated Construction | The generator, and transformer room is not separated by fire-rated construction that is openings, non-rated doors, penetrations on ground floor east side of the building. | Separate the generator and transformer room by a minimum 2-hr fire-rated construction. Seal and/or protected all openings to maintain the required fire separations | Within 3 months |

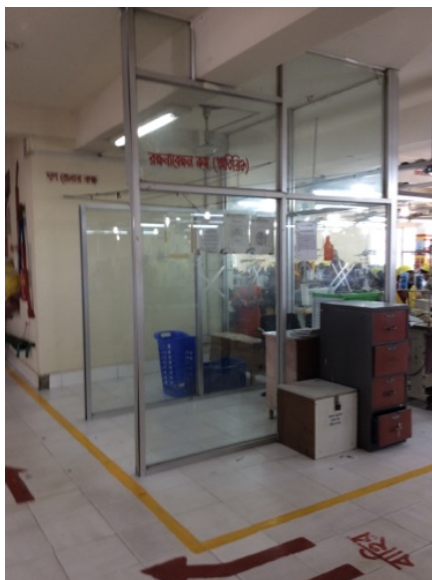
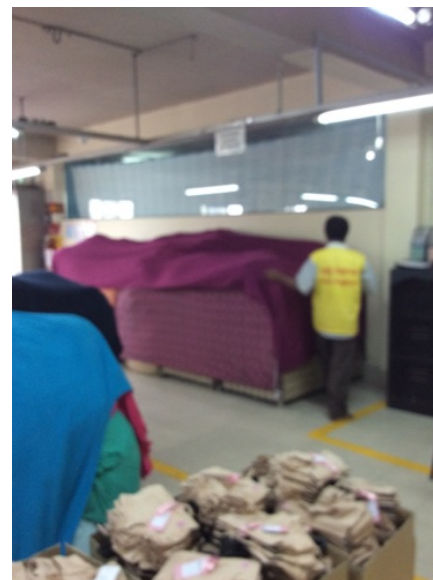
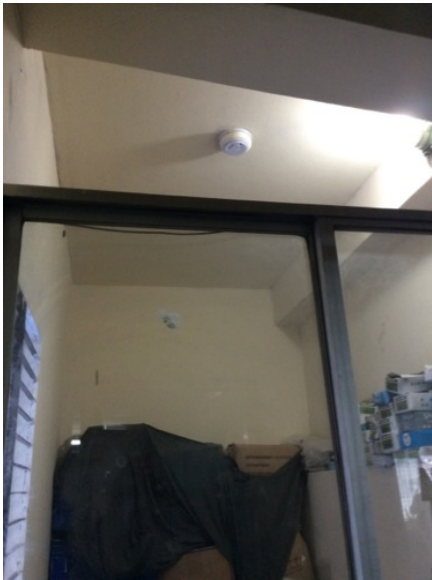
| F-2 | Fire Rated Construction | Areas used for combustible storage are not separated by fire-rated construction on floors 1, 2 and 4. | <p>Provide dedicated storage rooms separated by minimum 1-hr fire-rated construction.</p> <p>Where separate storage rooms are not feasible, provide defined storage areas and limit the storage arrangement as follows:</p> <ul style="list-style-type: none"> <li>- Maximum height of 2.4m and maximum area of 23m<sup>2</sup></li> <li>- If sprinkler protected: maximum height of 3.66m and maximum area of 93m<sup>2</sup></li> </ul> <p>Separate areas of unenclosed combustible storage by a minimum clear distance of 3m.</p> | Within 3 months |

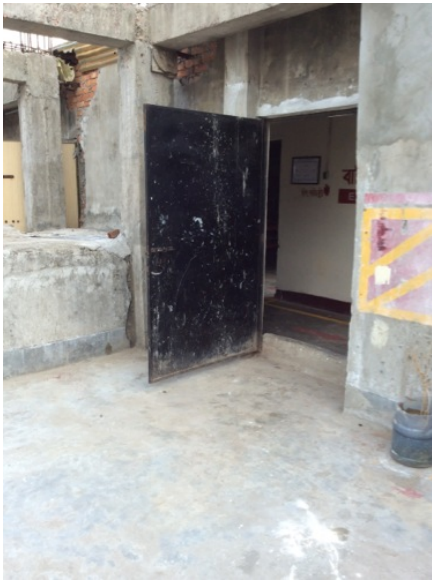
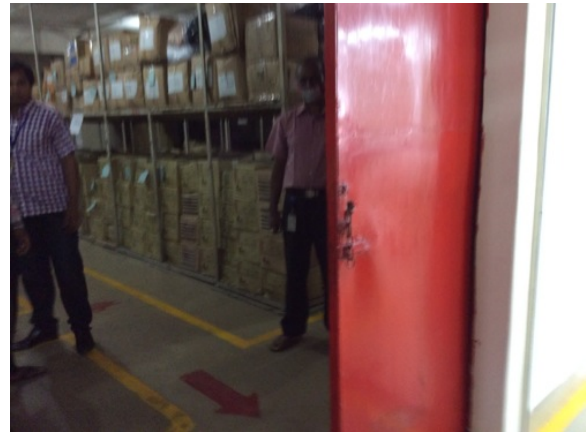
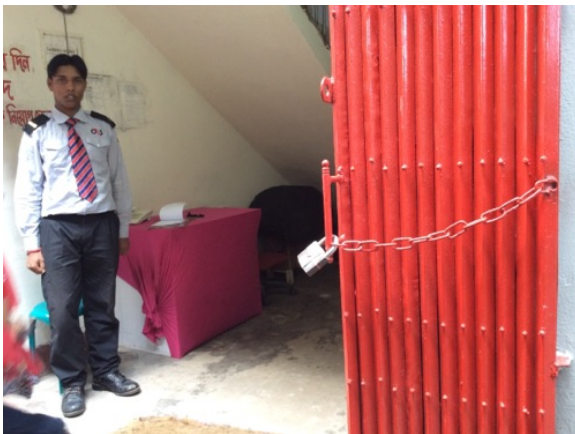
| F-3 | Fire Rated Construction | The exit stairs are not separated from work areas, and other spaces on each floor by fire-rated construction. | <p>Provide minimum 1.5-hr fire rated doors and seal all unprotected openings to separate the exit stairs from work areas and other building spaces on all floor levels. Ensure that the fire doors are self-closing and positive latching and that they are provided with fire exit (panic) hardware where serving production floors.</p> <p>If fire doors are required to be held open for functional reasons, provide automatic-closing devices tied to the fire alarm system.</p> | Within 3 months |

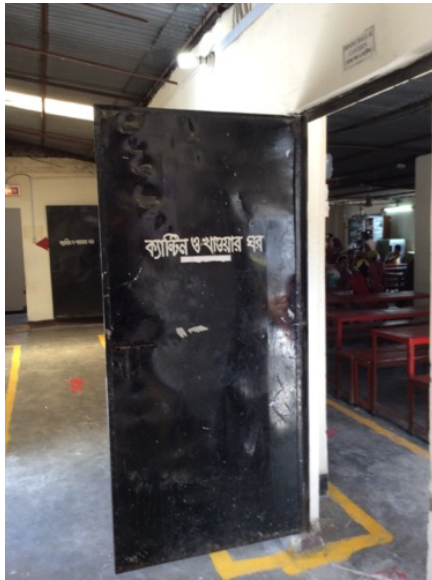
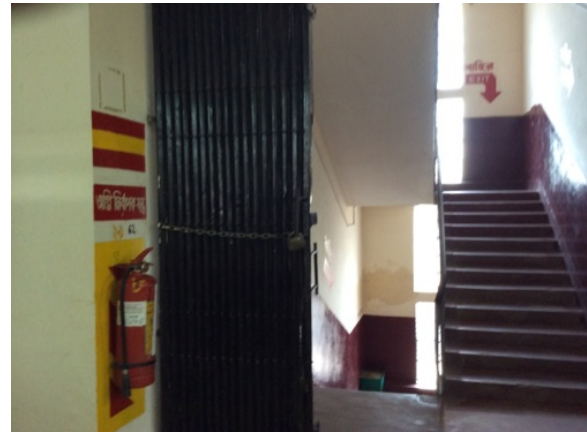
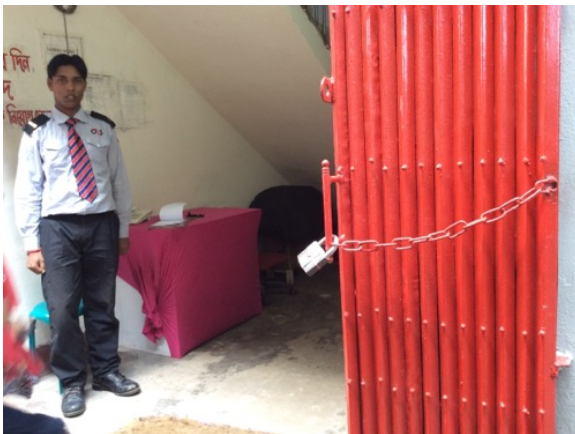
| F-4 | Egress | Egress doors / gates with locking features are provided at building exits, exit stairs, along egress routes, exit discharge on all floors. All gates/doors are open and unlocked during inspection. | Remove locking features from all egress doors / gates.<br><br>If locks are required for security reasons, utilize special door locking features complying with NFPA 101. | Immediate |

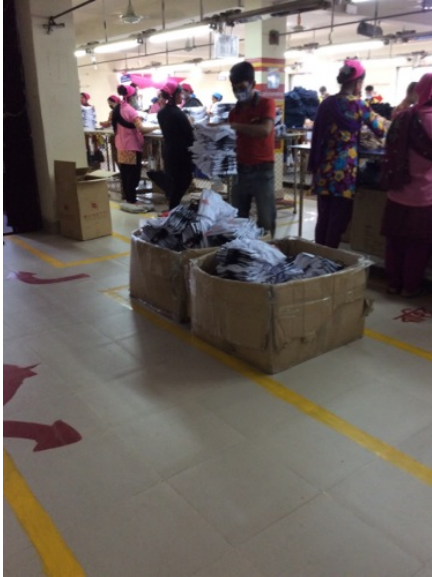
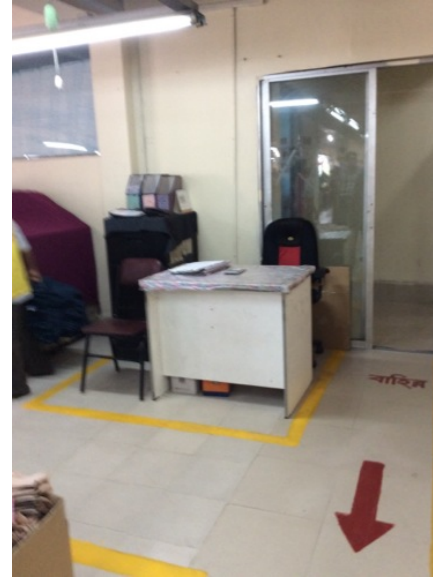
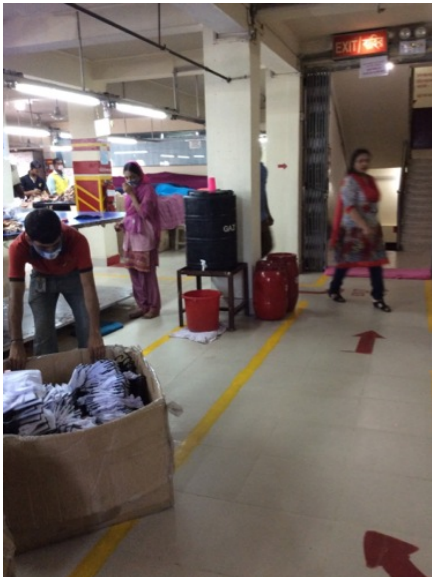
| F-5 | Egress | Storage was located in the egress path on 1st floor. | Keep egress paths and stairs clear of storage. | Immediate |

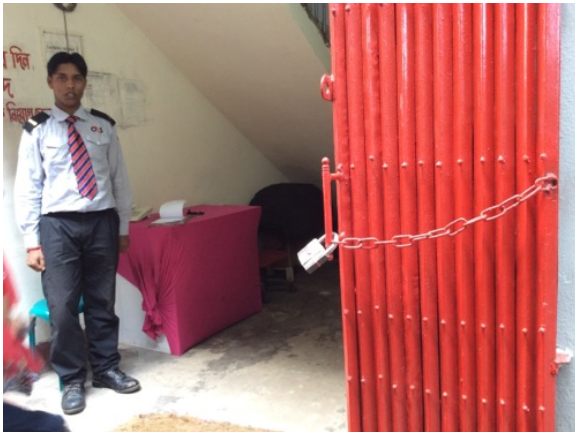
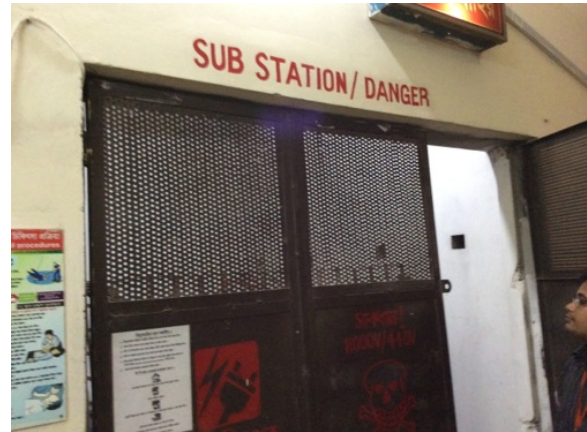
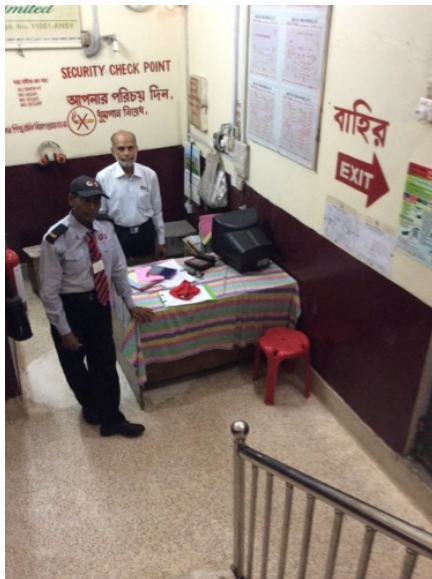
| F-6 | Egress | Storage was located in the exit stair ground floor, east exit stair. | Remove all storage from exit stairs and egress paths. | Immediate |

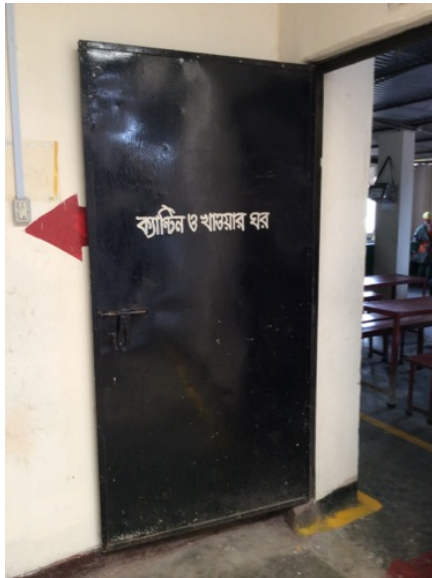
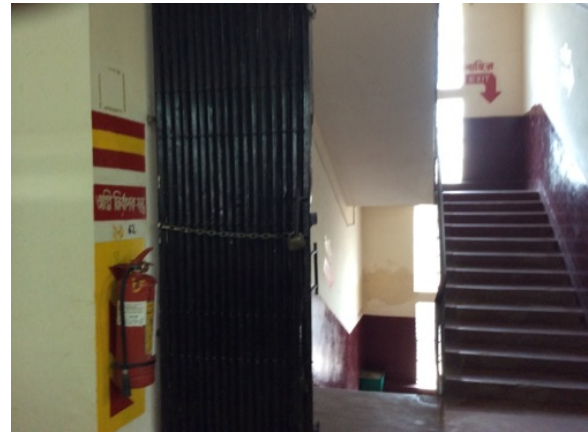
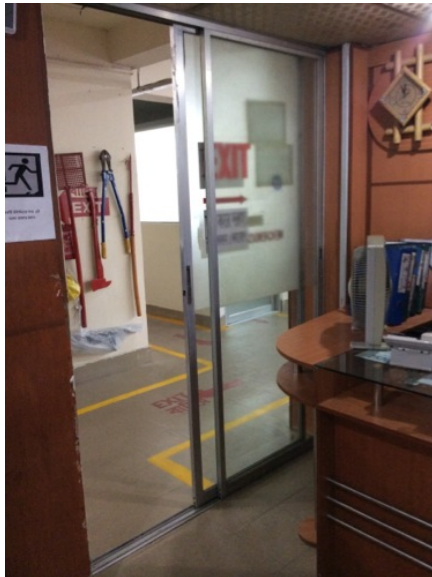
| F-7 | Egress | Collapsible gates / sliding doors are provided at building exits, exit stairs, along egress routes, exit discharge on all floors. | <p>Replace all gates / sliding doors along the means of egress with side-hinged, swinging egress doors.</p> <p>If locks are required for security reasons, utilize special door locking features complying with NFPA 101.</p> | Within 1 month |

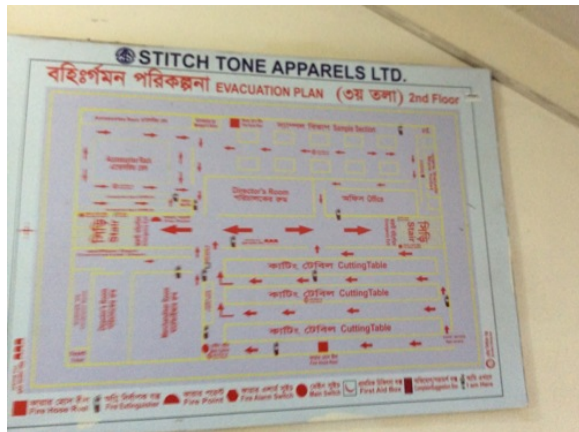
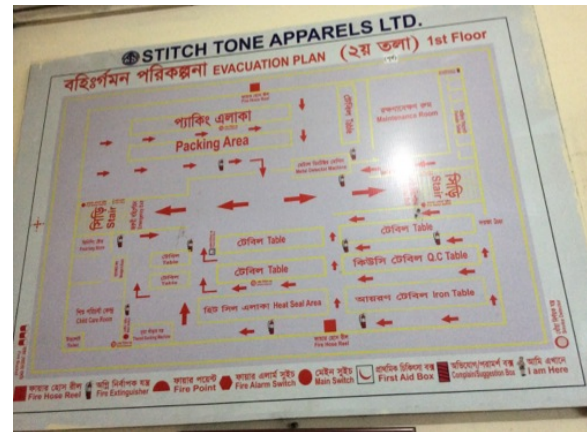
| F-8 | Egress | The width of egress aisles is less than 36-in on floors 1 and 2. The cutting table blocks the aisle width. | Provide minimum aisle widths of 36-in. | Within 3 months |

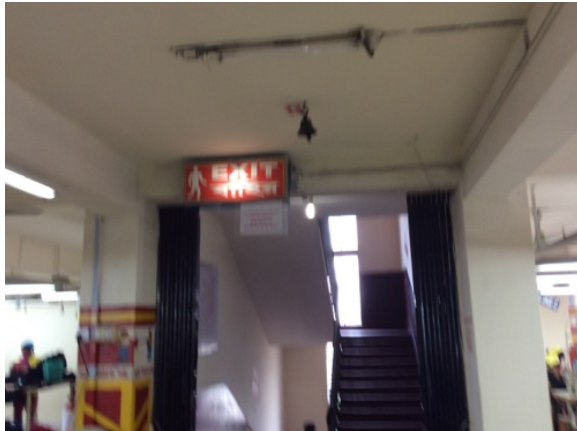
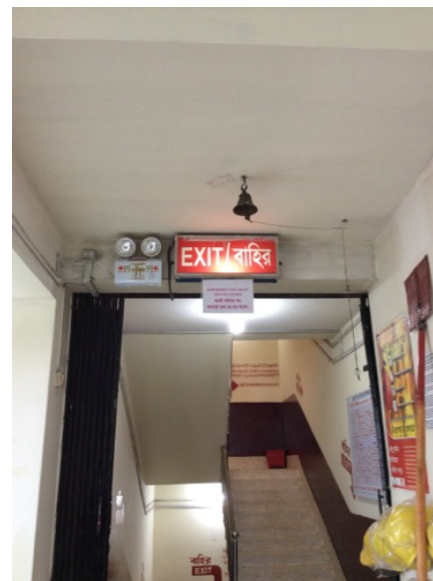
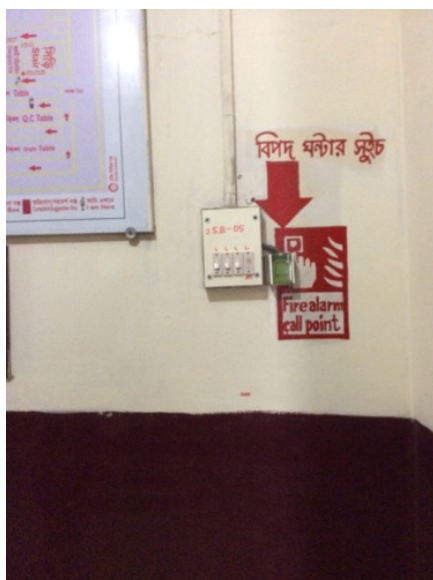
| F-10 | Fire Protection | The fire alarm system is antiquated, not a listed system, and does not provide alarm and notification features consistent with acceptable standards. | Replace the fire alarm system with a new, listed addressable fire alarm system in accordance with NFPA 72. | Design within 4 months, install within 9 months |

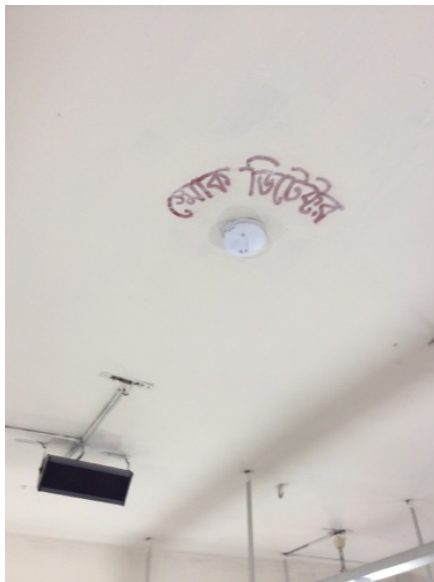
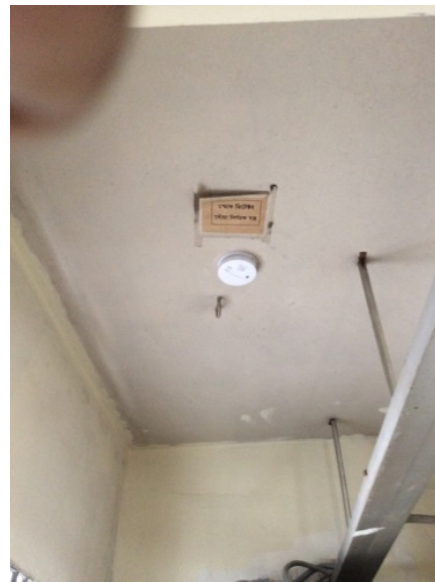
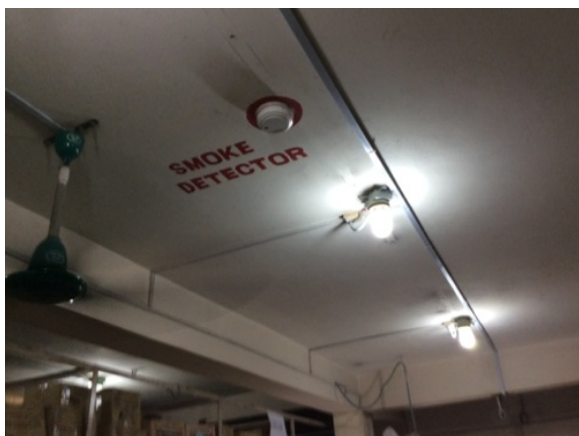
| F-12 | Fire Protection | The building is equipped with single-station smoke alarms. Smoke alarm activation sounds only a local alarm and does not provide automatic fire alarm notification of occupants. | Remove single-station smoke alarms. Provide automatic smoke detection throughout the building in accordance with NFPA 72 | Within 6 months |
